Subject: Arkansas Nuclear One - Unit 2 Docket No. 50-368 License No. NPF-6 2P99 Steam Generator Tubing Inspection Results

# CONDITION MONITORING AND INSPECTION RESULTS ARKANSAS NUCLEAR ONE – UNIT TWO 2P99 MID-CYCLE OUTAGE

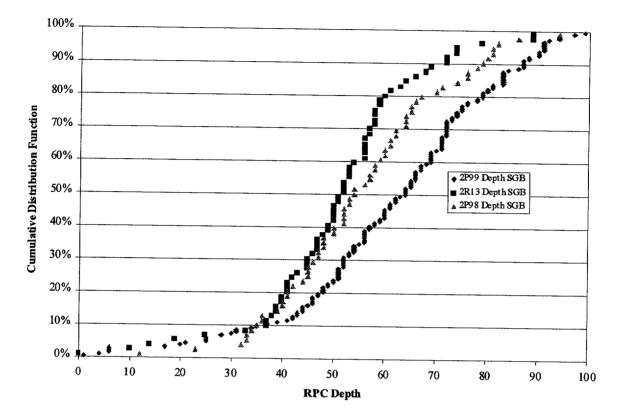
# Figure 1

The eggcrate axial indication of the largest flaw was measured at 85.5% average depth. This value was based on use of the 0.115" pancake coil. The overall depth distribution was also evaluated based on rotating pancake coil (RPC) maximum depth. This is depicted in Figure 1. The overall depth distribution is greater than what was found in the previous two inspections. A change in the growth rate or a change in the probability of detection can cause this difference.

# ANO2 SGB RPC Depth Distribution

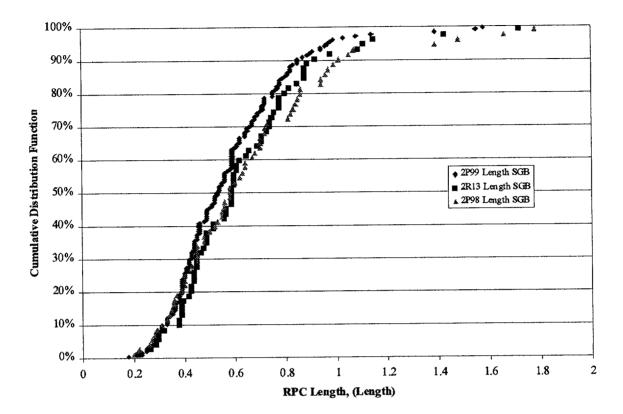
The length distribution from the 2P99 inspection results was compared with the previous outages to determine if a change had occurred. Figure 2 depicts the length distributions for the previous three outages. The overall length distribution is still bound by the previous distributions. The average and extreme value lengths are slightly shorter than those measured in previous inspections.

#### ANO2 SGB RPC Length Distribution

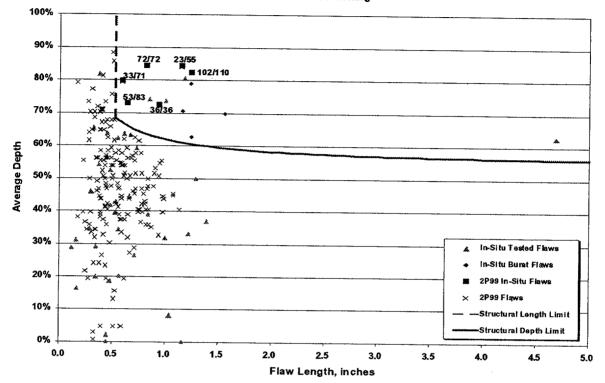
# Figure 3

ANO2 2P99 SGB Axial Flaws: Average Depth vs Axial Length Pressure Test Screening

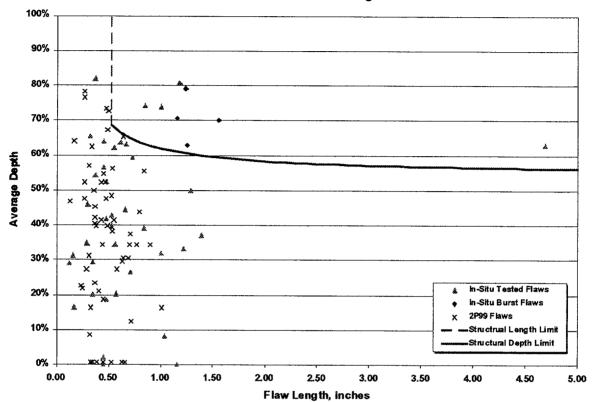
ANO2 2P99 SGA Axial Flaws: Average Depth vs Axial Length Pressure Test Screening

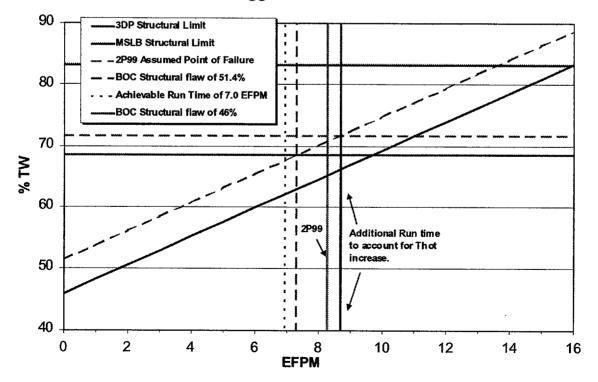
# Deterministic Analysis for Eggcrate Axials

A deterministic evaluation using the worse case identified flaw (72-72) was developed to support initial operation of the plant. Based on conservative growth rates and back calculating a beginning depth, an operating runtime of 7.0 EFPM was determined to be the point at which the worse case flaw would exceed the  $3\Delta P$  criterion. The following figure depicts the data:

The beginning of cycle (BOC) depth was determined by assuming that Tube 72-72 burst at the peak pressure achieved (4147 psig) after 8.3 EFPM. Using a 95/95 growth rate of 28% TW/EFPY yields a BOC depth of 51.4% TW. Use of this BOC depth, in turn results in an operating run time of 7.0 EFPM when adjusted for Thot increases.
