U.S. NUCLEAR REGULATORY COMMISSION
REGION I

Report No. 40-08794/86-01

Facility Name: Molycorp, Incorporated

Inspection Summary: Inspection on July 17, 1986 (Inspection Report Number 40-08794/86-01)

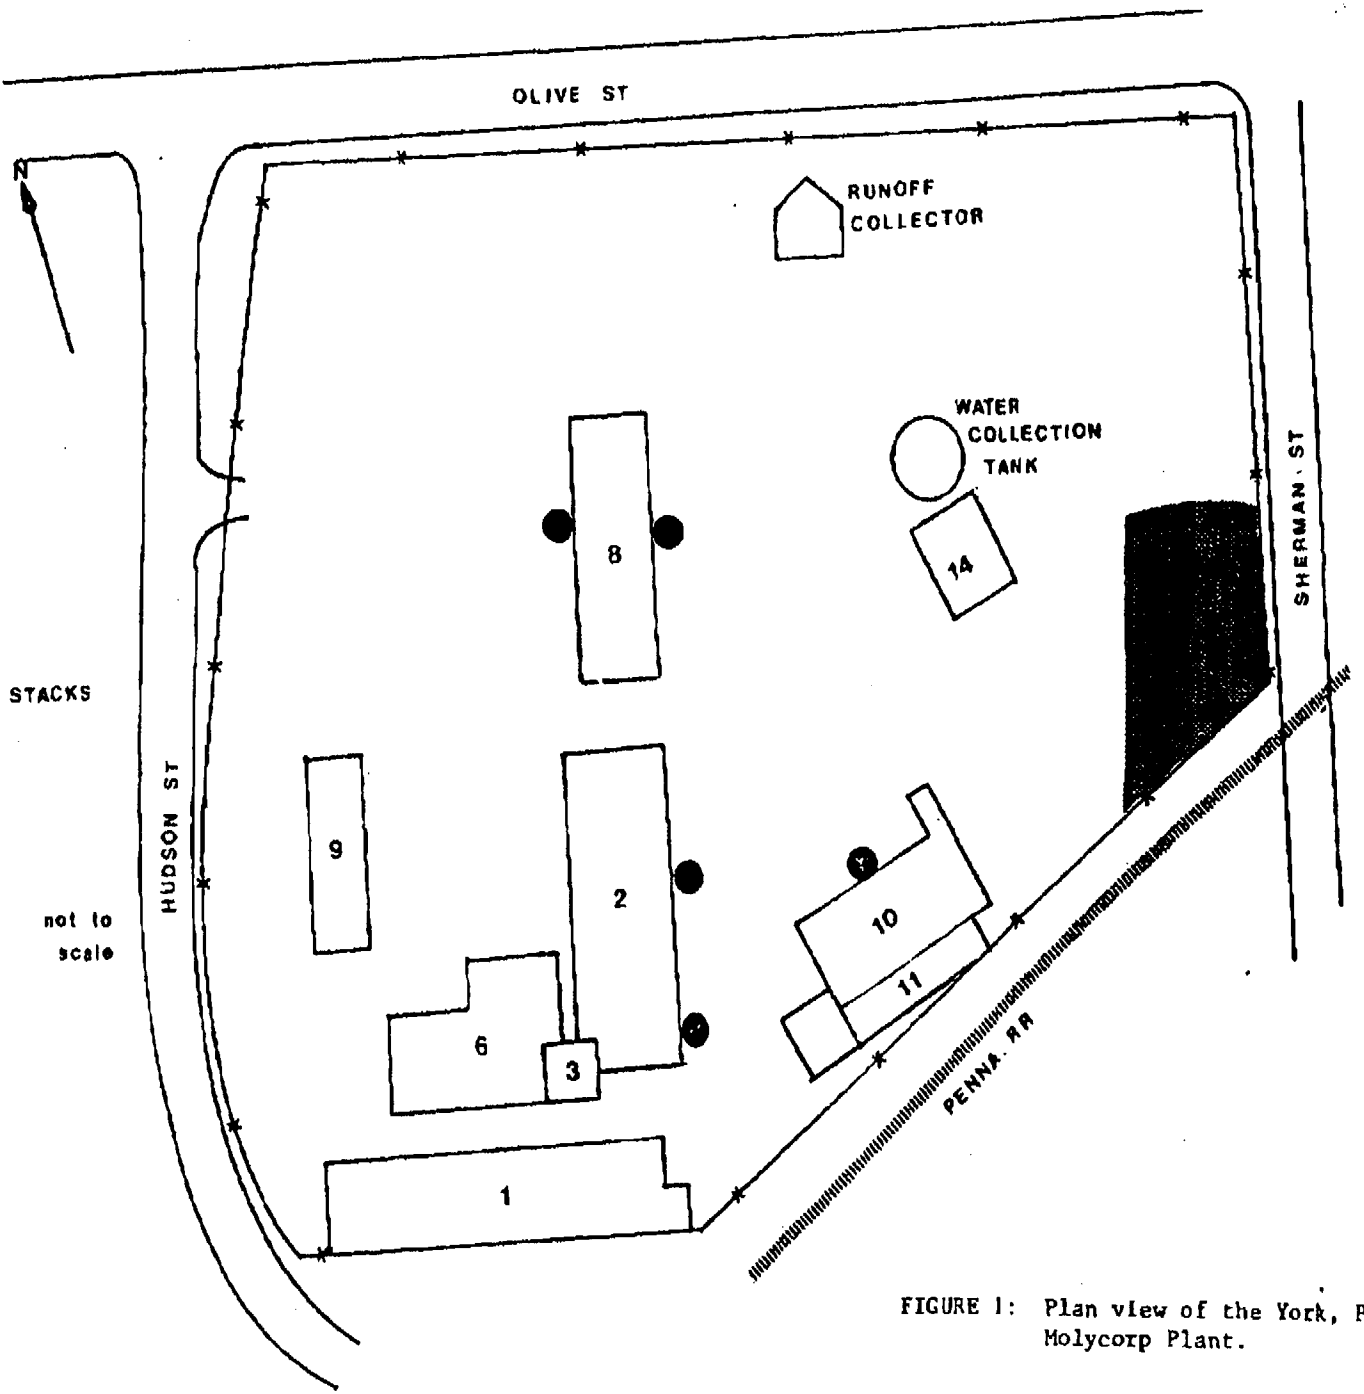
FIGURE 1: Plan view of the York, PA Molycorp Plant.

At the Olive Street end of the facility (see figure 1) is a small pit that holds rain water run off. This pit is built within the natural slope of the ground and any water overflow from the site runs into the pit. The pit drains directly into a quarry located close to the licensee's property line. The licensee controls when the pit contents are discharged to the quarry. The inspectors took samples from the pit and brought them to the Region I Laboratory for analysis. No radioactivity was detected in the sample.
