# **Circuit Failure Mode And Likelihood Analysis**

A Letter Report to the USNRC

December 20, 1999

Sandia National Laboratories  
Albuquerque New Mexico 87185-0747

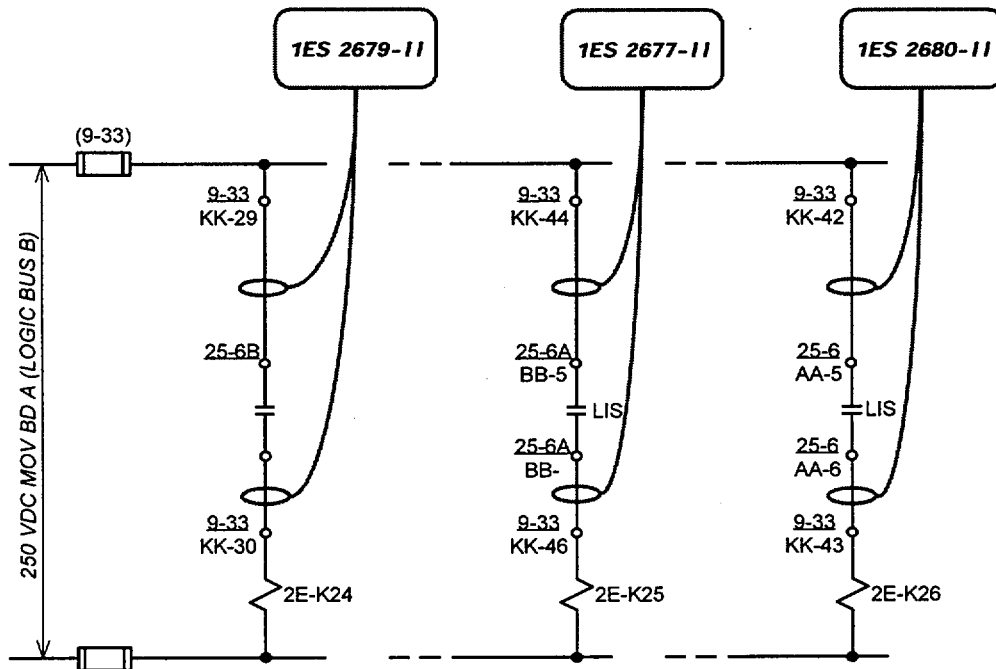
Figure C-1 Partial schematic of ABS relay logic circuit.

These particular relays are intended to initiate alarms for a low water level condition in the reactor. Sheet 2 of 730E929 is referenced in the tables of contact functions on sheet 1 but was not included in the package of electric system drawings. Figure C-1 shows a schematic of the relevant relay branches in the ABS relay logic circuit. Unfortunately, the relay IDs given on the two drawings do not match. It is possible, however, to postulate that internal conductor-to-conductor shorts within an ABS relay logic circuit cable could cause the annunciator alarm.

In addition, information gathered regarding these cables (see Figure C-1) indicates that they all were routed through the zone of fire influence as shown in Table C-4, thus giving credence to the possibility that one (or more) conductor shorts may have occurred to initiate the alarm. It is important to realize that Checkpoint 131 is in the reactor building and is the closest checkpoint to the cable penetration from the cable spreading room where the fire initiated.

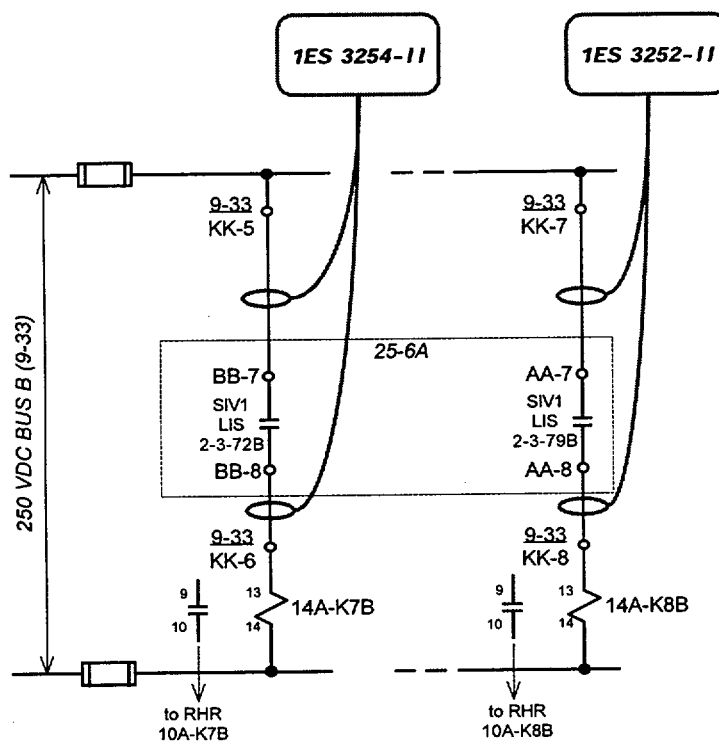
Figure C-2. Partial schematic of Core Spray relay logic circuit.

The GE elementary drawing (730E930 SH 14) of the Core Spray System indicates that the following cables affecting two of these circuit annunciator relays were identified as being fire damaged. Figure C-2 shows the relevant portions of the alarm logic relay circuit for the core spray system. Table C-7 indicates the type and cable trays these cables were located in at three of the fire influence zone checkpoints. As a result of this information, it appears that a conductor-to-conductor shorting event—simulating low level condition signal from the level switch contacts—is a very definite possibility.

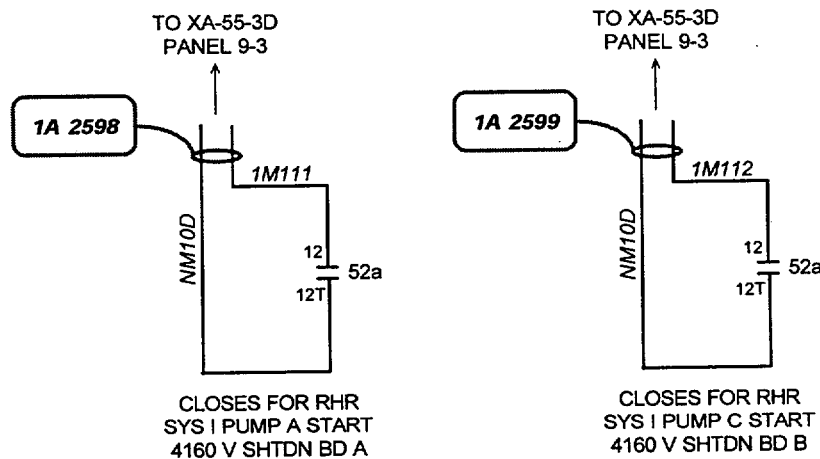
Figure C-3. Partial schematic of annunciator circuit for the RHR Pump Start alarms.

Information gathered regarding the cable routings indicates different cable identifiers for these circuits (e.g., 2A 2598 vs. 1A 2598). This discrepancy may simply be an error made during the markup of drawing 45N620-2. (Also, assuming the “2A” identifier indicates a system II component, the fact, as will be discussed later, that the drawing package includes markups of the control circuits for RHR pumps 2A and 2C makes this assumption appear to be consistent with the bulk of the available information.) Cables 2A 2598 and 2A 2599 were both routed through the zone of fire influence as shown in Table C-9.

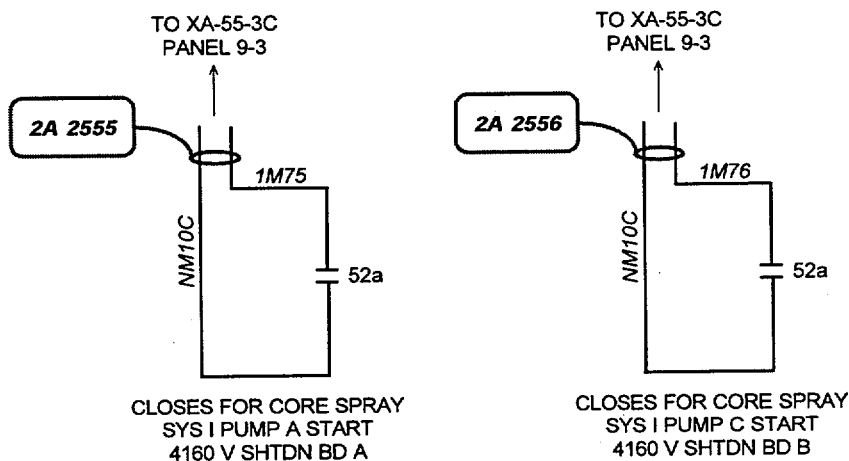
Figure C-4. Partial schematic of annunciator circuit for the Core Spray Pump Start alarms.

Figure C-4 shows a partial schematic of the Core Spray Pump Start alarm circuit. Unlike the case for the RHR pump alarm circuit markups, the CS pump alarm circuit markups indicate cables 2A 2555 and 2A 2556 as the cables of concern (i.e., no discrepancies).

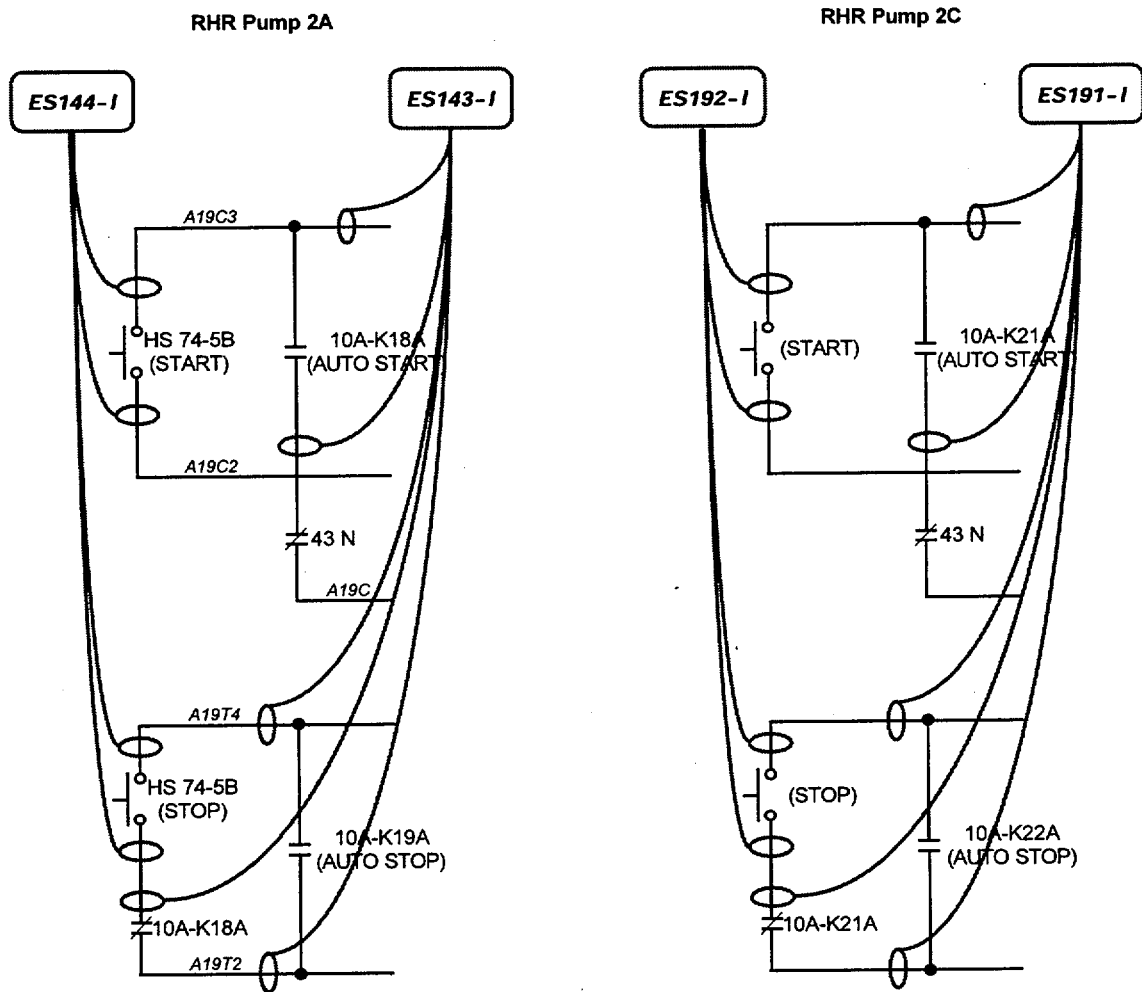
Figure C-5. Partial schematic of the relay and hand switch branches for the RHR pump

contacts in cable ES144-I (ES190-I) or shorting of the two conductors leading to the auto-start relay in cable ES143-I (ES191-I) would have been able to initiate the pump's operation. Conductor shorting in these cables for the stop (or "trip") circuits is problematical. Shorts that bypass either the hand switch (STOP) contacts or the auto-stop relay contacts should have resulted in tripping the power breaker for the pump motor(s). However, the events log indicates that the operator could not stop the pumps after their spurious restart at 12:44. This might be explained in one of two ways: 1) conductors leading to or from the STOP hand switch contacts may have failed in an open circuit manner (a very convenient explanation) or 2) the trip coil was a time-delay type wherein continuous shorting of the start/auto-start contact conductors could have overridden the influence of the trip coil. There is no information available to determine if one or either of these possibilities is correct.

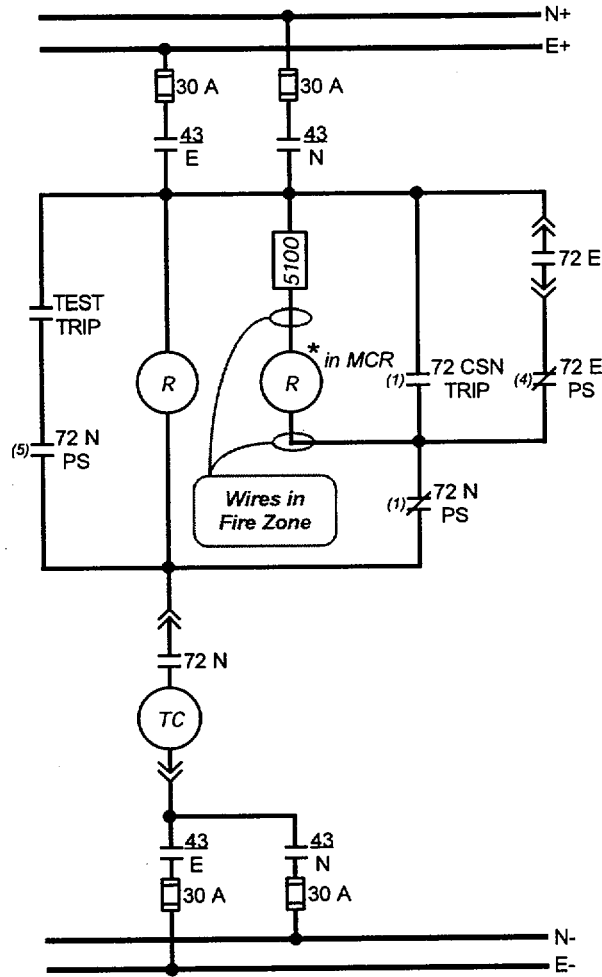
Figure C-8. Direct-current breaker trip control circuit. Alternating-current (480 V) breaker trip control circuit is similar in design. (Ref: TVA Dwgs 45N714-7 & 45N779-6)

Power to the trip control circuit (Fig. 8) is selectable by setting device 43 to the normal (N) or alternate (E) power supply. This closes the 43N or 43E contacts to the control circuit power supply buses. The breaker is usually tripped manually by a control switch on the switchboard (72 CSN) which allows control power to energize the trip coil (TC) through the closed 72N contacts. These contacts are closed whenever the 72N circuit breaker is closed. In this case, however, both circuit breakers (72N and 72E) were open, thus it is not reasonable to postulate that the trip coil was continuously energized by a current backfed through the indicating light during the fire. On the other hand it is reasonable to suppose that a hot short on the indicating light circuit energized the upstream connection to the 72N contacts and only allowed the trip coil to be energized each time the breaker was closed. This, of course, caused the 72N breaker to immediately trip open again. The same scenario applies to the alternate feeder breaker 72E as well as to the normal and alternate feeder breakers on the 480-volt MOV boards.

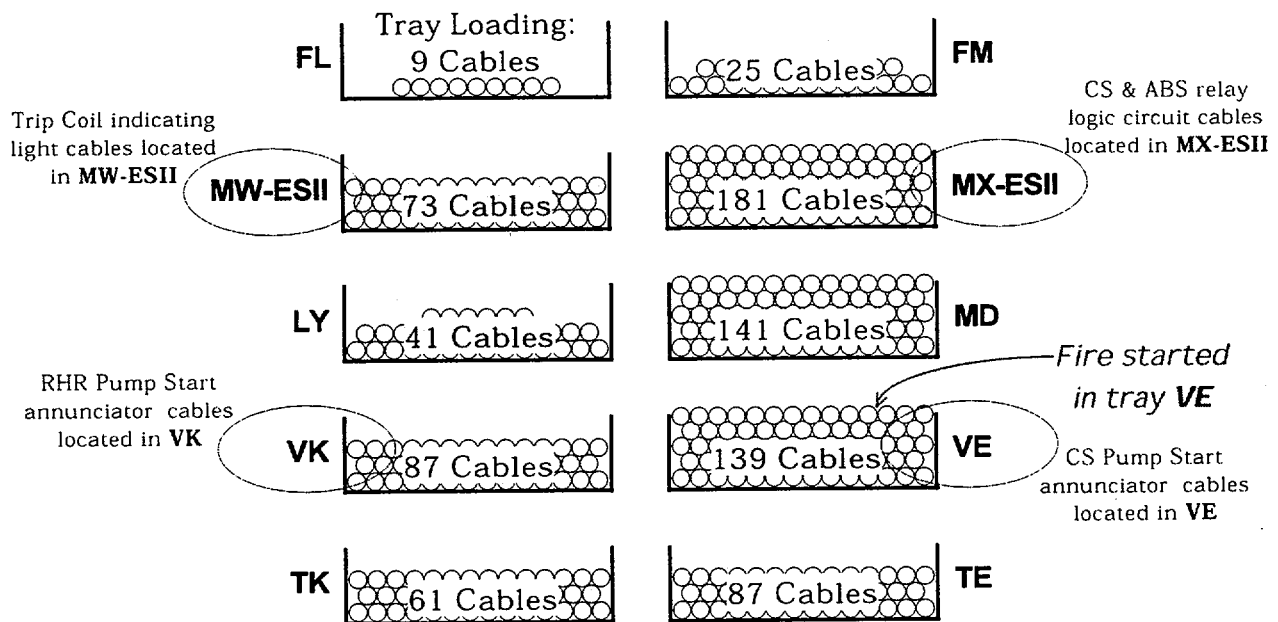
Figure C-9. Cable tray locations and contents. (Ref: Exhibit C1, pp. 30-32 of 69, *Physical Damage to Electric Cables and Raceways Involved in the Browns Ferry Nuclear Plant Fire on March 22, 1975*, contained in Regulatory Investigation Report Office of Inspection and Enforcement Region II)

This figure also helps explain the timing of the alarms received early in the fire event. The Core Spray pump start alarm circuits are contained in tray VE, where the fire started, and the RHR pump start alarm circuits are contained in tray VK just next to VE. The auto-blowdown and core spray logic circuitry is located two trays above VE (in MX-ESII), and with the fuel loading of trays MX-ESII, MD, and VE it is conceivable that the fire would spread to MX-ESII very rapidly. Finally, the trip coil indicating light circuits are all contained within tray MW-ESII, further away from the ignition point than the other three trays, hence, the effects should have been noted later in the event (as indeed they were).
