Docket No. 50-277, 50-278
SUBJECT: Licensee Event Report, Peach Bottom Atomic Power Station Unit 2 & 3

Reference: Docket No. 50-277, 50 278
Report Number: 2-99-008
Revision Number: 00
Event Date: 12/02/99
Report Date: 01/01/00

LICENSEE EVENT REPORT (LER)

TITLE (4)
This LER reports an inoperability of all RHR pumps simultaneously during the RHR Logic System Functional Test.

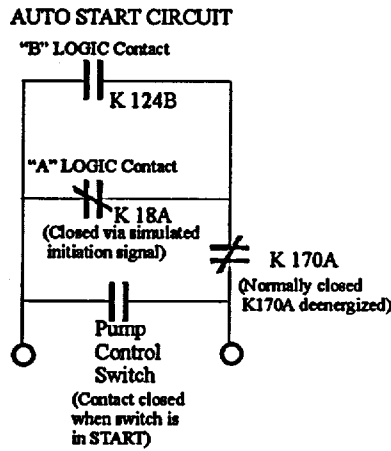
"A" RHR PUMP START LOGIC WHEN INITIATION SIGNAL SIMULATED DURING LSFT

As shown in attachment 1 for the "A" RHR LSFT, when testing the "A" pump, a simulated initiation signal causes the K18A relay to energize and close the K18A contact in the pump auto start logic. Subsequently, the "A" RHR pump starts. The K18A relay also closes a contact in the pump stop logic. The purpose of this contact is to prevent the "A" pump from restarting when the control switch is taken to STOP and an initiation signal is present.

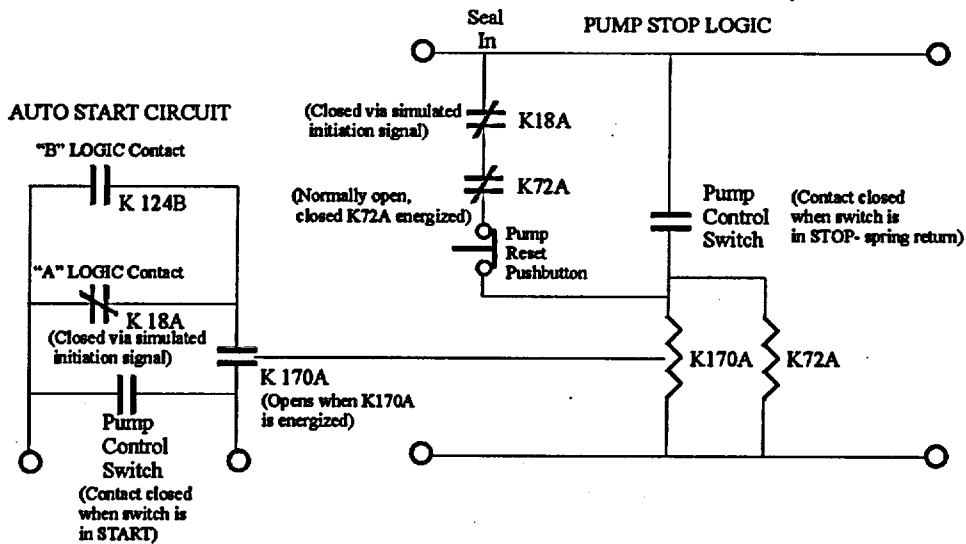
"A" RHR PUMP START LOGIC WHEN PUMP WAS STOPPED USING CONTROL SWITCH AND INITIATION SIGNAL STILL SIMULATED

After verifying that the pump started as required, the test procedure directed the crew to momentarily take the "A" pump control switch to STOP and verify the "A" pump stopped. When the control switch was momentarily placed in STOP, the K72A and K170A relays energized. The K72A contact closed and, since the simulated initiation signal was still active and the K18A contact closed, the K72A and K170A relays remained energized through the seal-in portion of the logic.

When the K170A relay energized, the K170A contact opened in the pump auto start logic. With the K170A contact open, the pump will not start automatically, regardless of which RHR logic (A or B) sends an initiation signal to the pump. The procedure did not address the seal-in logic and the need to reset it. In order to reset the seal-in logic the procedure should have directed the crew to remove the simulated initiation signal before proceeding to the next pump.

The cause of the event was inadequate procedural guidance for performing the RHR Logic System Functional Test. Specifically, the procedure did not require resetting each pump immediately after the pump was tested. Instead, all pumps were reset after the final pump was tested and all four RHR pumps were inoperable simultaneously for a short period of time during the test.

- All RHR Logic System Functional Test procedures will be revised prior to the next scheduled test performance to require the auto start logic for each pump to be reset immediately after the pump is tested and prior to proceeding to the next pump.
- All other Emergency Core Cooling System Logic System Functional Test procedures are being reviewed to determine if a similar situation exists. These tests will not be performed until this review is complete.
