SUBJECT: PUBLIC MEETING CONDUCTED ON JANUARY 13, 2000

Plant Incident Report 1999-2650

*Unplanned descent of Unit 1
Reactor Coolant Pump Motor 1-03*

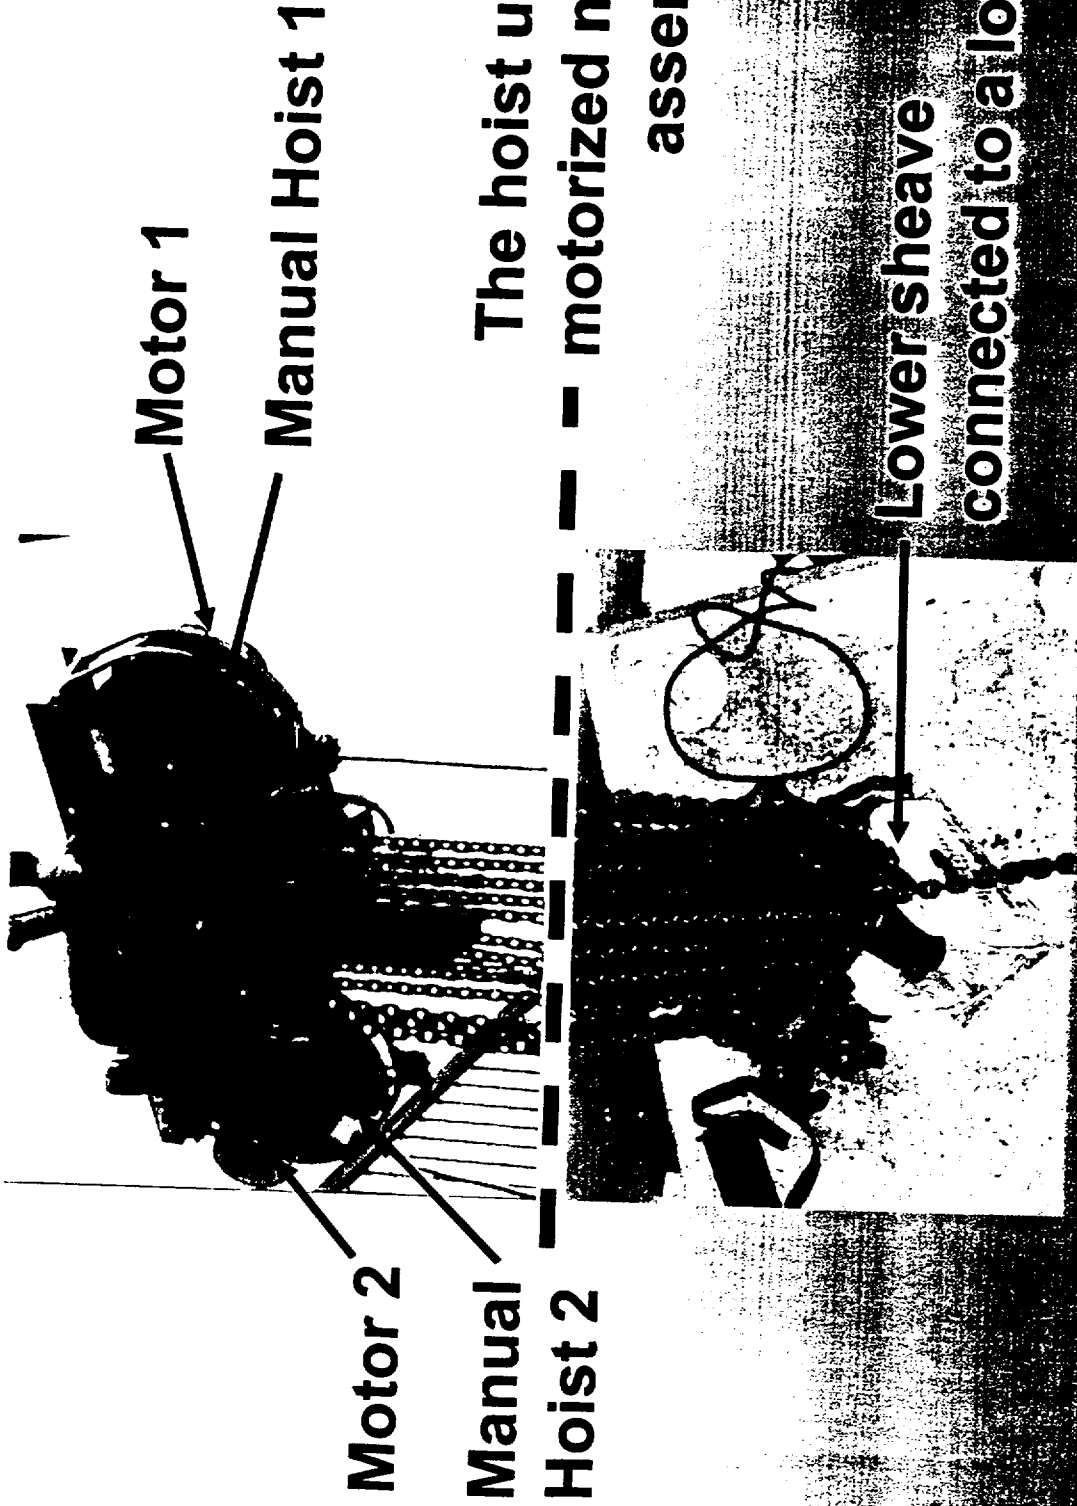
Hoist Unit CP2-MEMHCH-42

The hoist unit is a dual motorized manual hoist assembly.

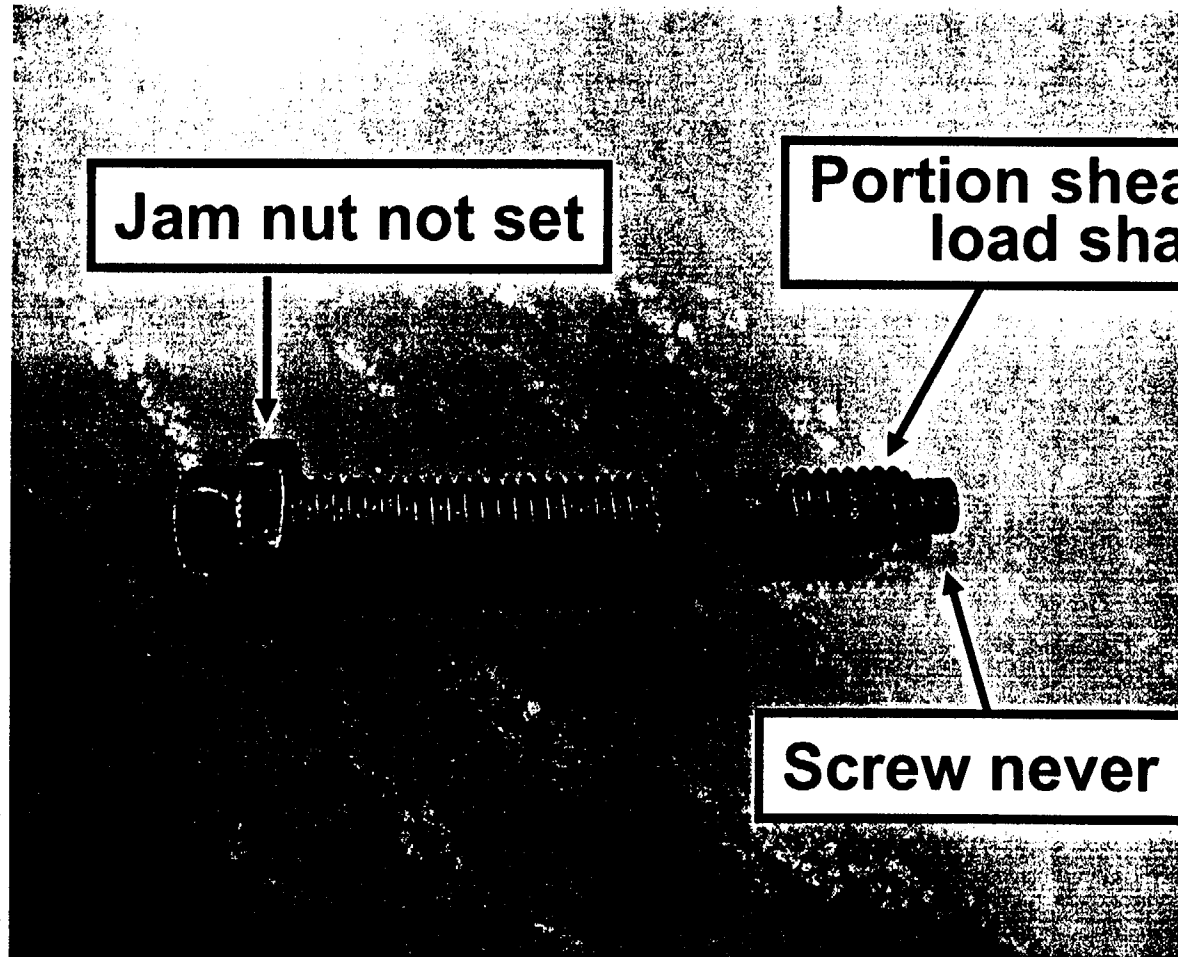
Set Screw

Jam nut not set

Portion sheared in load shaft

Screw never engaged

- **During re-assembly, the load shaft was not fully shouldered into the ball bearing on the hand wheel side of the frame unit.**
- **The set screw hole in the load shaft and the groove in the spindle shaft were misaligned.**
- **The set screw was not properly installed.**

- **Scrap these two hoists.**
- **Identify & inspect ACCO Wright hoists.**
- **Revise Preventive Maintenance Work Orders to require additional inspections.**
- **Revise operating procedures for hoists.**
- **Develop a maintenance procedure for working on hoists.**
- **Evaluate ACCO Wright motorized manual hoists.**

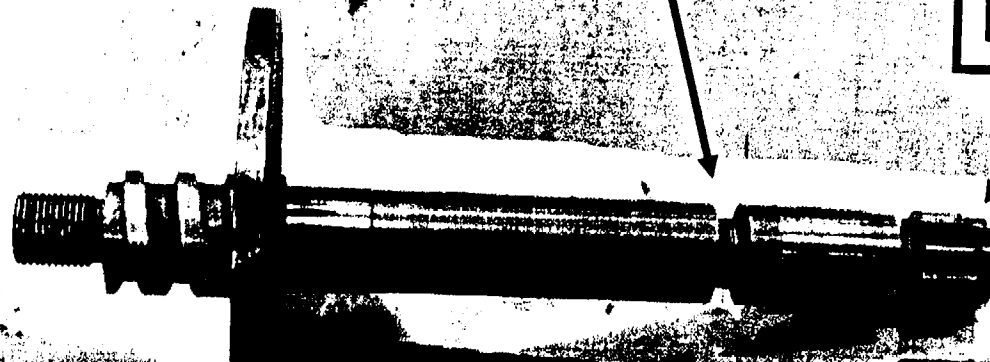
Spindle Unit from Failed Hoist

Set screw goes in here

Note damage

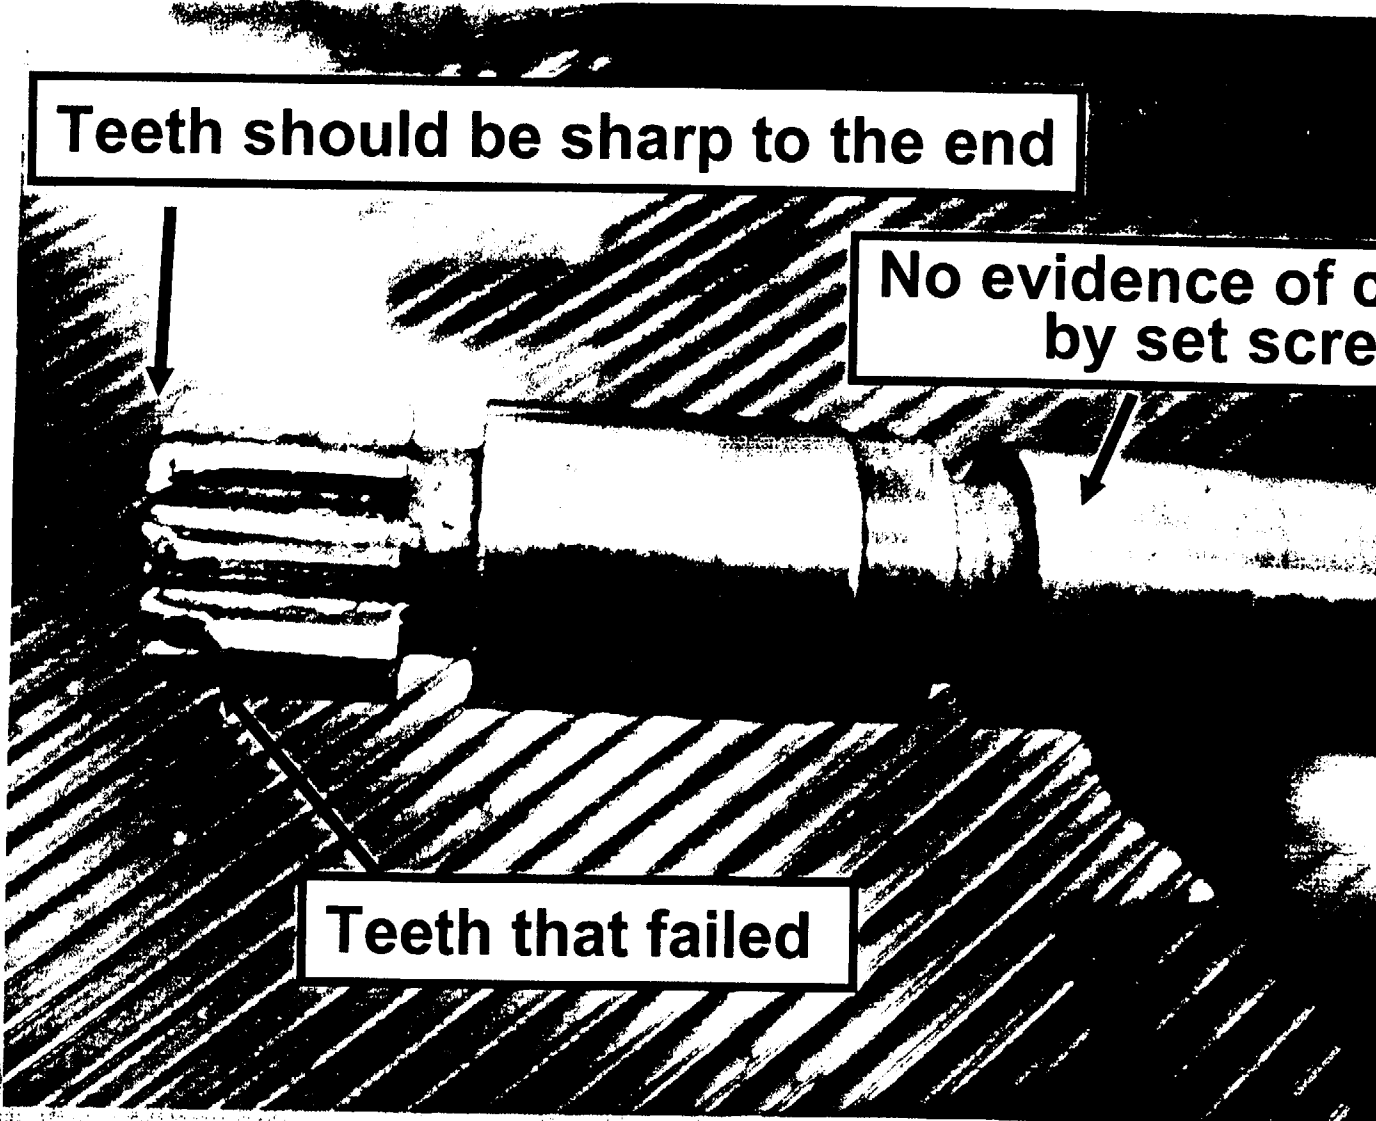
Damage to Spindle Teeth

Teeth should be sharp to the end

No evidence of contact
by set screw

Teeth that failed

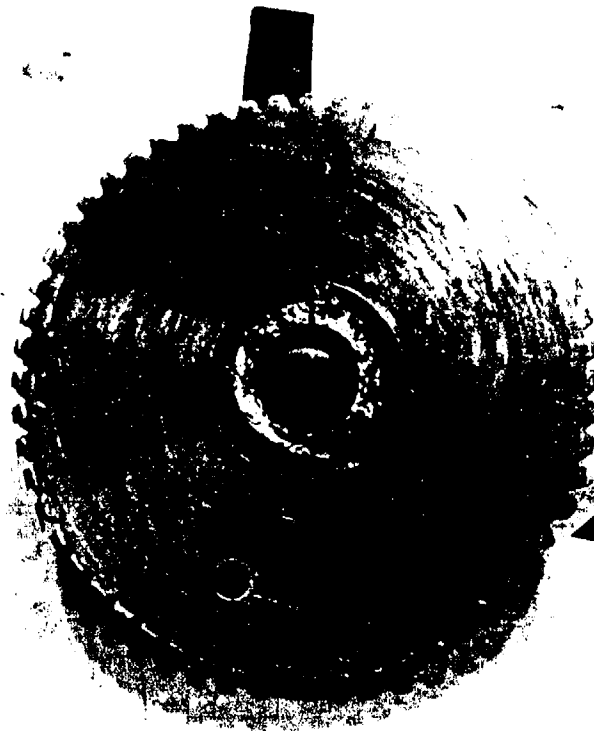
Failed Gear

Damage after the failure
