**U.S. NUCLEAR REGULATORY COMMISSION
REGION IV**

Report No.: 50-445/99-18
50-446/99-18

Facility: Comanche Peak Steam Electric Station, Units 1 and 2

Dates: November 14, 1999, through December 25, 1999

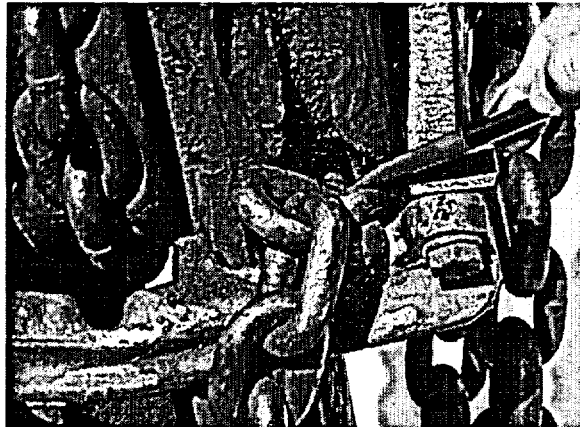
The condition of the chain hoist was unknown following the event. The licensee clearly observed that a chain link was wedged in the lower chain block between the outermost sheave and a brass guide bar across the sheaves (see photo below). It was speculated that this was all that was preventing the motor from descending further. Each of the hoist's drive trains was equipped with an electric and mechanical brake. The brakes had failed to prevent the initial drop, so it was unknown whether any of them were engaged and holding the load.

The RCP motor did not free fall during this event, since its decent was slowed by friction generated in the chain hoist. However, none of the brakes on the failed drive train were engaged and the brakes on the intact drive train were destroyed during the event, since they were insufficient to hold the load. The only thing that arrested the fall was the link of chain that lodged in the lower chain block. The postevent examination of the hoist revealed severe damage to the brass retaining bar and its threaded fasteners which

indicated that, had the chain lodged in the center of the chain block rather than the edge, the retaining bar may have failed, allowing the motor to continue to fall.

The inspectors observed the licensee's decision making process during several strategy meetings to plan the recovery of the motor. Despite the sense of urgency, the licensee methodically evaluated several possible strategies, including rigging temporary kevlar slings to the motor as well as shoring the motor from underneath. The licensee ultimately chose to stabilize the chain by shackling opposite passes of chain together as close to the chain blocks as possible so that, in the event the one link of chain became dislodged, the remaining chain would not be able to free wheel through the chain blocks. Once this had been completed, the licensee was able to lower the motor to its base using the polar crane's main hook. This was accomplished without further incident.
