**1999 Annual Site Inspection
and Monitoring Report for
Uranium Mill Tailings Radiation
Control Act Title I Disposal Sites**

January 2000

Long-Term Surveillance and Maintenance Program

1999 Annual Report

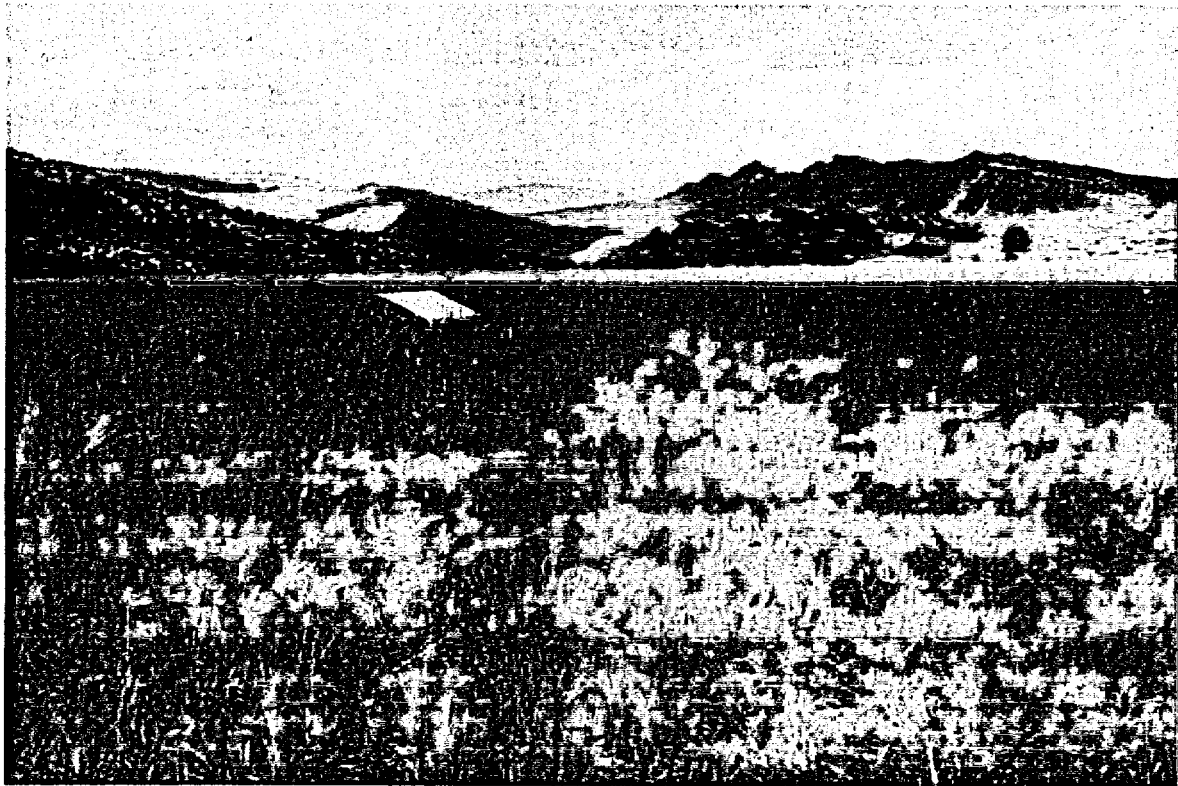
DUR 6/99. PL-1. Vegetation on Top of the Disposal Cell

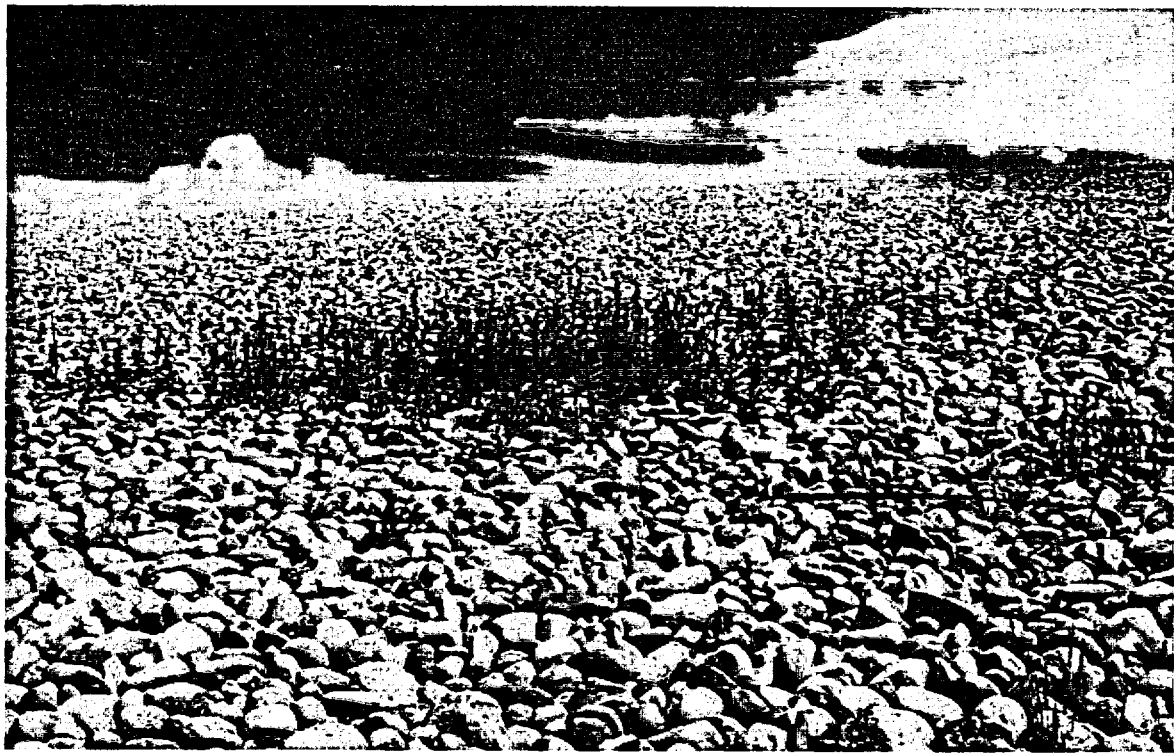
DUR 5/99. PL-2. Thistle Colony on East Side Slope of Disposal Cell

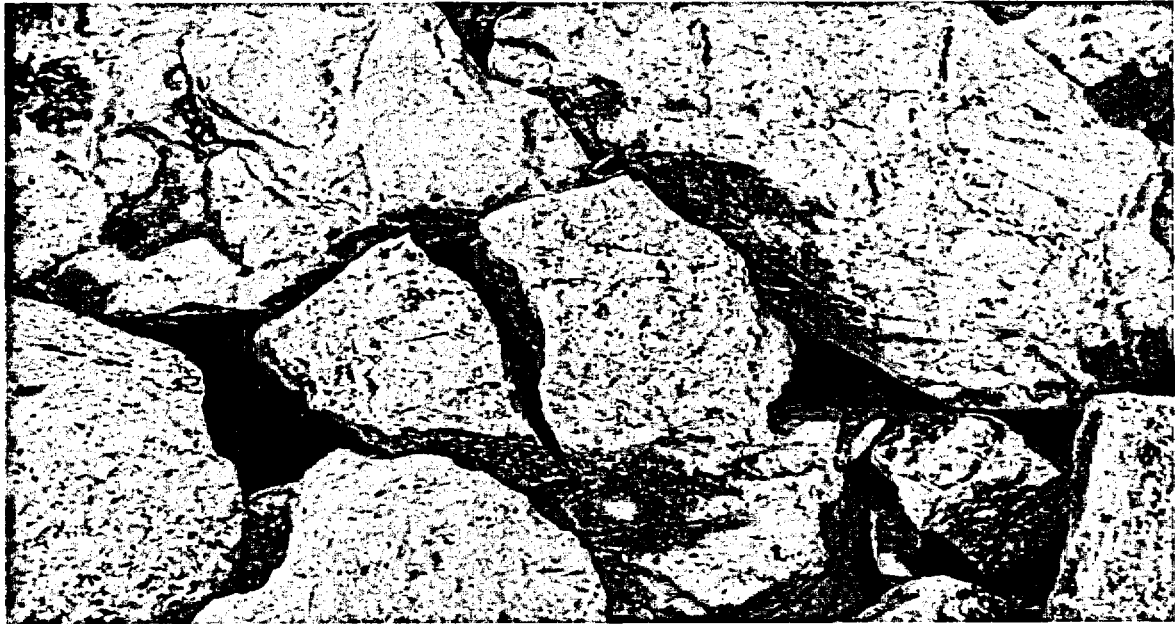
FCT/99. PL-1. Fractured Riprap on Side Slope

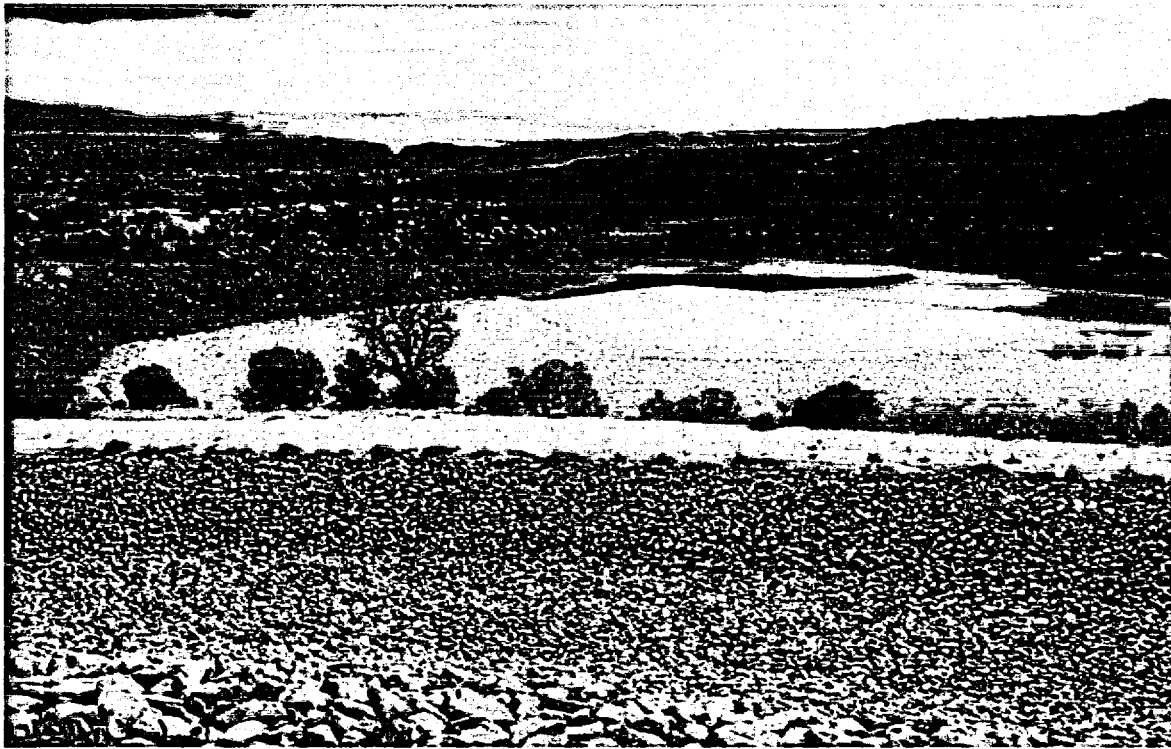
Disposal Cell Top and Side Slopes. Rock covers the 2-acre top (NAT PL-3) of the disposal cell and the approximate 8 acres of the side slopes. The rock shows no signs of degradation and no vegetation is evident.

NAT/99. PL-3. Disposal Cell Top and Side Slopes

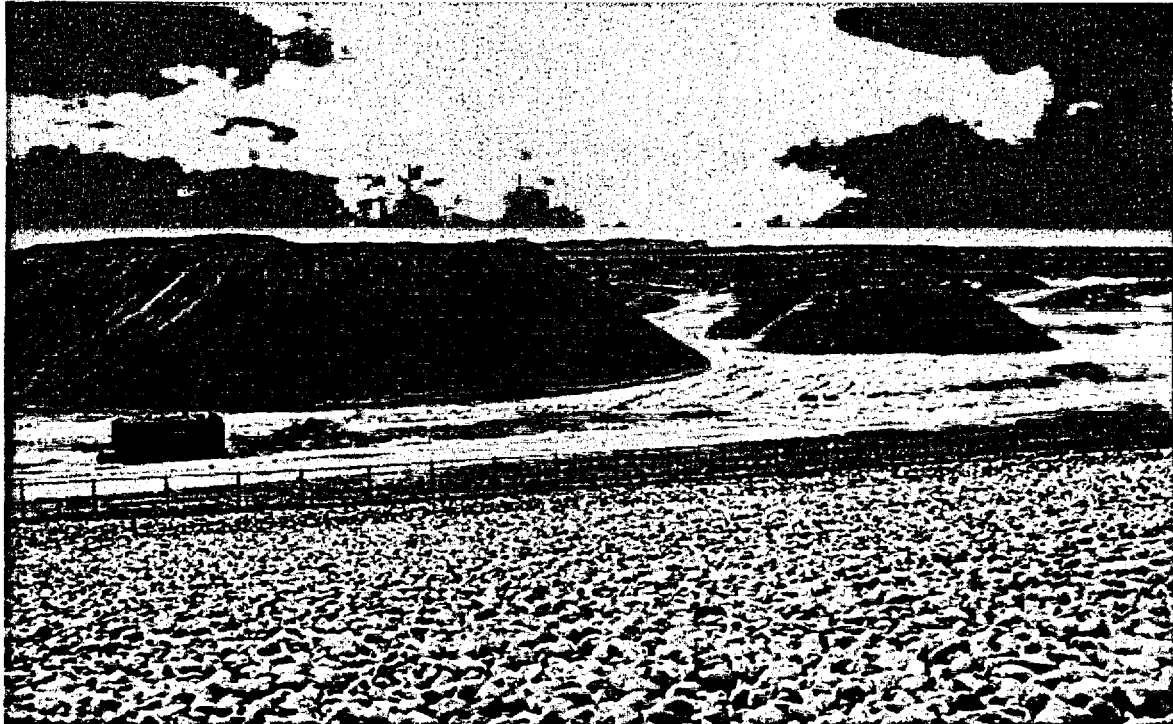
SHP 6/99. PL-1. NECA Gravel Pit Activities in Proximity to Southeast Perimeter Fence of Disposal Cell

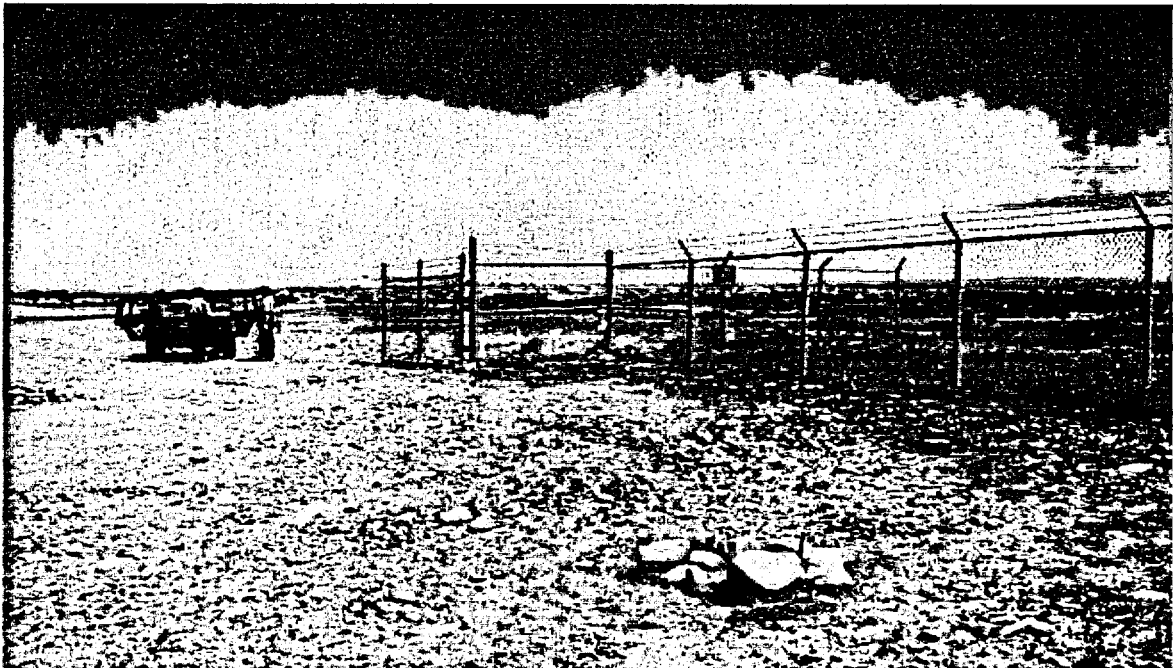
SHP 6/99. PL-2. Rocks Placed by Inspectors Denoting Location of BM-6

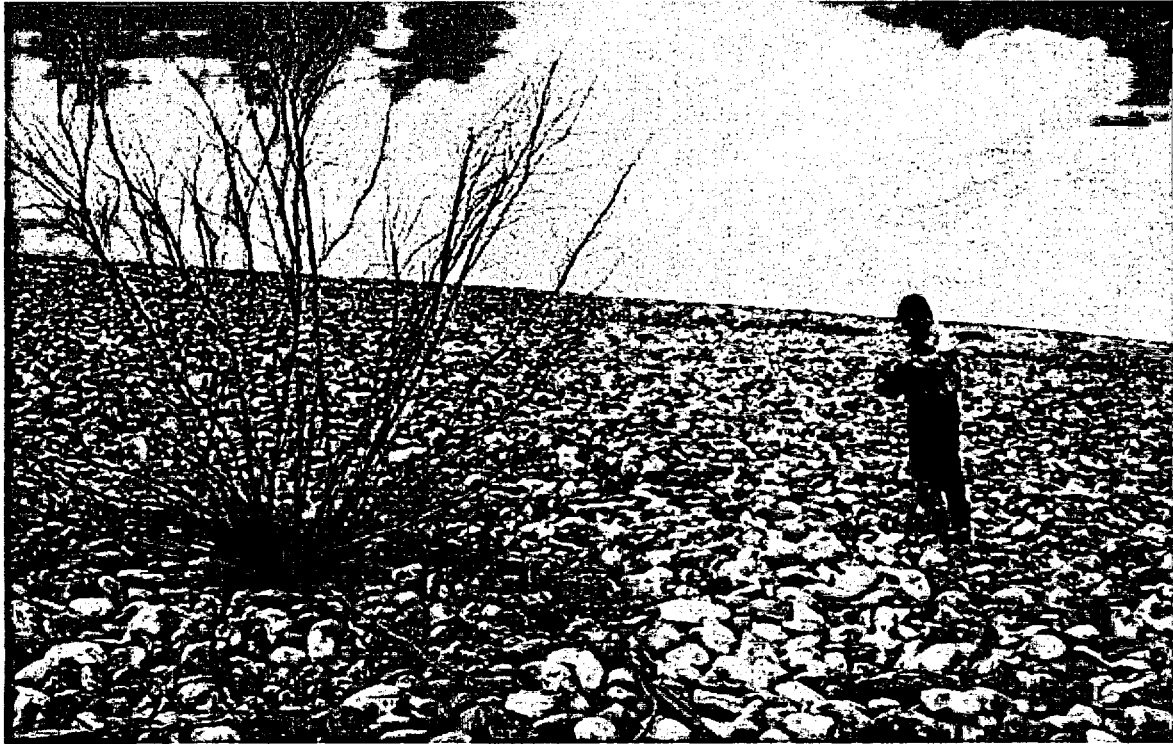
SHP 6/99. PL-3. Dead Tamarisk on Northeast Side Slope of Disposal Cell

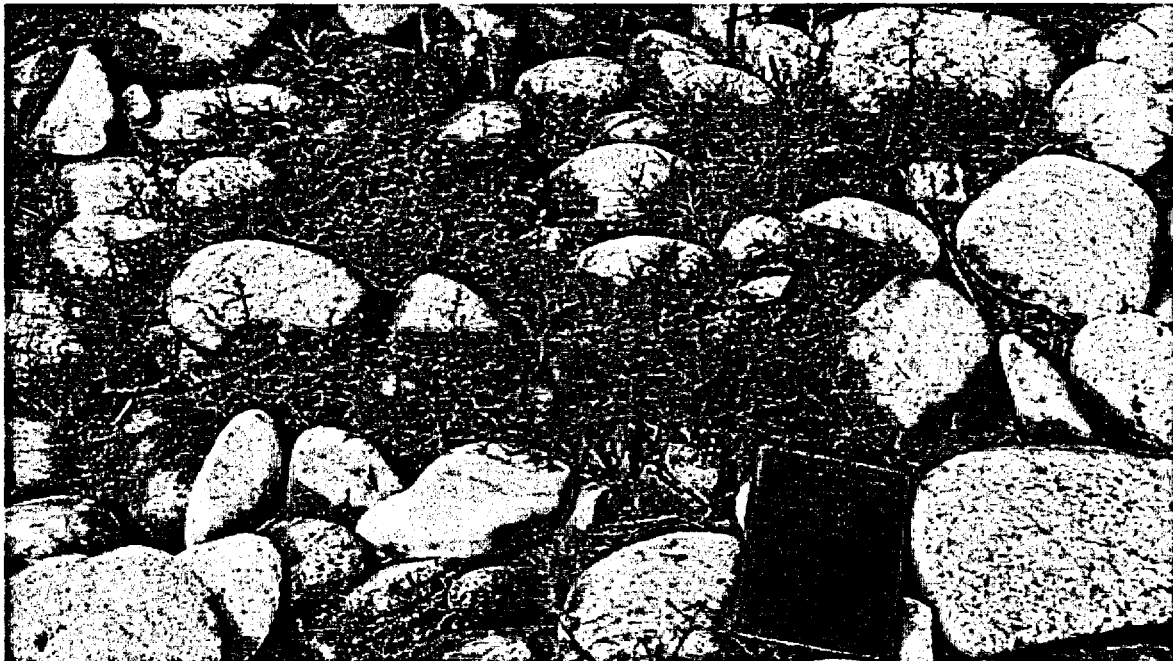
SHP 6/99. PL-4. Spring Crop of Russian Thistle on Northeast Side Slope of Disposal Cell
