Containment Protective Coatings Research

SRTC NPP Protective Coatings Research Program Overview

SRTC Project Alignment with Industry PIRT System D [4] SRTC System 5: Steel Substrate, Epoxy Primer, Epoxy Topcoat

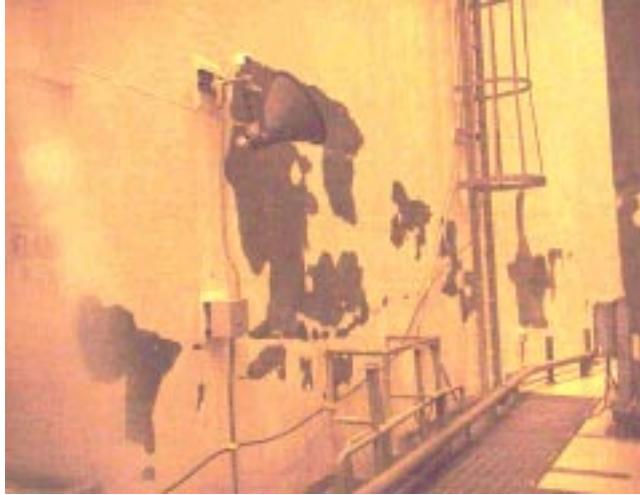
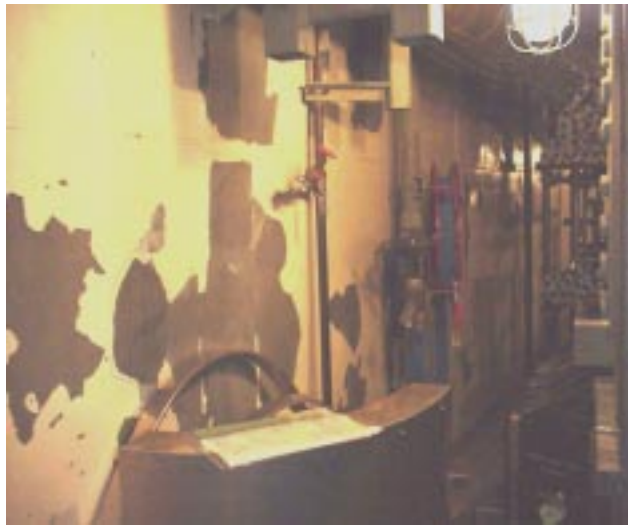
**Examples of Failures of a “Qualified” Coatings System
Phenoline Topcoat with CZ11 Primer on Steel Liner**

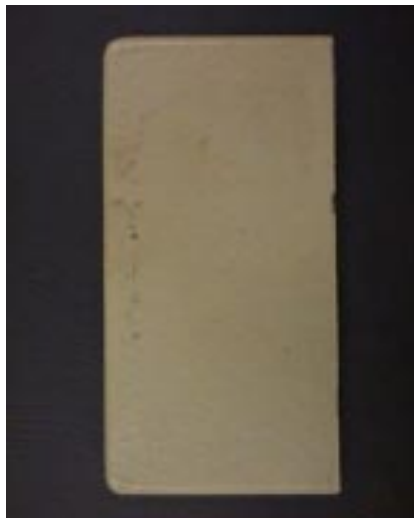
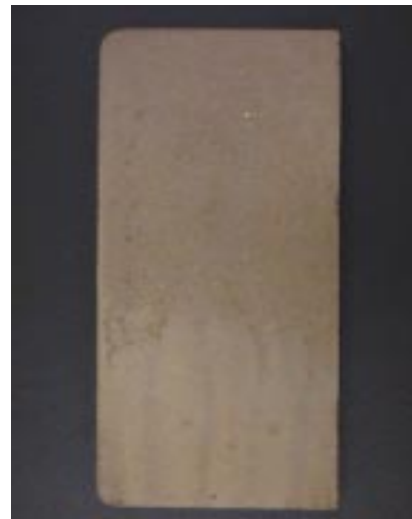
- System 5 (Amercoat 370), Non-Defected, Aged (1×10^9 R)
- Abbreviated D3911 Exposure
- Post DBA Results (photo on right)
 - » Blisters
 - » Minor Cracking (Below Water Line)
 - » Debris Source Term from Small Chips

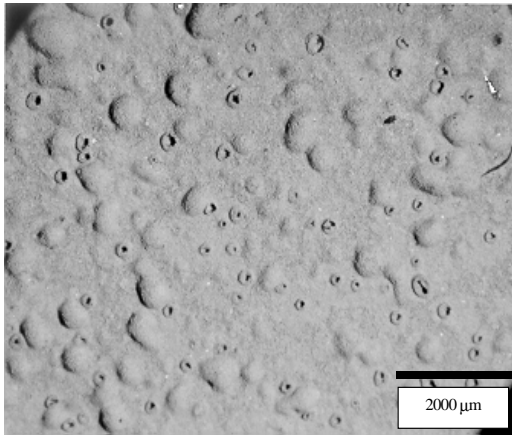
Blistering in Vapor

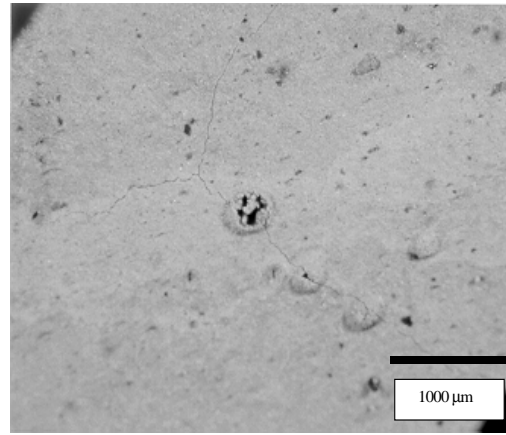
**Cracking and Minor Blistering
in Water**

- Blister Areal Fraction: 22%
- Debris Areal Fraction: 0.8%

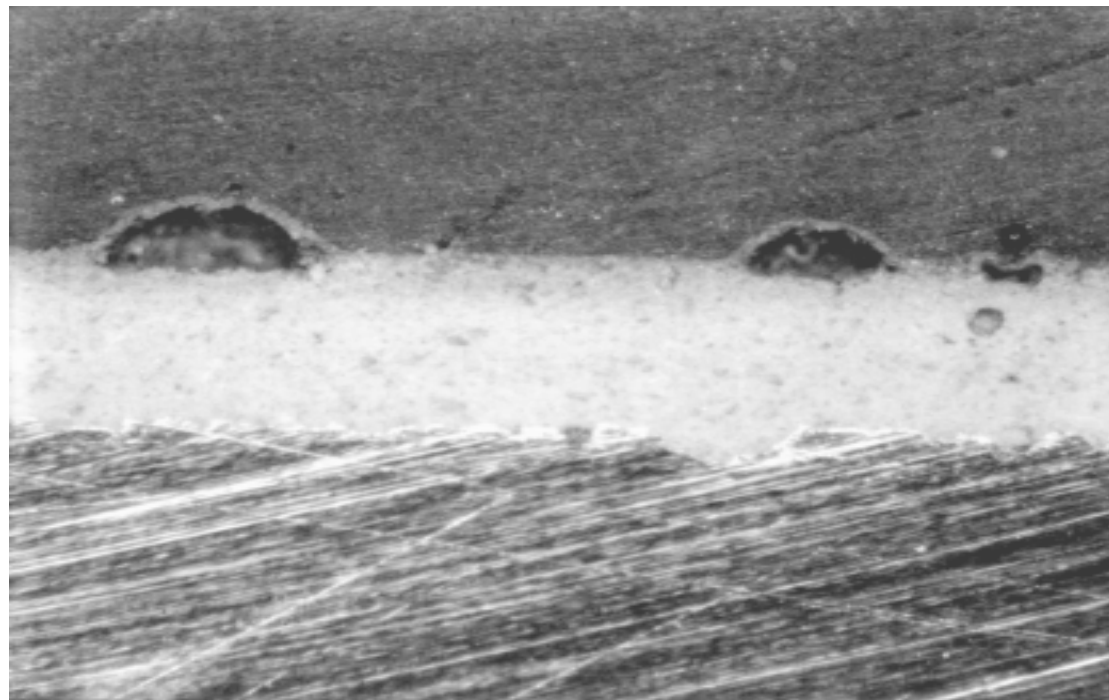
Aged Epoxy Polyamide (System 5) with blisters
