**Nebraska Public Power District**  
*Nebraska's Energy Leader*

**Subject: Licensee Event Report No. 2000-001**  
**Cooper Nuclear Station, NRC Docket 50-298, DPR-46**

TITLE (4)  
**Turbine Bypass Valve Incorrect Setting Results in Operation Prohibited by Technical Specifications.**

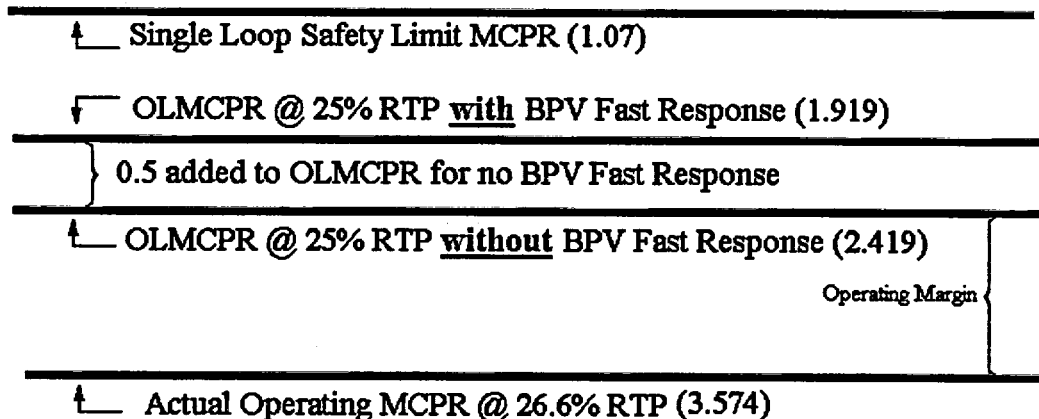
Figure 1 - MCPR Illustration

An evaluation of the thermal limits was conducted for the time frame that CNS was operating between 25 and 30 percent RTP on January 7, 2000. Analysis above 30 percent was not required as a reactor scram results from turbine trip and adds significant margin to MCPR. The thermal limit of interest due to the slow opening or failure of the Turbine Bypass Valves is the MCPR limit. The MCPR limits for Cycle 19 are documented in the Cycle 19 Core Operating Limits Report (COLR) Revision 1. The Actual Operating MCPR can be found on the process computer cases routinely printed in the Control Room. On January 7, 2000 at 26.6 percent RTP, values for Actual Operating MCPR and Operating Limit MCPR (OLMCPR) were found to be 3.574 and 1.919 respectively.

For the evaluation of as-found conditions on January 7, 2000, the SLMCPR for single recirculation loop operation was used for conservative measure in order to bound this event, since the single loop operation has a higher MCPR safety limit. The plant was in fact operating with both recirculation loops during and after discovery. Without any bypass valve capability, the OLMCPR must be increased by a penalty of 0.5 to afford adequate margin to the SLMCPR. This results in a limit of 2.419 (1.919 + 0.5) at approximately 25 percent RTP and core flow less than 50 percent. This would still allow CNS 32 percent margin from the Actual Operating MCPR (3.574) to the revised OLMCPR (2.419). Should the transient have occurred at an OLMCPR of 2.419, sufficient margin still existed such that the plant would not have violated the SLMCPR. See MCPR Illustration below.
