Nebraska Public Power District
Nebraska's Energy Leader

NLS2000014
February 8, 2000

Subject: Licensee Event Report No. 2000-001
Cooper Nuclear Station, NRC Docket 50-298, DPR-46

TITLE (4)
Turbine Bypass Valve Incorrect Setting Results in Operation Prohibited by Technical Specifications.

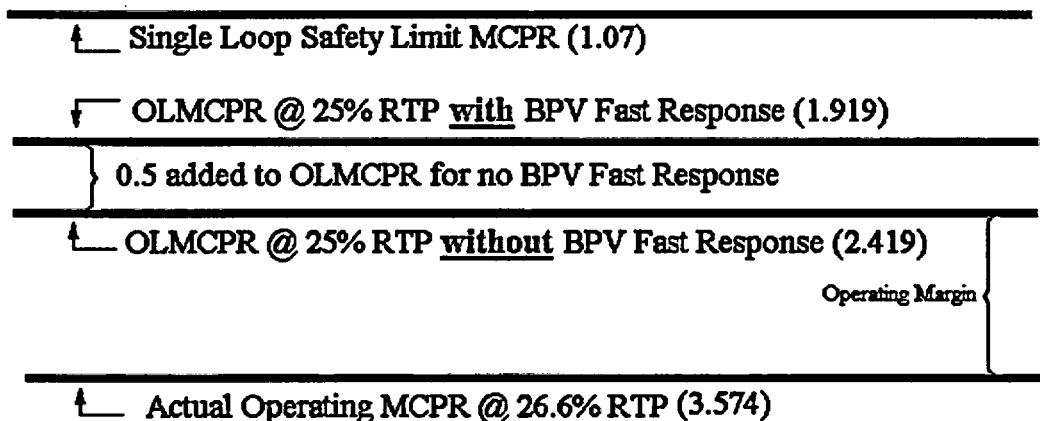
Figure 1 - MCPR Illustration

An evaluation of the thermal limits was conducted for the time frame that CNS was operating between 25 and 30 percent RTP on January 7, 2000. Analysis above 30 percent was not required as a reactor scram results from turbine trip and adds significant margin to MCPR. The thermal limit of interest due to the slow opening or failure of the Turbine Bypass Valves is the MCPR limit. The MCPR limits for Cycle 19 are documented in the Cycle 19 Core Operating Limits Report (COLR) Revision 1. The Actual Operating MCPR can be found on the process computer cases routinely printed in the Control Room. On January 7, 2000 at 26.6 percent RTP, values for Actual Operating MCPR and Operating Limit MCPR (OLMCPR) were found to be 3.574 and 1.919 respectively.

The analysis of a FWCFMD event assumes that the transient starts with the plant operating at the OLMCPR. Transient analysis demonstrates that if the plant is at the OLMCPR and a transient event occurs, the plant will not violate the Safety Limit MCPR (SLMCPR). This analysis assumes proper operation of the BPV fast-open feature.

For the evaluation of as-found conditions on January 7, 2000, the SLMCPR for single recirculation loop operation was used for conservative measure in order to bound this event, since the single loop operation has a higher MCPR safety limit. The plant was in fact operating with both recirculation loops during and after discovery. Without any bypass valve capability, the OLMCPR must be increased by a penalty of 0.5 to afford adequate margin to the SLMCPR. This results in a limit of 2.419 (1.919 + 0.5) at approximately 25 percent RTP and core flow less than 50 percent. This would still allow CNS 32 percent margin from the Actual Operating MCPR (3.574) to the revised OLMCPR (2.419). Should the transient have occurred at an OLMCPR of 2.419, sufficient margin still existed such that the plant would not have violated the SLMCPR. See MCPR Illustration below.
