Beaver Valley Power Station, Unit No. 2
Docket No. 50-412 License No. NPF-73
LER 99-009-01

LER 99-009-01, 10 CFR 50.73(a)(2)(i), "Missed Performance of Technical Specification Surveillance Requirement 4.8.1.1.1a Following Failure to Re-Establish Auto Bus Transfer Capability of 4KV Bus 2A." This LER supplement clarifies the actions taken by involved personnel with this occurrence and the event contributors, and a previously completed corrective action.

TITLE (4)
Missed Performance of Technical Specification Surveillance Requirement 4.8.1.1.1a Following Failure to Re-Establish Auto Bus Transfer Capability of 4KV Bus 2A

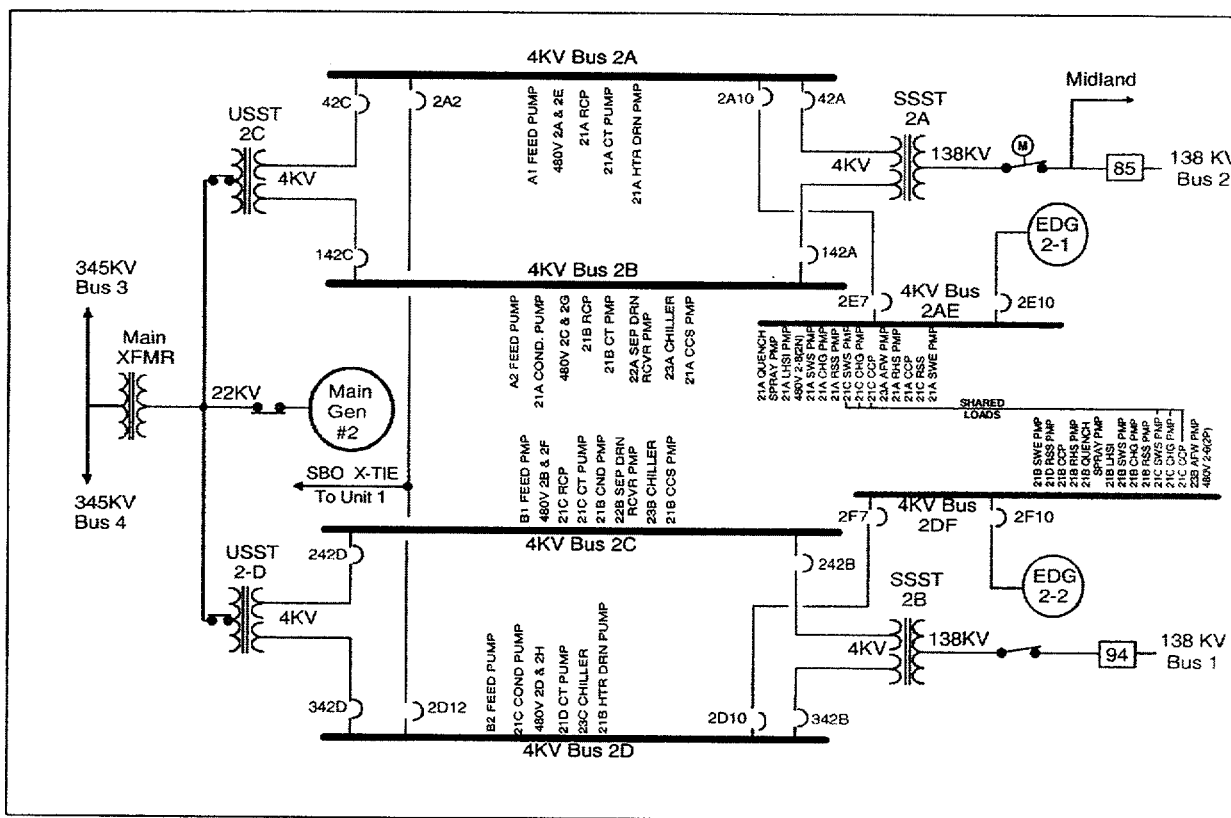
FIGURE 1

On October 12, 1999, at approximately 1730 hours, the power supply input to Unit 2 4KV Bus 2A was transferred from the onsite Unit Station Service Transformer (USST) 2C to the offsite System Station Service (SSST) Transformer 2A (see Figure 1). This was done to support start-up of a cooling tower pump. The pump was started and 4KV Bus 2A was realigned back to USST 2C, at approximately 1741 hours (same day). Subsequently, at approximately 0322 hours on October 13, 1999, it was discovered that the auto bus transfer feature of 4KV Bus 2A to the off-site alternating current (A.C.) power source had not been reestablished when 4KV Bus 2A was realigned back to USST 2C. This event occurred when the auto-closure circuit for input power supply breaker ACB-42A of SSST 2A to 4KV Bus 2A Bus was not placed in the "after-close position", as required by procedure. This had rendered 4KV automatic offsite A.C. power to Bus 2A inoperable and required entry into ACTION a of Technical Specification (TS) 3.8.1.1 within 1 hour, which was not performed. The TS implications of this event were recognized at approximately 1700 hours on October 13, 1999.

4KV Electrical Distribution - Unit 2
