Subject: **Docket No. 50-333**
LICENSEE EVENT REPORT: LER-00-002 (DER-00-00348)

HPCI Inoperable Due To Speed Control Problem

TITLE (4)
HPCI Inoperable Due To Speed Control Problem

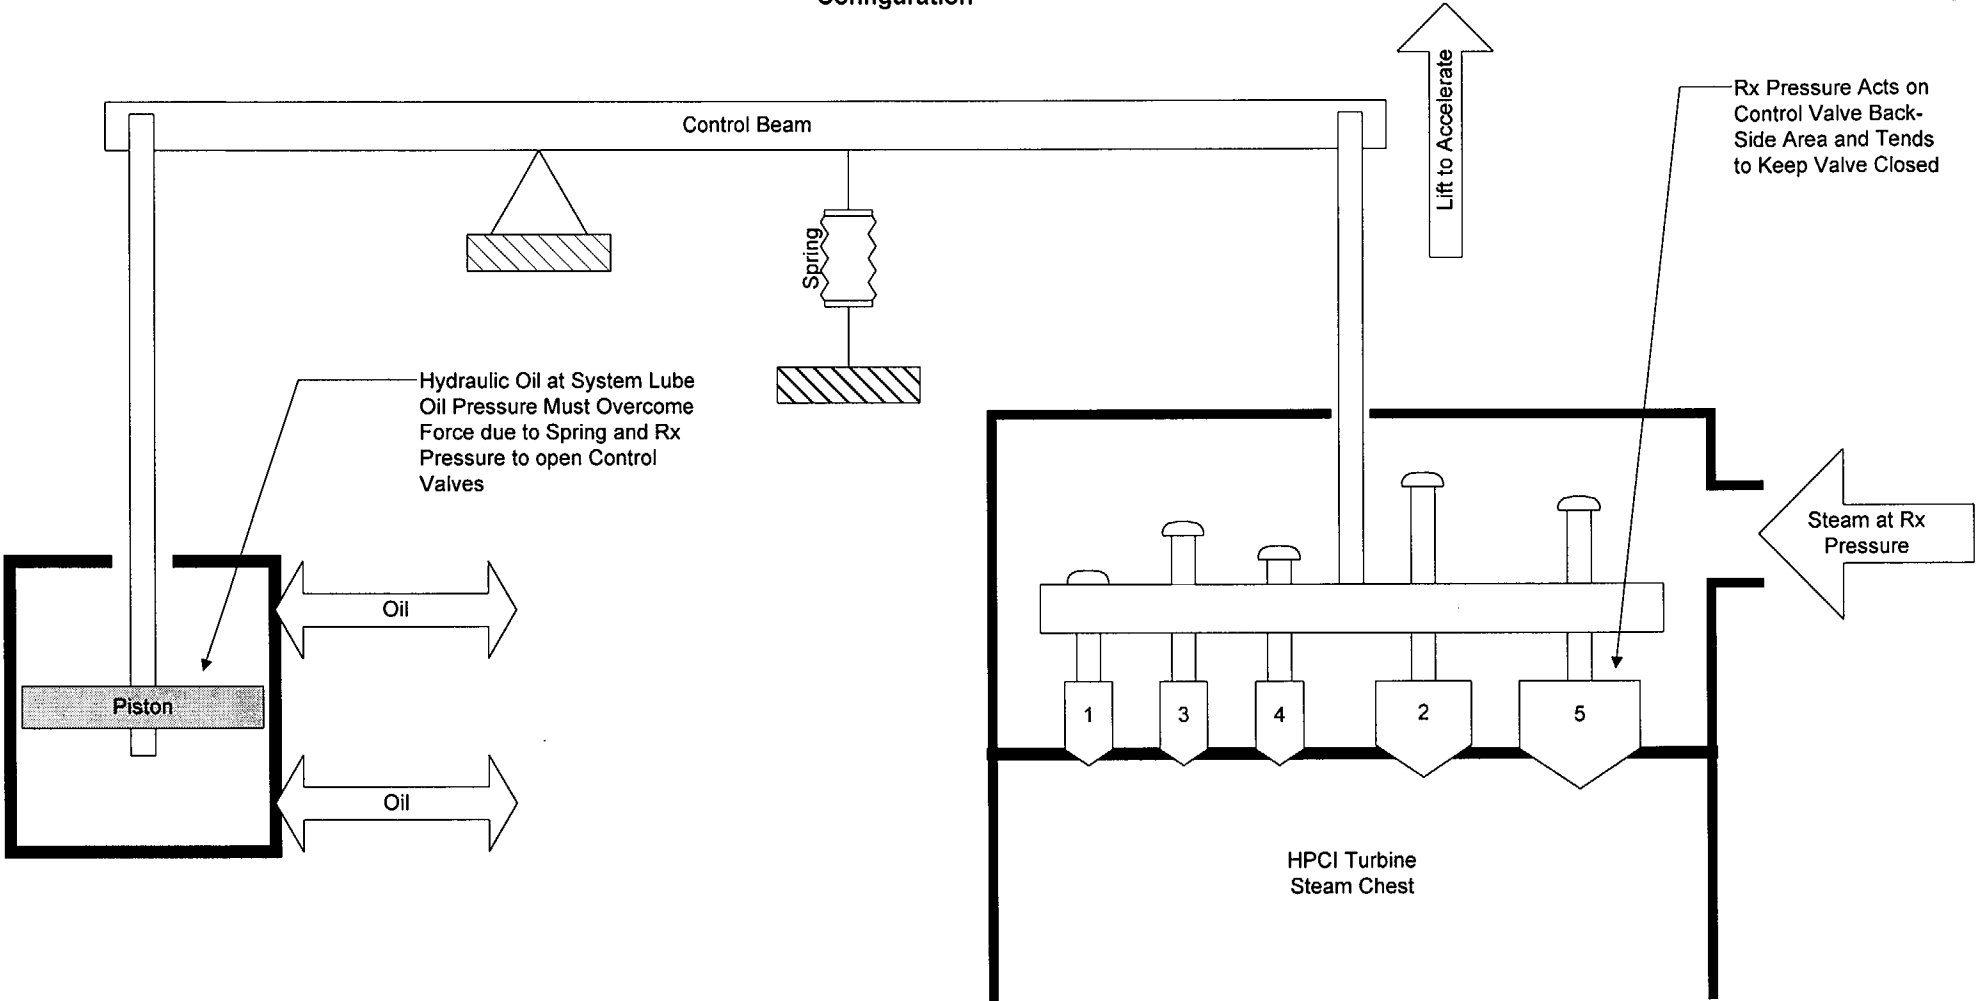
Figure 1
LER 00-002

An evaluation was conducted based on the data captured during the January 31, run of ST-4P. Plant technical staff performed this analysis with the assistance of an individual with expertise in the design and operation of the HPCI turbine and speed control system. It was determined that the cause of the speed transient was improperly set (high) lubricating oil pressure for the HPCI system. The discussion below describes how high lubricating oil pressure causes the speed transient observed during the January 31, 2000 run of ST-4P as well as during previous HPCI surveillance tests. Refer to Figure 1 for this discussion.

The HPCI turbine steam chest is configured with 5 control valves (CVs) of varying diameters, which open in stages to admit steam to the HPCI turbine. These valves are sized to maintain adequate turbine horsepower over the entire spectrum of reactor pressures for which the HPCI system is credited (150-1195 psid-Reactor to Torus). In order to open any one CV, the hydraulic oil pressure must overcome the combined force of the spring, which closes all CVs on loss of oil pressure, and the force due to reactor pressure acting on the upstream side of the respective CV.

The high hydraulic oil pressure resulted in the equilibrium force balance on CV5 occurring at higher reactor pressures than intended by original design, resulting in opening CV5. When CV5 opened at these higher reactor pressures, high-energy steam was admitted to the turbine steam chest through CV5 causing speed transient which was corrected by the HPCI System speed control loop.

Post event evaluation also determined that the spring tension on the HPCI governor control beam was not in accordance with the vendor manual. This discrepancy had an effect analogous to high system oil pressure because it took less force from the hydraulic control system to open CV5 than it would have with the spring tension set in accordance with the vendor manual.

An evaluation of the relative contribution of these discrepancies determined that the oil system setpoint was the predominant contributor to the speed transient and that the spring tension setting contributed to a lesser degree.

Simplified Diagram
HPCI Control Valve
Configuration

1. The HPCI system oil pressure was reset to a lower value with the turbine running at 4000 RPM. This resolved the degraded condition. **(Complete)**
2. This condition resulted in the HPCI system discharge piping and associated instrumentation being subjected to pressures beyond design. The condition of the piping and associated instrumentation was evaluated and determined to be operable. **(Complete)**

5. The spring tension on the HPCI governor control beam will be reset in accordance with the vendor manual. **(Scheduled Completion Date: Prior to Restart from RO14)**
