Subject: Grand Gulf Nuclear Station  
Docket No. 50-416  
License No. NPF-29  
Main Steam Lines Exceeded Leakage Limits  
LER 1999-006-01

NRC FORM 366 (6-1998)		U.S. NUCLEAR REGULATORY COMMISSION			APPROVED BY OMB NO. 3150-0104 EXPIRES 06/30/2001 Estimated burden per response to comply with this mandatory information collection request: 50.0 hrs. Reported lessons learned are incorporated into the licensing process and fed back to industry. Forward comments regarding burden estimate to the Records Management Branch (T-6 F33), U.S. Nuclear Regulatory Commission, Washington, DC 20555-0001, and to the Paperwork Reduction Project (3150-0104), Office of Management and Budget, Washington, DC 20503. If an information collection does not display a currently valid OMB control number, the NRC may not conduct or sponsor, and a person is not required to respond to, the information collection.				
<b>LICENSEE EVENT REPORT (LER)</b>					DOCKET NUMBER (2) <b>05000-416</b>		PAGE (3) <b>1 of 8</b>		
FACILITY NAME (1) <b>Grand Gulf Nuclear Station</b>					TITLE (4) <b>Main Steam Lines Exceeded Leakage Limits</b>

## LICENSEE EVENT REPORT (LER)

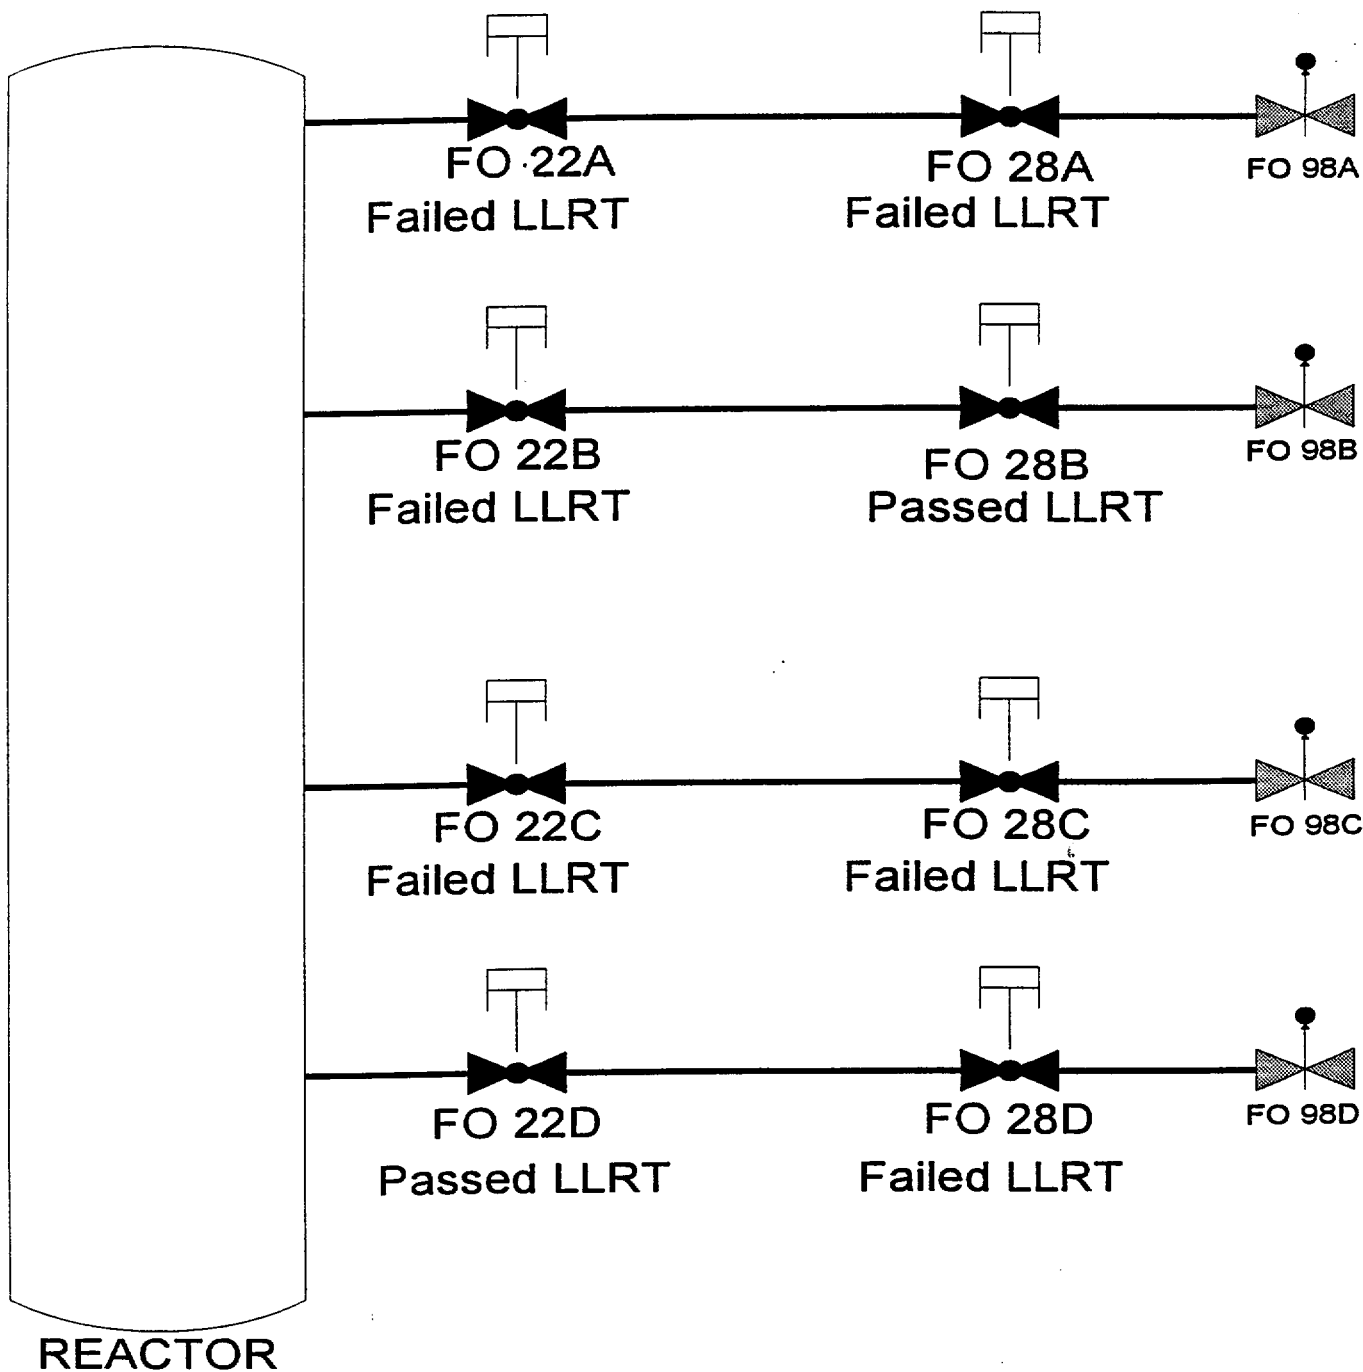
Technical Specification 3.6.1.3 requires that the leakage rate through all four main steam line penetrations be limited to a cumulative leakage rate of less than or equal to 100 scfh (47,200 sccm). Following performance of Local Leak Rate Testing of all eight MSIVs, the leakage rates for six of the valves exceeded both the Technical Specification leakage limit for total MSL leakage and the acceptance limit of 11,800 sccm (25 scfh) for each individual MSIV (minimum pathway leakage). Of this population of six MSIVs, the leakage through four MSIVs could not be quantified due to excessive leakage beyond the capability of the test equipment to pressurize the test volume to the required test pressure. Thus, the leakage is considered to have exceeded the total TS allowed MSL penetration leakage of 100 scfh (47,200 sccm). As-found data for each of the eight MSIVs is provided in Section G "Additional Information", of this report. Section G also provides as Figure 1, an information-only schematic of the valve configurations being discussed in this report. The MSSVs are designated as F098A-D.

Realistically, it is not expected that this condition would have resulted in a large release given a postulated radiological accident since the MSLs can be isolated by the Main Steam Shutoff Valves (MSSVs), designated in Figure 1 as F098A-D. The MSSVs were verified to be leaktight by testing and confirmed to have been capable of mitigating the magnitude of any postulated offsite releases. If during a LOCA, adequate core cooling cannot be maintained, then entry into the Severe Accident Procedures (SAPs) would occur. The SAPs direct operators to initiate the MSIV Leakage Control (MSIV-LCS), if required. Procedure 04-1-01-E32-1 states that the outboard MSIV-LCS is the preferred system to initiate, which directs closure of the MSSVs. While these valves do not meet the redundant power supply requirement (i. e., all MSSVs are powered by ESF Div. II), their effectiveness in isolating the steam lines and thus substantially mitigating any postulated steam line releases would be assured for all but the very low probability event of a severe accident coincident with both a loss of offsite power and a Div. II failure.
