**Sherwood Uranium Mill Project
TECHNICAL EVALUATION REPORT**

Monitoring and Stabilization Plan Supplement

February 2000

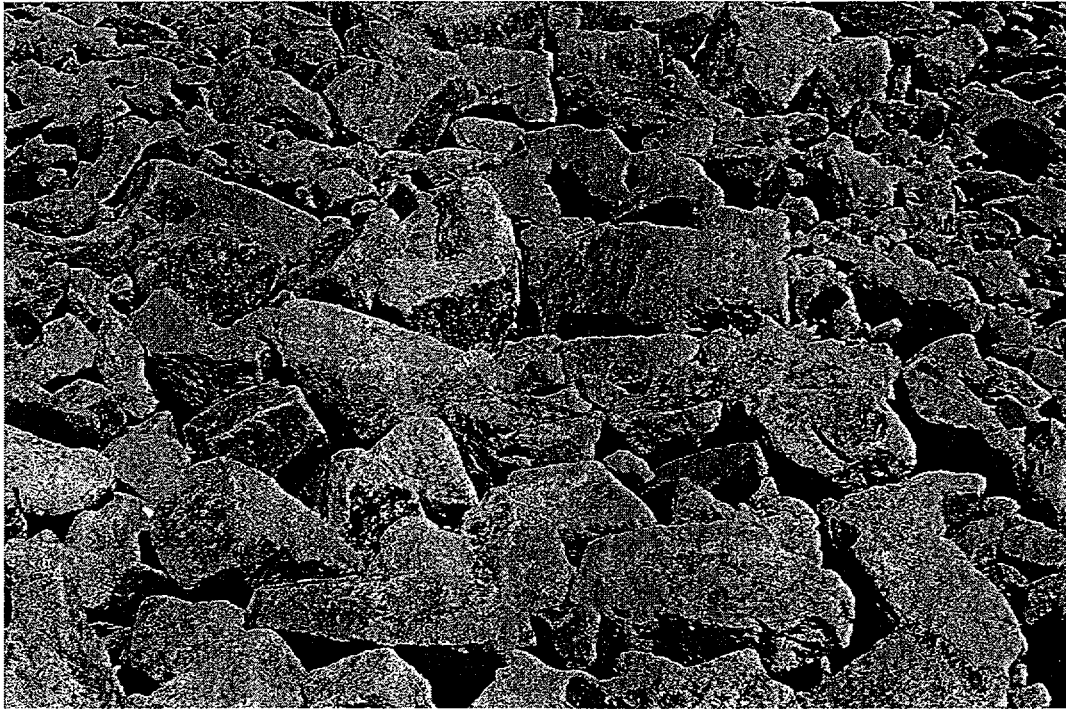
Photo 2.

higher fraction of sheet silicates, notably biotite and sericite/muscovite. Only a minor fraction of the quartz monzonite rocks displayed a greenish alteration product on outer surfaces or fracture surfaces, probably resulting from weathering. Most quartz monzonite rocks did not fracture by repeated hammer blows to the rock or by dropping rocks against riprap. (Photo2.)

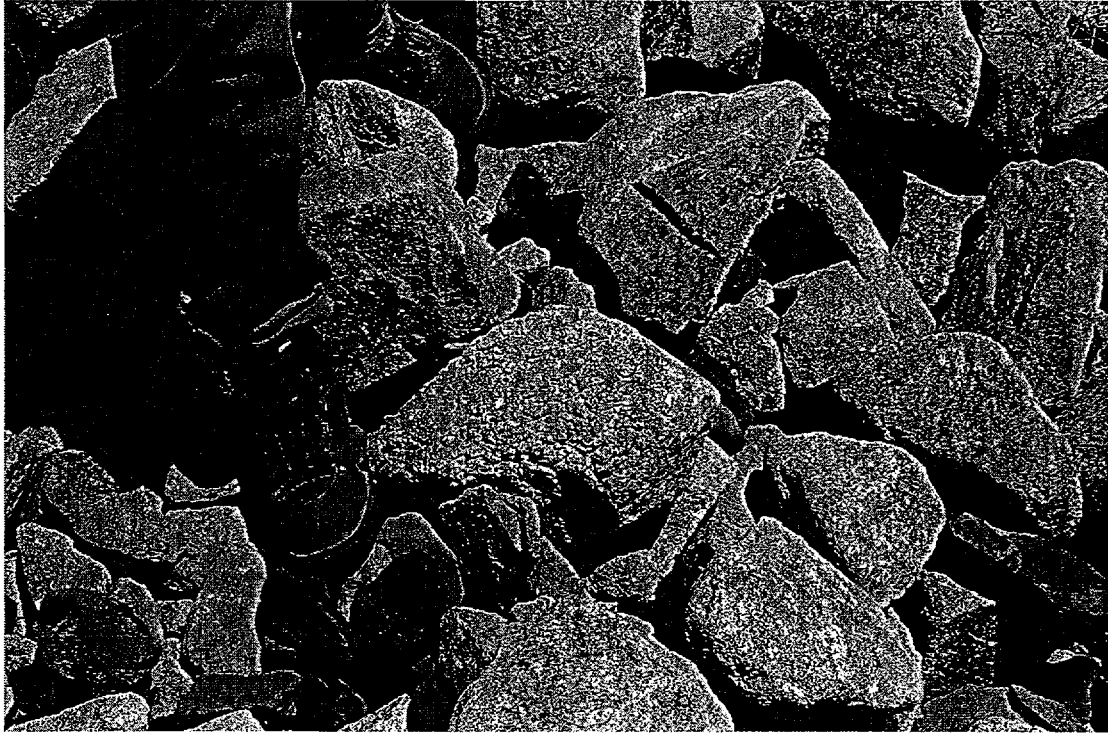
Photo 3.

There were very sparse dark volcanic rocks, less than 10 total, and even fewer light volcanic rocks, encountered over the two miles of riprap that were traversed. The volcanic rocks probably represent Tertiary andesites and dacites that have been mapped in the area of the basalt stockpile. The few volcanic rocks were probably inadvertently incorporated into the riprap when heavy equipment moved the basalt stockpile. These few volcanic rocks have largely crumbled. (Photo 3.)

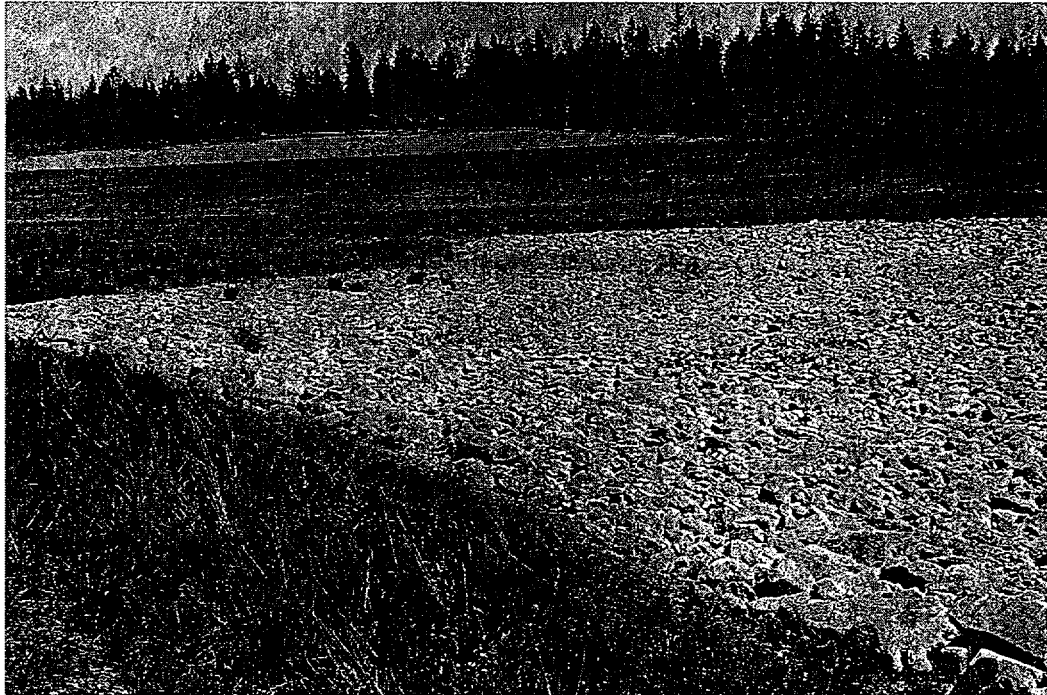
Photo 4.

The riprap associated with the cover outlet swale was reviewed. (Photo 4.) The southwest portion of the swale does show an increased percentage of quartz monzonite that has deteriorated at this time. However, the percentage remains small. Traversing the swale, the amount of deteriorated rock diminished and the rock was found to be consistent with the rock that was observed in the west side of the diversion ditch.

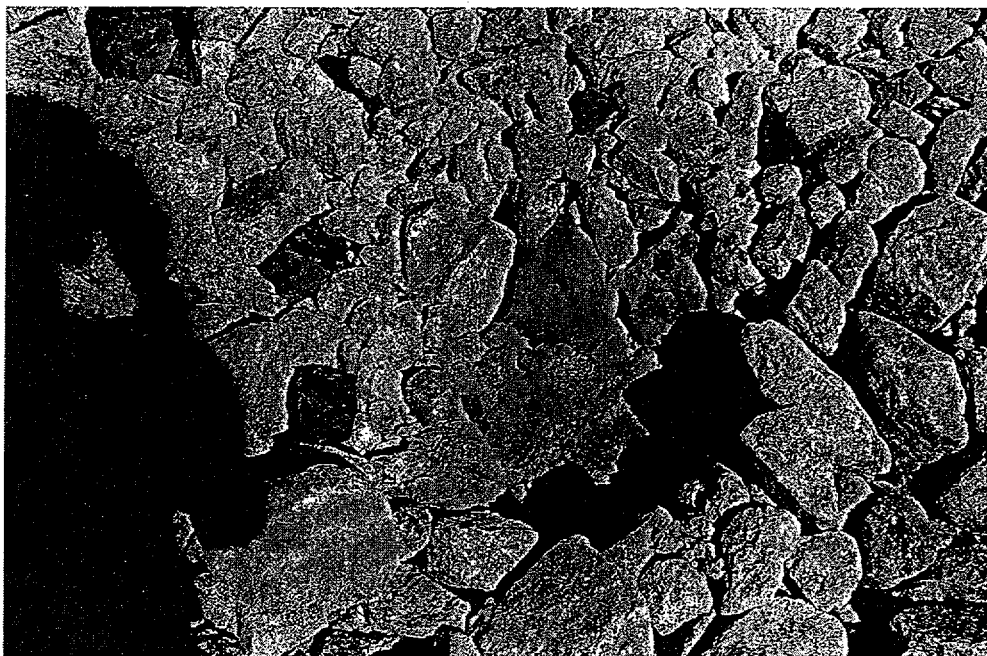
Photo 5.

An area approximately 50 feet by 30 feet in the middle of the swale has patches where the big rocks (15 inch rock) appear to be concealed underneath a layer of smaller rocks that are 2-3 inches in size. The smaller rocks are not fragments of rock that has deteriorated, but represent the initial smaller rock fraction that was placed. This area appears to be more of a gradation question than a rock durability question. John Blacklaw dug a hole by hand, approximately 5 inches deep, until digging became too hard to proceed. John dug a second hole approximately 4 feet away from the first which did uncover the large rock. (Photos 5 and 6)

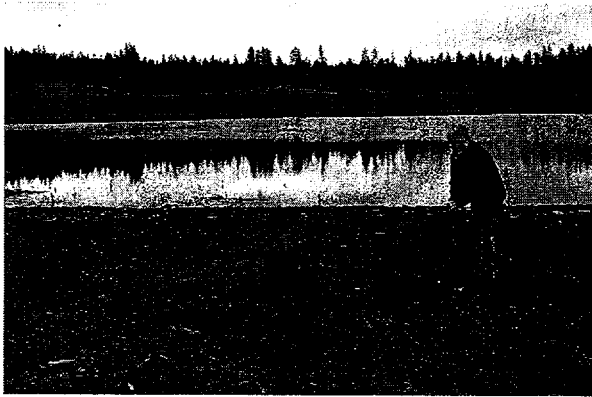
Evaluation of the near surface soils indicates that topsoil placement in the area of the pond has established a low-permeability layer and low infiltration rates. See photographs below for soil excavation and view of down hole.

Photograph shows Earl Fordham, PE digging a hole in the surface soil near the ponded area of the impoundment cover.

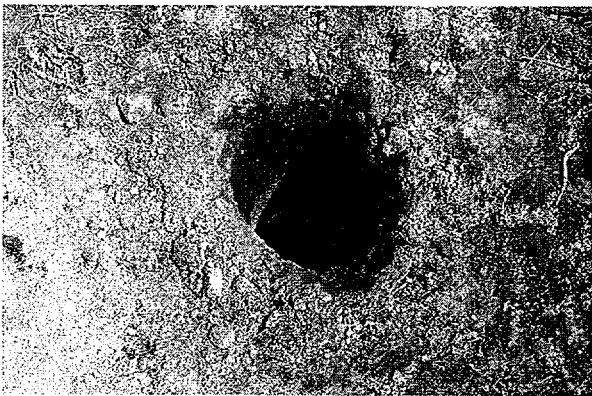
Photograph shows the dug hole after several days: The top portion of the hole (about 12 inches) is dark silty soil difficult to dig when dry (topsoil). Below is tan granular site soil. Water in the hole is approximately at the level of the pond surface.

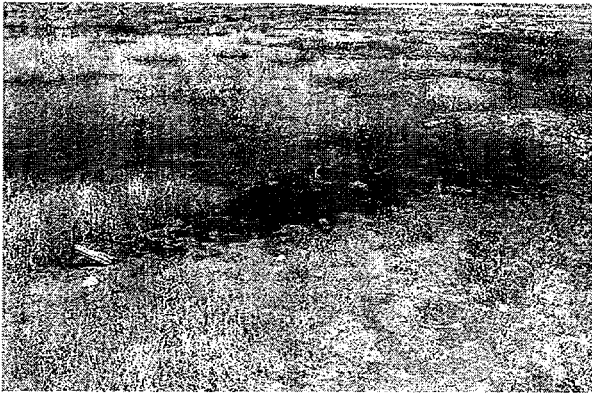
Pond vegetation showing soil transition to pond water and algae growth. Vegetation productivity is estimated at 20 to 40 percent coverage.

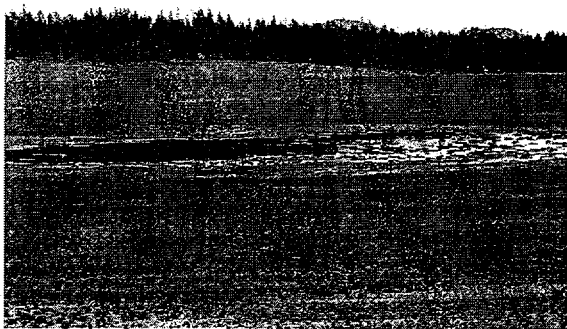
The pond area in early August had diminished about 50 percent since June 1999. Considerable evidence indicates deer and elk drinking at the pond and browsing the cover vegetation. Birds are prevalent. Frogs are found in pollywog and mature stages. Insects are present.

Distant photograph of the ponded area. Deer were browsing and drinking on the near side of the pond when this photograph was taken.

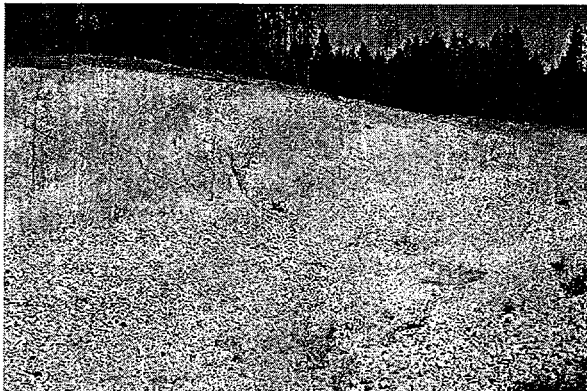
Photograph of the west side of the diversion channel. A sub-soil geological interface has produced a flow concentration effect. This in turn has caused a rill to form and increased soil deposition in the channel at this location.

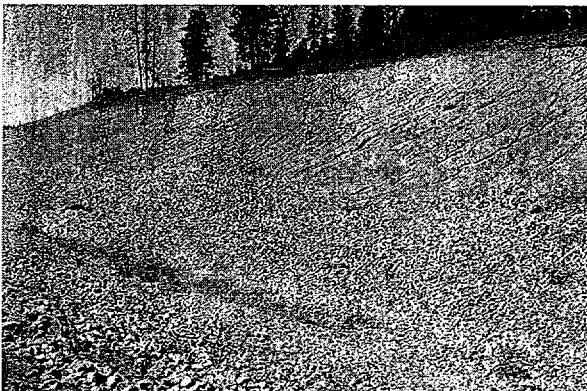
This photograph is on the east side of the diversion channel showing rilling in the soil area and deposition in the rock slope.

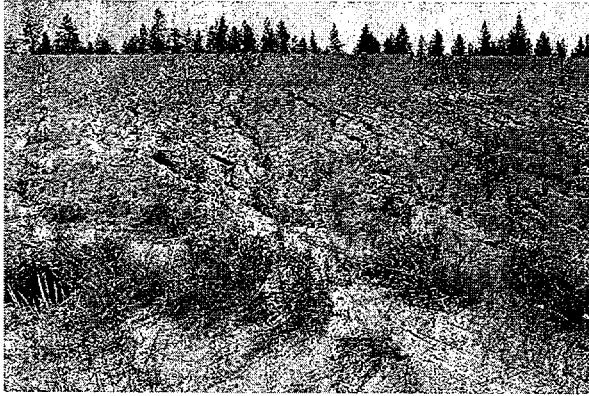
Photograph of the east margin surface showing rills on the upper portion of the slope. Some deposition is shown around the larger vegetation in the foreground.

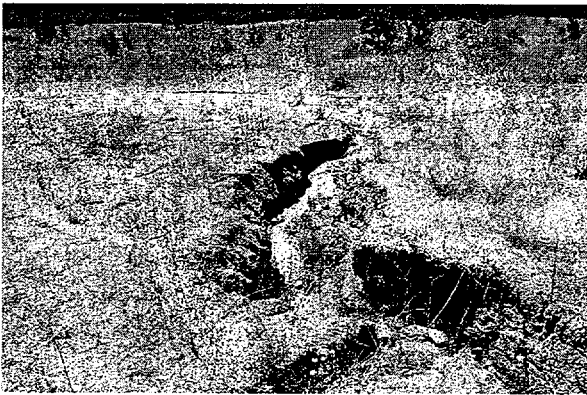
Photograph is of gully formed at the south end of the impoundment surface, between the swale and east margin. Runoff from this general area toward the south has cause this gully.

To stabilize the local area of the bench, it may be possible that recontouring of the bench, re-sloping of the bench, or removal of the bench may be warranted to eliminate the concentrated flow path. Although it is desirable that this area produces surface water flow to the outfall swale, this may require a considerable addition of soil fill and may not be warranted. Photographs below show the gully at the south edge of the constructed surface, the bench and the gully at the end of the bench.

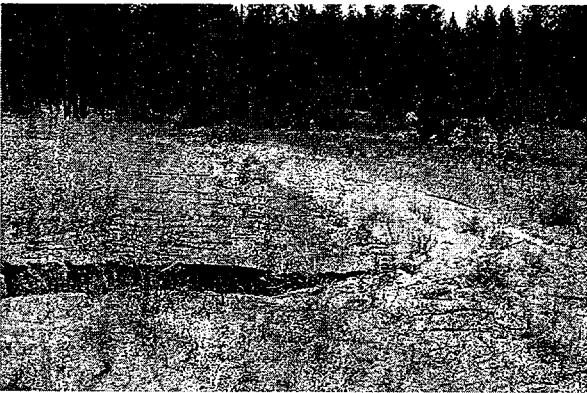
Photograph is of the south end of the impoundment where the gully flows into bench. Bench shows deposition and little capacity prior to breaching.

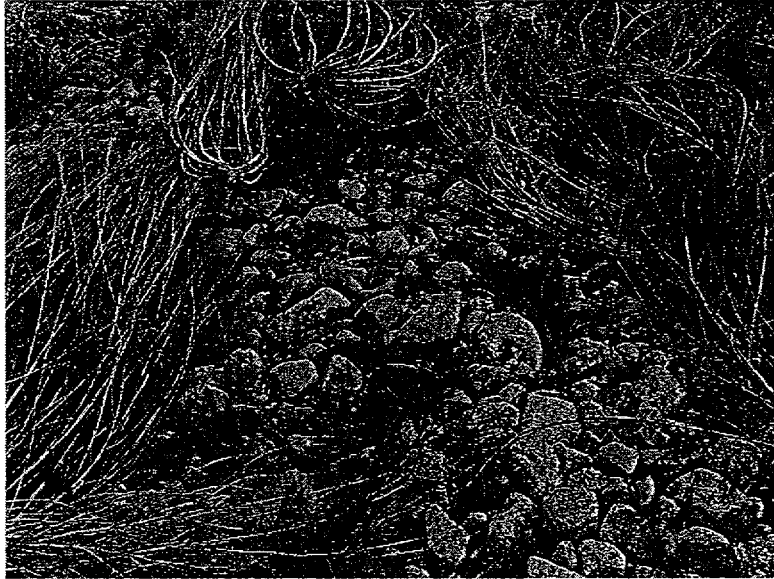
In order to simplify construction, most of the riprap used was oversized. The oversizing ranged from 25% to approximately 100 % (e.g., use 15 inch rock where 8 inch rock was called for in the design). The D_{50} rock sizes that were seen during the inspection were 3 inch, 6 inch, and 15 inch. Beneath the riprap was placed a filter layer of rock. The filters used beneath the riprap had D_{50} sizes of approximately 0.75 inches and 1 inch. Filter material is placed to prevent high water velocities in the within the voids of the riprap.

Picture 3: Vegetation in thin riprap

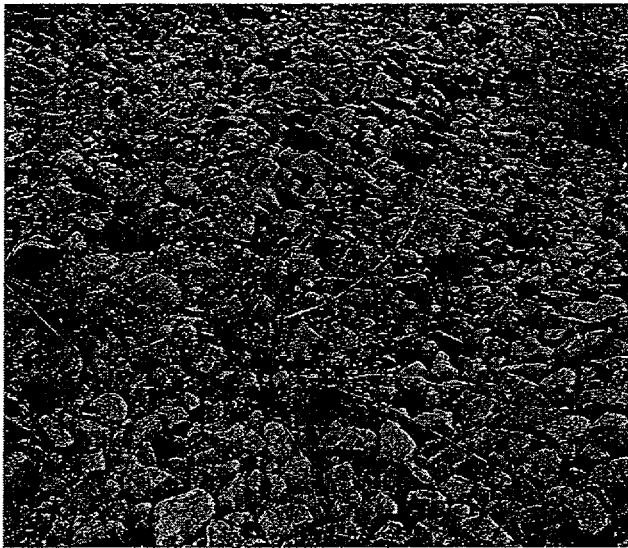
At Station 86+00, a thin area of riprap was noted (see picture 4). Station 86+00 corresponds to the first bend encountered during the inspection. The bend is approximately 30° to the left. Due to the channel width at this point, an apparent thin area was left in the outer diversion channel wall by the equipment used to excavate and build the diversion channel (e.g., scarring the wall). Again, vegetation has taken root where the thickness of the riprap is not uniform. Detailed investigation of this volunteer vegetation indicates that the roots are pervasive. It was with difficulty that the thickness of the riprap in these areas was determined.

Picture 4: Scarring in the channel walls

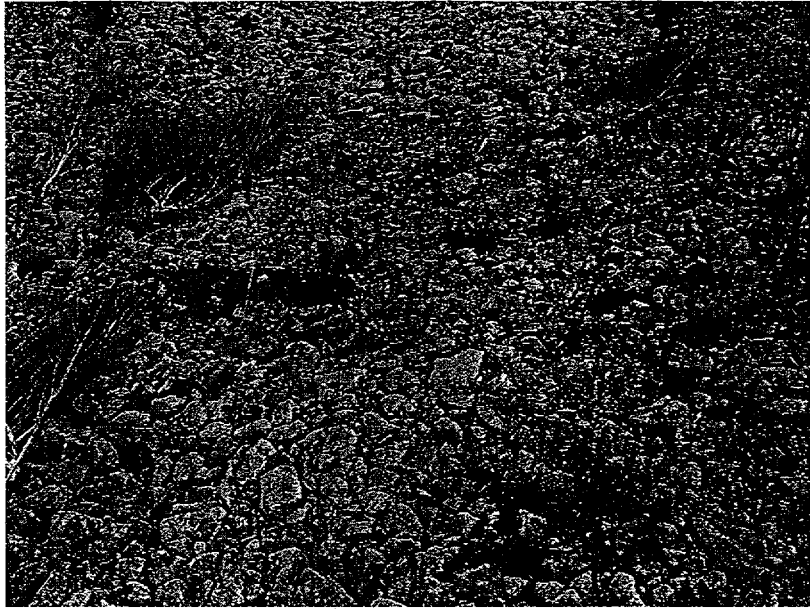
From the first bend, picture 5 shows the channel layout. At Station 83+28 (approximately 100 feet upstream of Confluence A), some uneven rock placement was noted as shown in picture 6.

Picture 6: apparent uneven rock placement

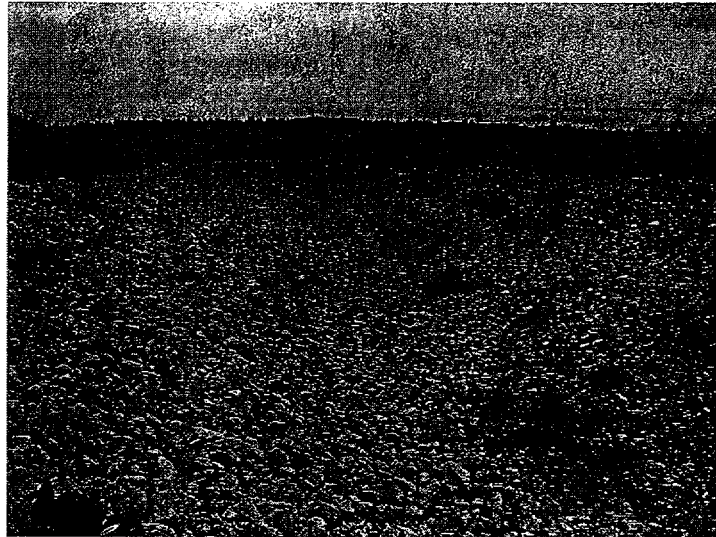
After Confluence A, the channel bends 30° back to the northeast as shown in picture 9. While construction traffic effects were noted, the channel was well graded.

Picture 9: downstream of Confluence A

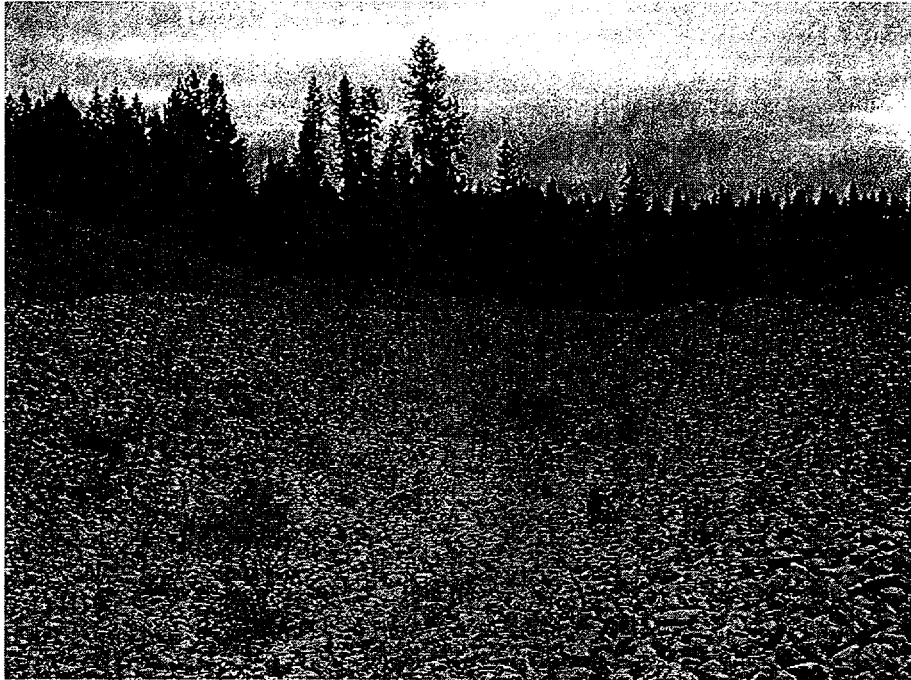
Picture 11

In the leg immediately upstream of Confluence B, construction traffic effects were noted on the outer bank of the channel as well as the effects of driving on the riprap at the bottom of the channel. Vegetation was also noted.

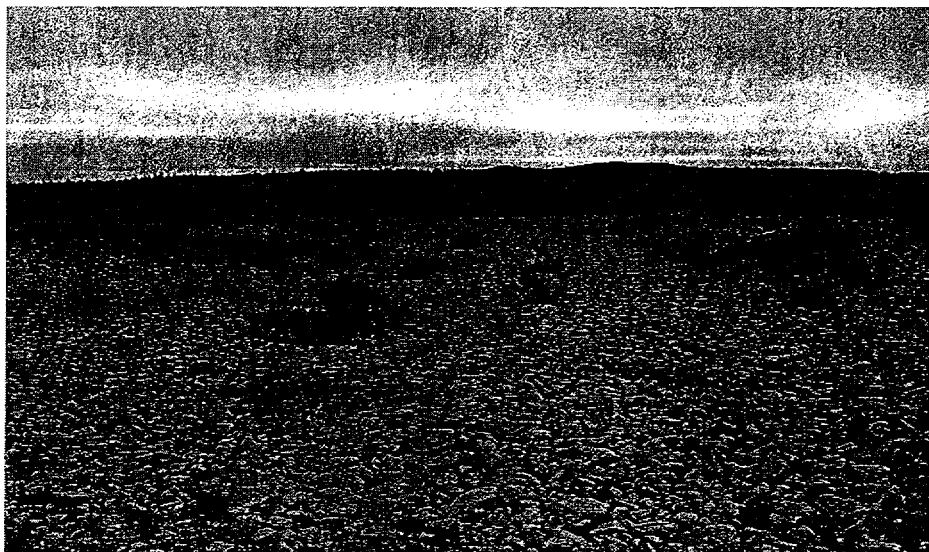
Picture 12 is taken from the upstream transition of Confluence B. Vegetation is easily visible. Construction traffic effects were absent. The area where traffic had traversed the confluence was visible, due to the weight compaction of the equipment moving in this area, but adverse effects did not occur. This absence of construction traffic effects may be due to the wider channel at the confluence.

Picture 12: Confluence B with vegetation

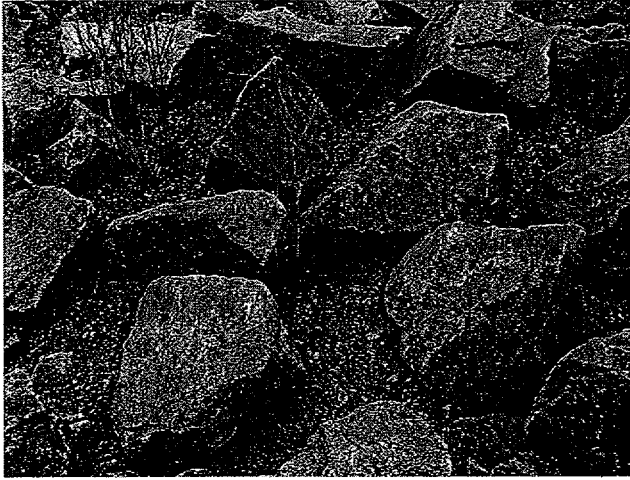
Picture 18: filter visible through void in riprap layer on inner slope at Confluence C

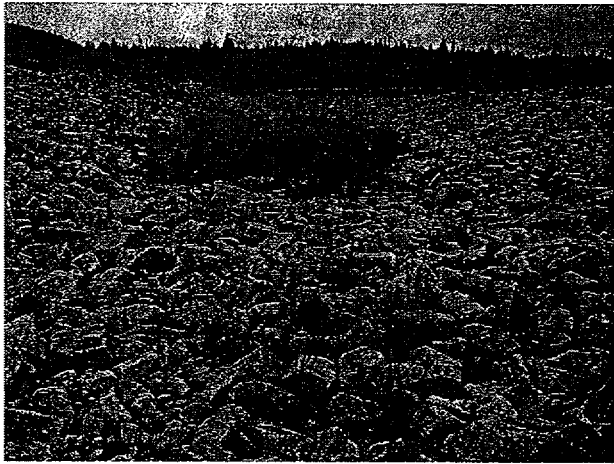
Picture 21: silting in channel from erosion

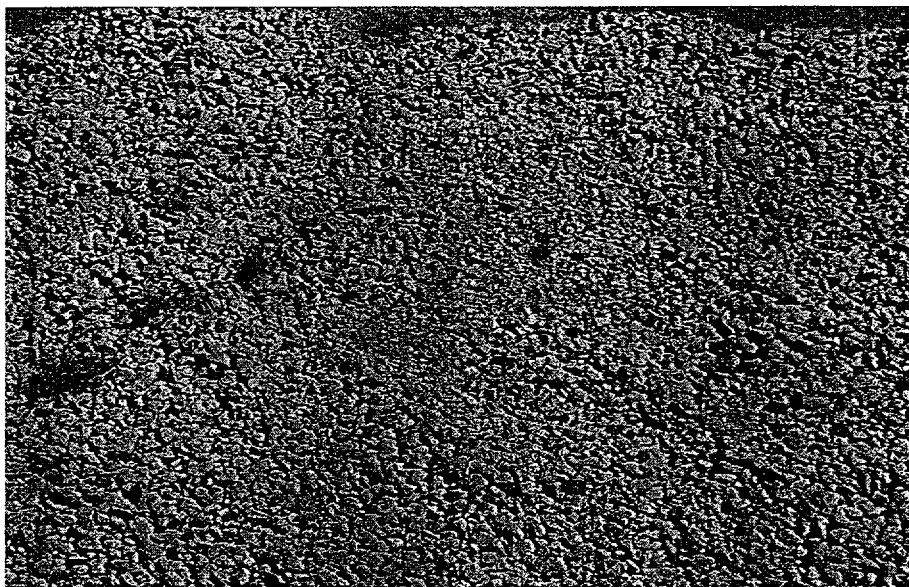
Picture 33: illusory area of poor grading

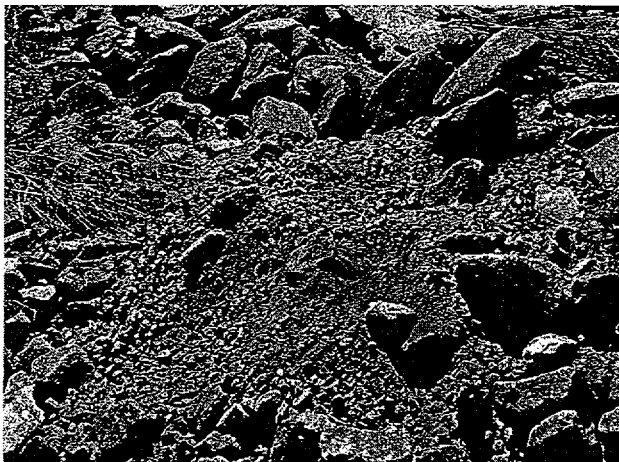
Picture 39: larger rock found under apparent filter layer

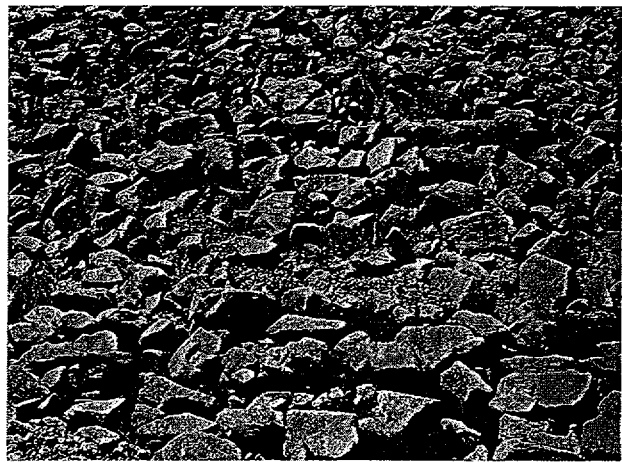
Picture 40: filter layer visible in Confluence F2 riprap

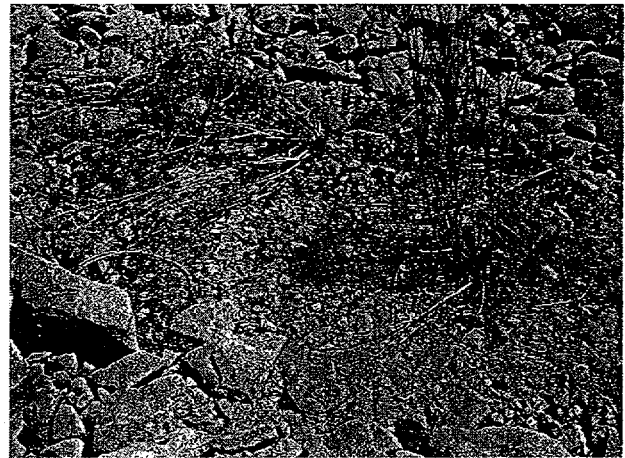
Picture 43: 15 ft² area with filter visible

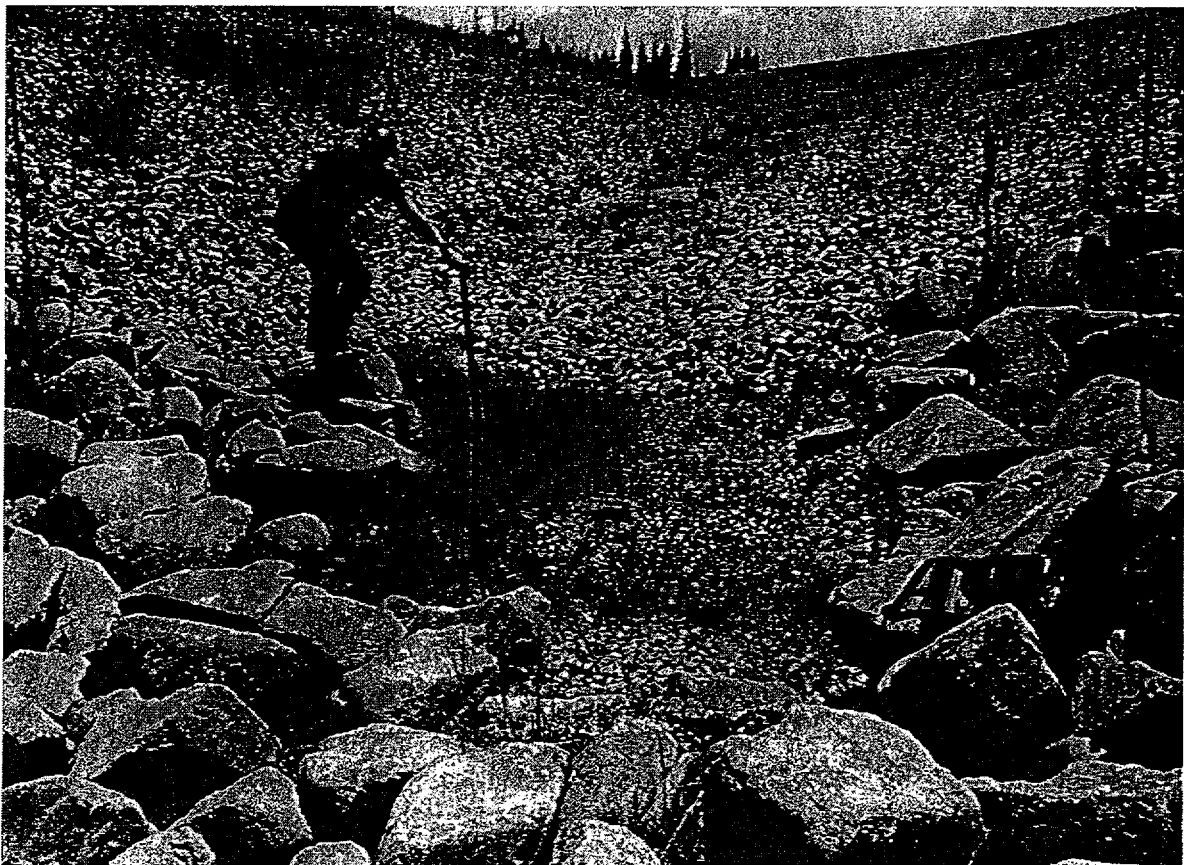
At Station 15+79 a 10 foot by 15 foot area found void of riprap. This area is located along the centerline of the diversion channel at the downstream transition from large ($D_{50} = 15$ inch) riprap used in Confluence G to the smaller ($D_{50} = 3$ inch) riprap used for most of the diversion channel. Picture 45 shows this area.

Picture 45: Confluence G downstream transition found void of riprap.

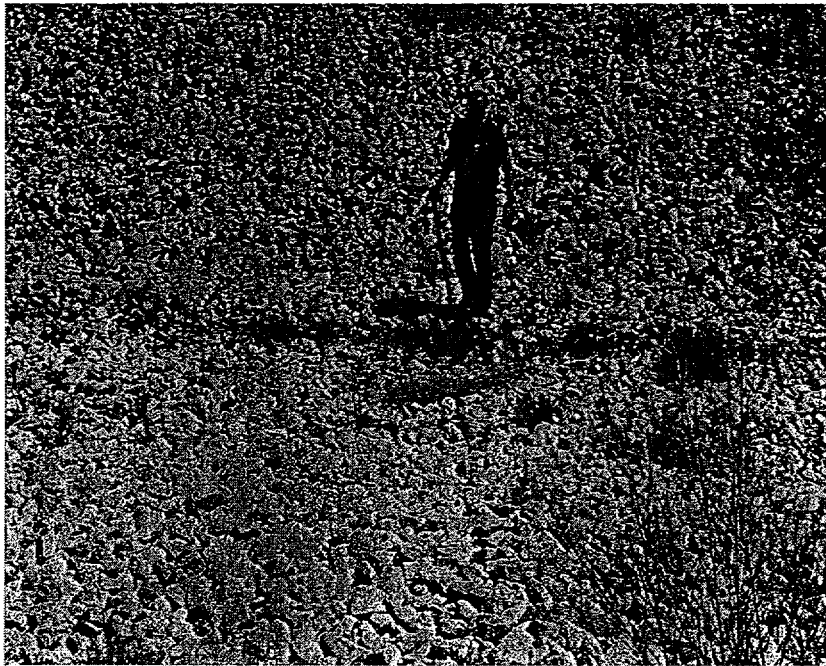
Picture 49
Riprap embedded into
filter layer

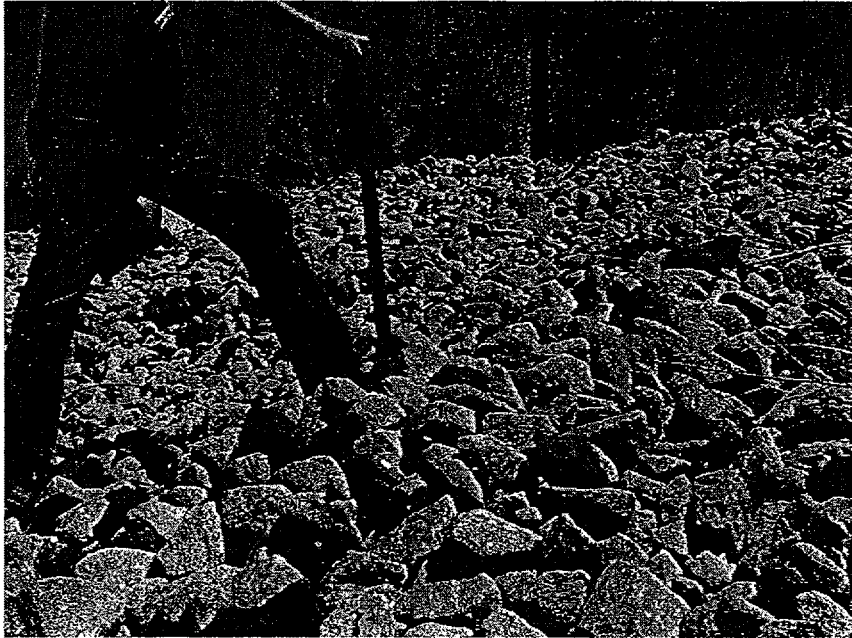
Picture 50:
construction traffic
effects creating
ridges and valleys

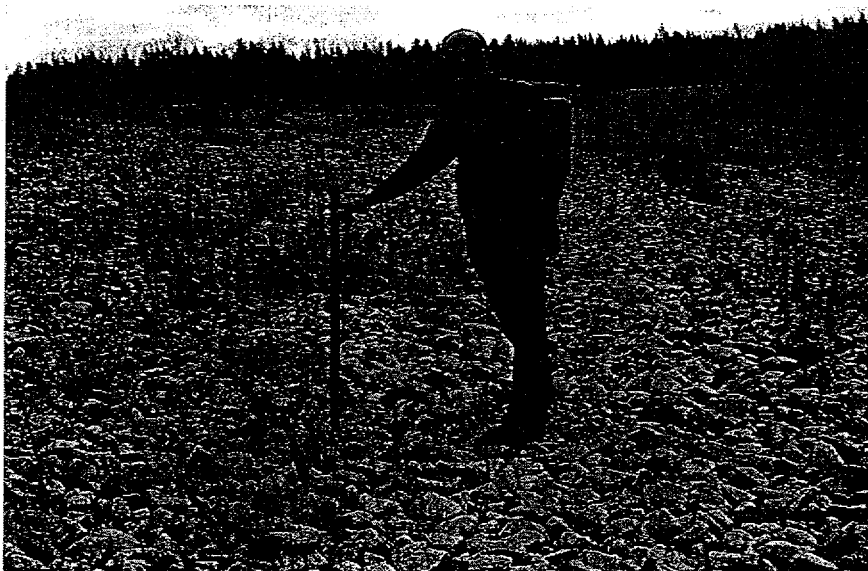
Picture 54: ridges and valleys from construction traffic are visible on the main embankment.

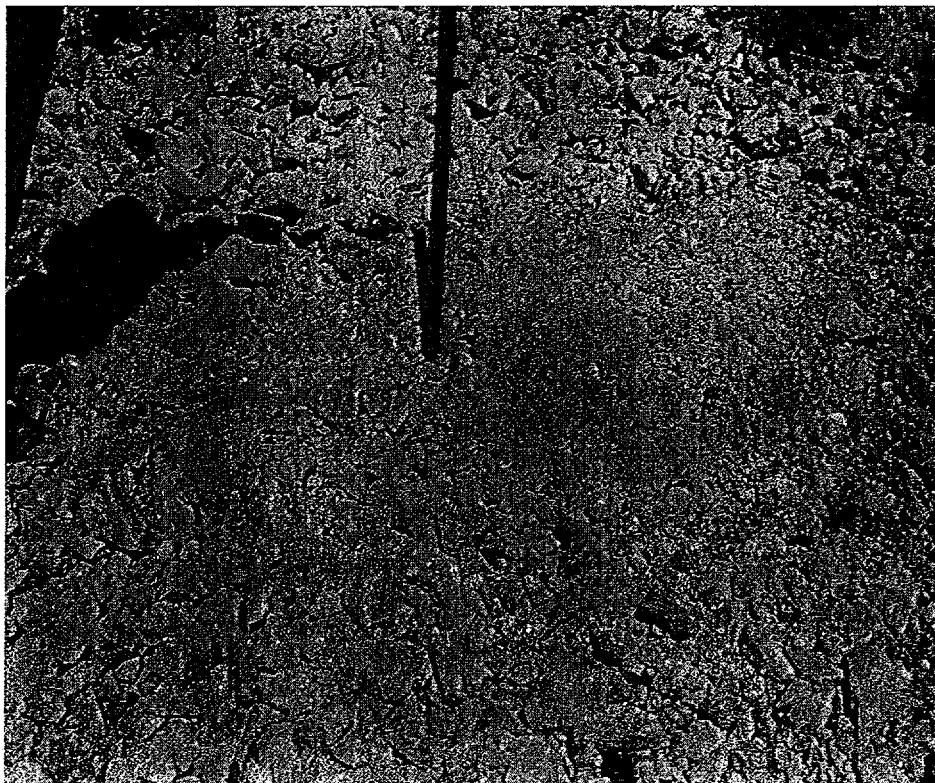
During the inspection one 18 ft² area was found with much smaller ($D_{50} = 1$ inch) rock overlaid 3-inch rock. Picture 56 below shows the examination hole dug to characterize the riprap layer.

Picture 56: small rock atop larger rock

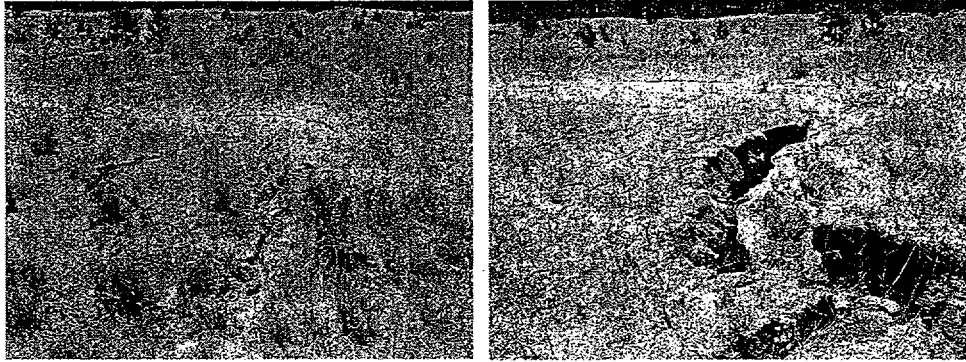
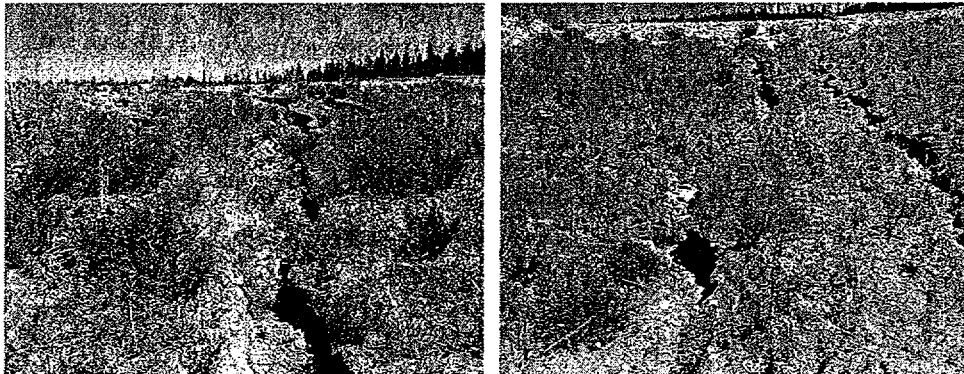
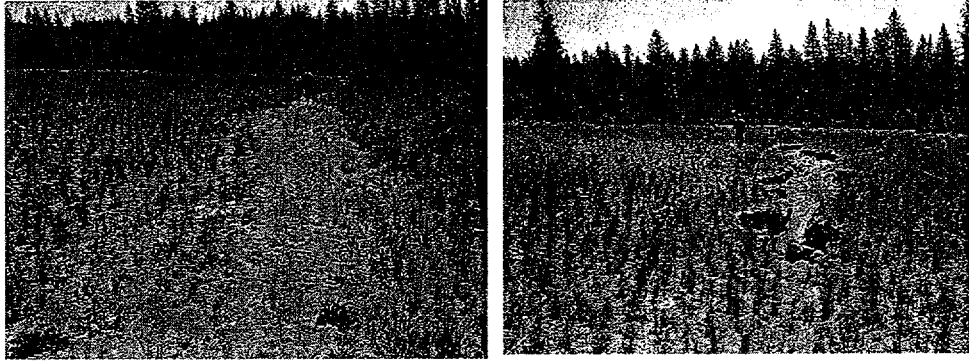
Swale Outfall Gully Erosion Issues

Issue 8 relates to the potential for gully formation at the swale outfall toe. Gullies might form in the future and head cut back into the swale outfall area. These gullies would likely stabilize when they encounter the structural capacity of the monzonite sub-grade and riprap from the constructed swale outfall. Weathered monzonite could be exposed locally in the bottom of these gullies. (The monzonite sub-grade, as seen in field inspections, has not eroded at this time, although there is some surface rock that is loose that may eventually move during heavy seasonal swale outfall flows.)
