NP-33-00-001-00

LER 2000-001  
Davis-Besse Nuclear Power Station, Unit No. 1  
Date of Occurrence - September 26, 1998

TITLE (4)  
Failure To Perform Technical Specification Action With Switchyard Circuit Inoperable Due To Inadequate Procedure

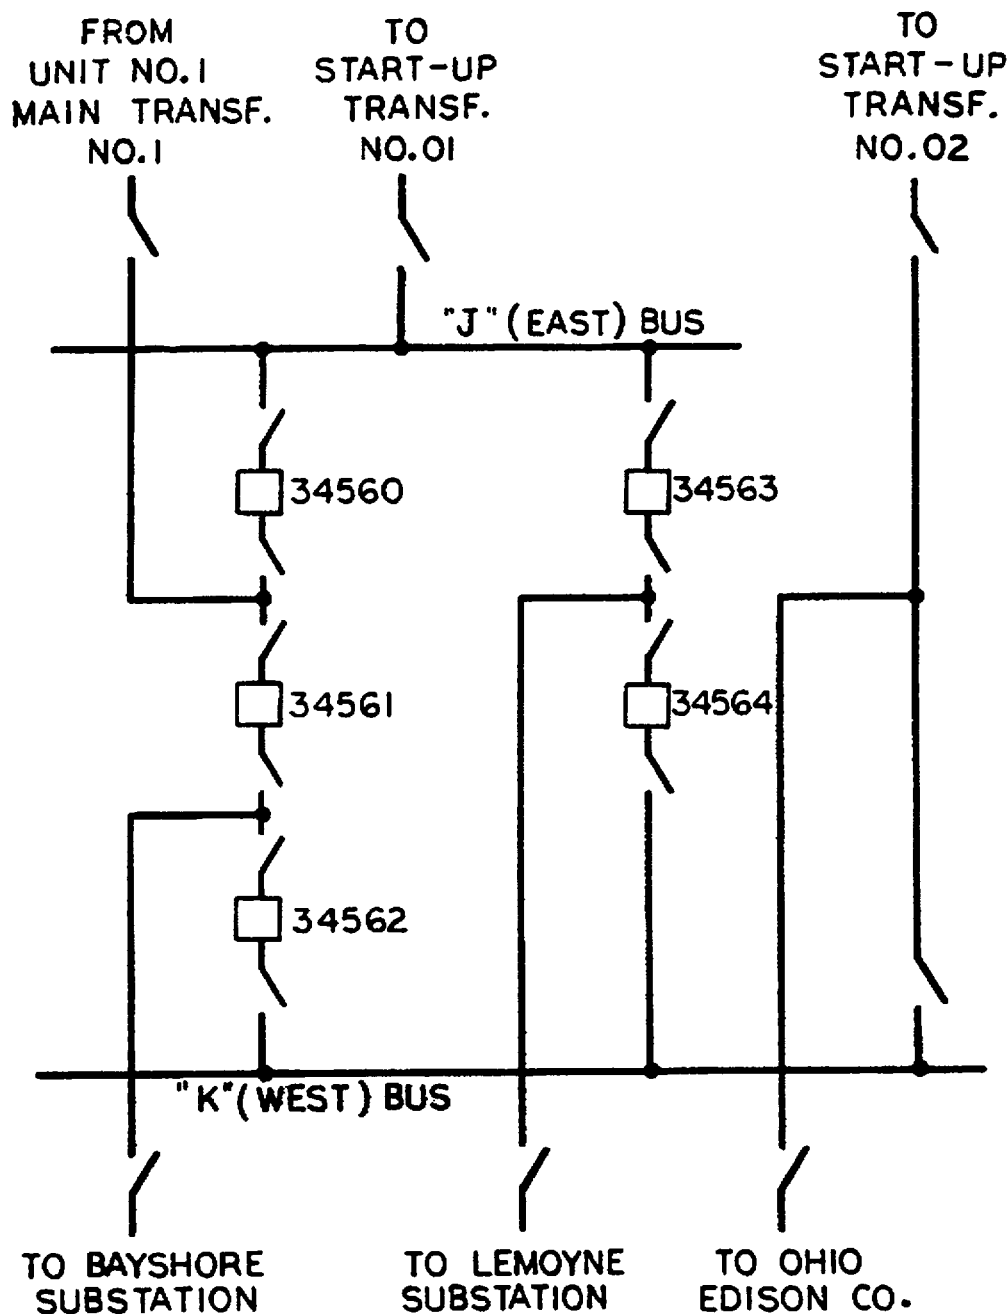
FIGURE 1

When a fault is detected on a switchyard breaker, protective relays open the breaker in an attempt to clear the fault. Protective relaying also exists for detecting when a breaker has failed to properly isolate a circuit. This relaying initiates a lockout of the circuits adjacent to the failed breaker, which opens all breakers associated with those circuits. Refer to Figure 1 for a diagram of the Davis-Besse Nuclear Power Station (DBNPS) Switchyard. If this lockout relaying fails and initiates a lockout of breaker 34562, breakers 34561 and 34564 would open, as well as the breakers on the Bayshore and Ohio Edison lines. A similar condition can occur if breaker 34564 experiences a lockout. The lockout of breakers 34562 and 34564 is discussed in the DBNPS Updated Safety Analysis Report (USAR) Section 8.2.1.1, Offsite Power System Reliability Considerations, but the configuration of the switchyard during maintenance is not discussed. With breaker 34563 open because of the low air pressure condition, a lockout of breaker 34562 would result in a loss of offsite power. Station operating procedures identified that Technical Specification LCO 3.8.1.1 should be entered when either the Bayshore or Lemoyne 345 kV transmission lines were removed from service as a result of the potential for this lockout fault, but did not identify entry into the LCO when opening other switchyard breakers.

Davis-Besse Nuclear Power Station 345 kV Switchyard One-Line Diagram
