Tennessee Valley Authority, Post Office Box 2000, Soddy-Daisy, Tennessee 37379

March 6, 2000

SEQUOYAH NUCLEAR PLANT (SQN) - REQUEST FOR APPROVAL OF
ALTERNATIVE TO AMERICAN SOCIETY OF MECHANICAL ENGINEERS
(ASME) CODE REQUIREMENTS - REPAIR OF CANOPY SEAL WELD
J-1 - UNIT 1

ENCLOSURE
SEQUOYAH NUCLEAR PLANT - UNIT 1
REPAIR AND REPLACEMENT REQUEST FOR RELIEF

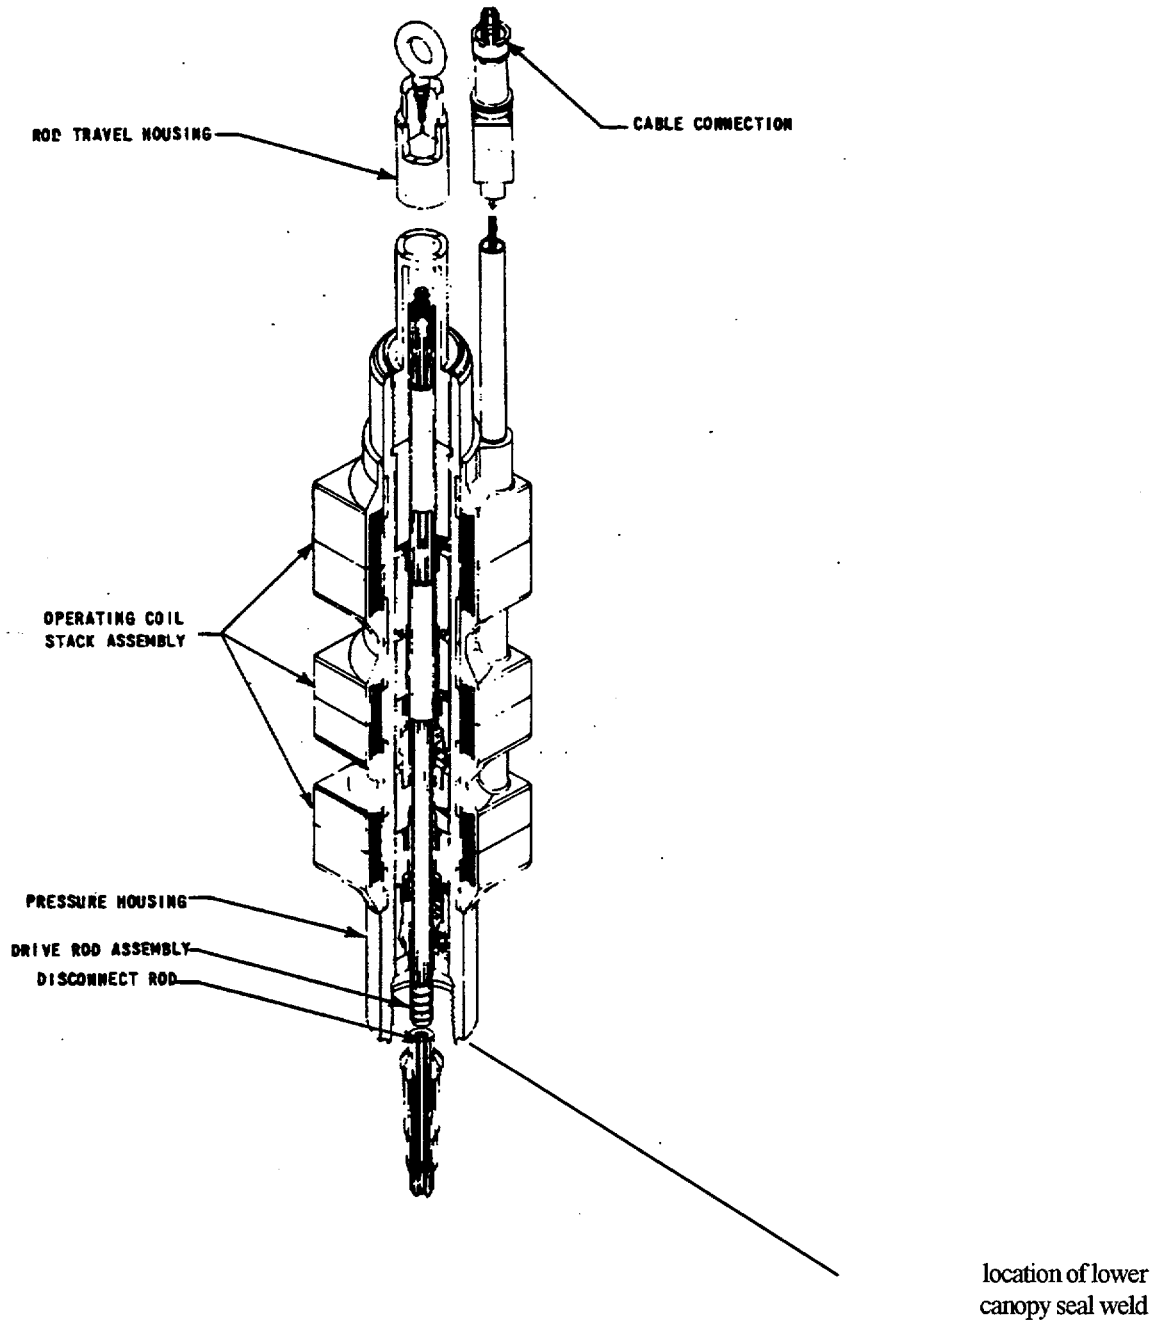
FULL LENGTH CONTROL ROD DRIVE MECHANISM

Summary: During the Sequoyah Nuclear Plant Unit 1 Cycle 10 refueling outage (U1C10 RO) activity of inspecting the reactor vessel head, boric acid residue was noticed on the control rod drive mechanism (CRDM) at the J-1 location (see Attachments 1, 2, and 3). The J-1 location is a dummy can and does not house an active CRDM. The American Society of Mechanical Engineers (ASME) Code requires the defects be removed and the configuration of the material be reproduced in order to restore the canopy seal to its original design condition. Because of the physical space limitations, and in consideration of radiation exposure, Sequoyah proposes as an alternative to perform a weld buildup over the leaking canopy seal weld (see proposed design in Attachment 4) rather than removing the defect and performing a weld repair. Also, an enhanced visual examination is proposed as an alternative to the liquid penetrant examination required by the original construction code for the final weld buildup.

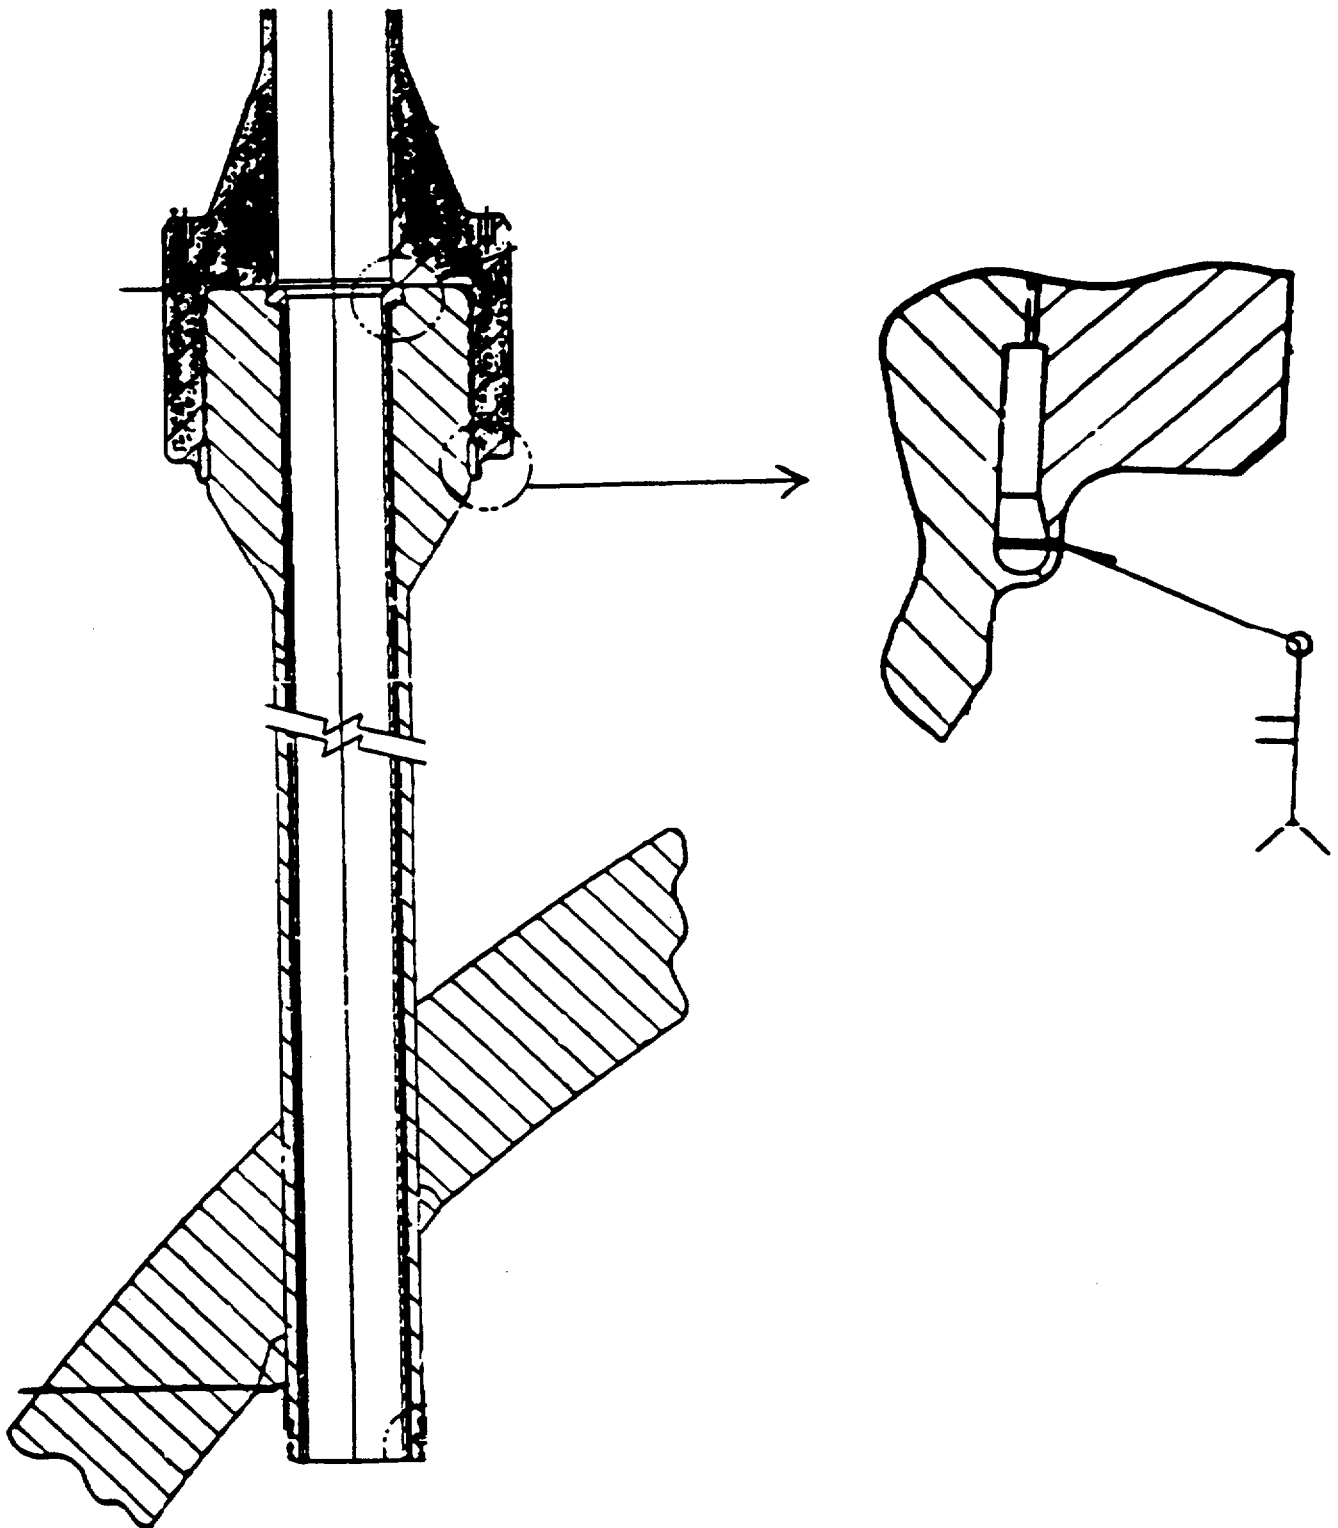
TYPICAL LOWER CANOPY SEAL WELD DETAIL

During the UIC10 RFO activity of inspecting the reactor vessel head, boric acid residue was noticed on a CRDM at the J-1 location at the lower canopy seal weld. See Attachments 1, 2 and 3 for configuration and location of the CRDM and canopy seal weld.

- b. An enhanced visual examination using a remote video camera with a magnification of approximately 8X will be used to monitor the repair and to perform a visual examination of the final weld at the enhanced magnification.

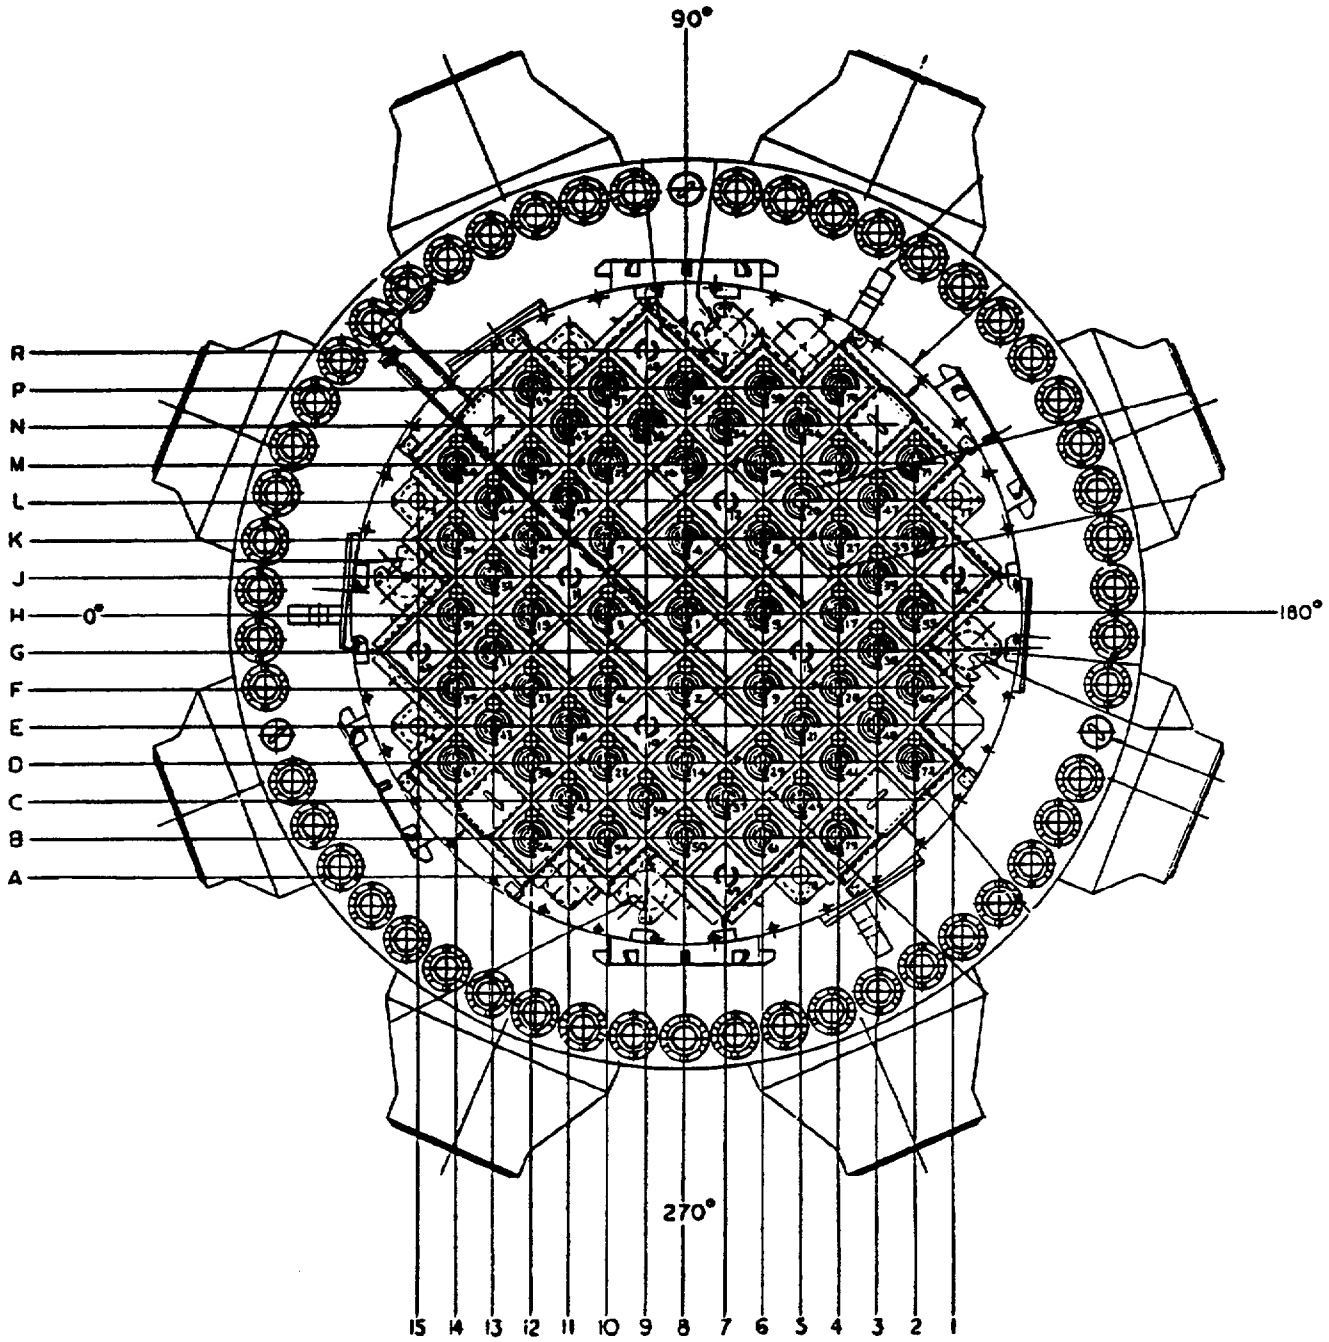
LOCATION OF CRDM TO BE REPAIRED

CRDM with Lower Canopy Seal Weld Overlay Repair
Location
J-1
