Commonwealth Edison Company
LaSalle Generating Station
2601 North 21st Road
Marseilles, IL 61341-9757
Tel 815-357-6761

LaSalle County Station, Unit 2
Facility Operating License No. NPF-18
NRC Docket No. 50-374

Subject: Licensee Event Report

In Licensee Event Report (LER) #97-001, Commonwealth Edison (ComEd) Company committed to provide a supplemental report to provide additional information related to the cause of the reported event. ComEd has completed the review of the event and is submitting LER #97-001-01, Docket No. 050-374 to fulfill our previous commitment.

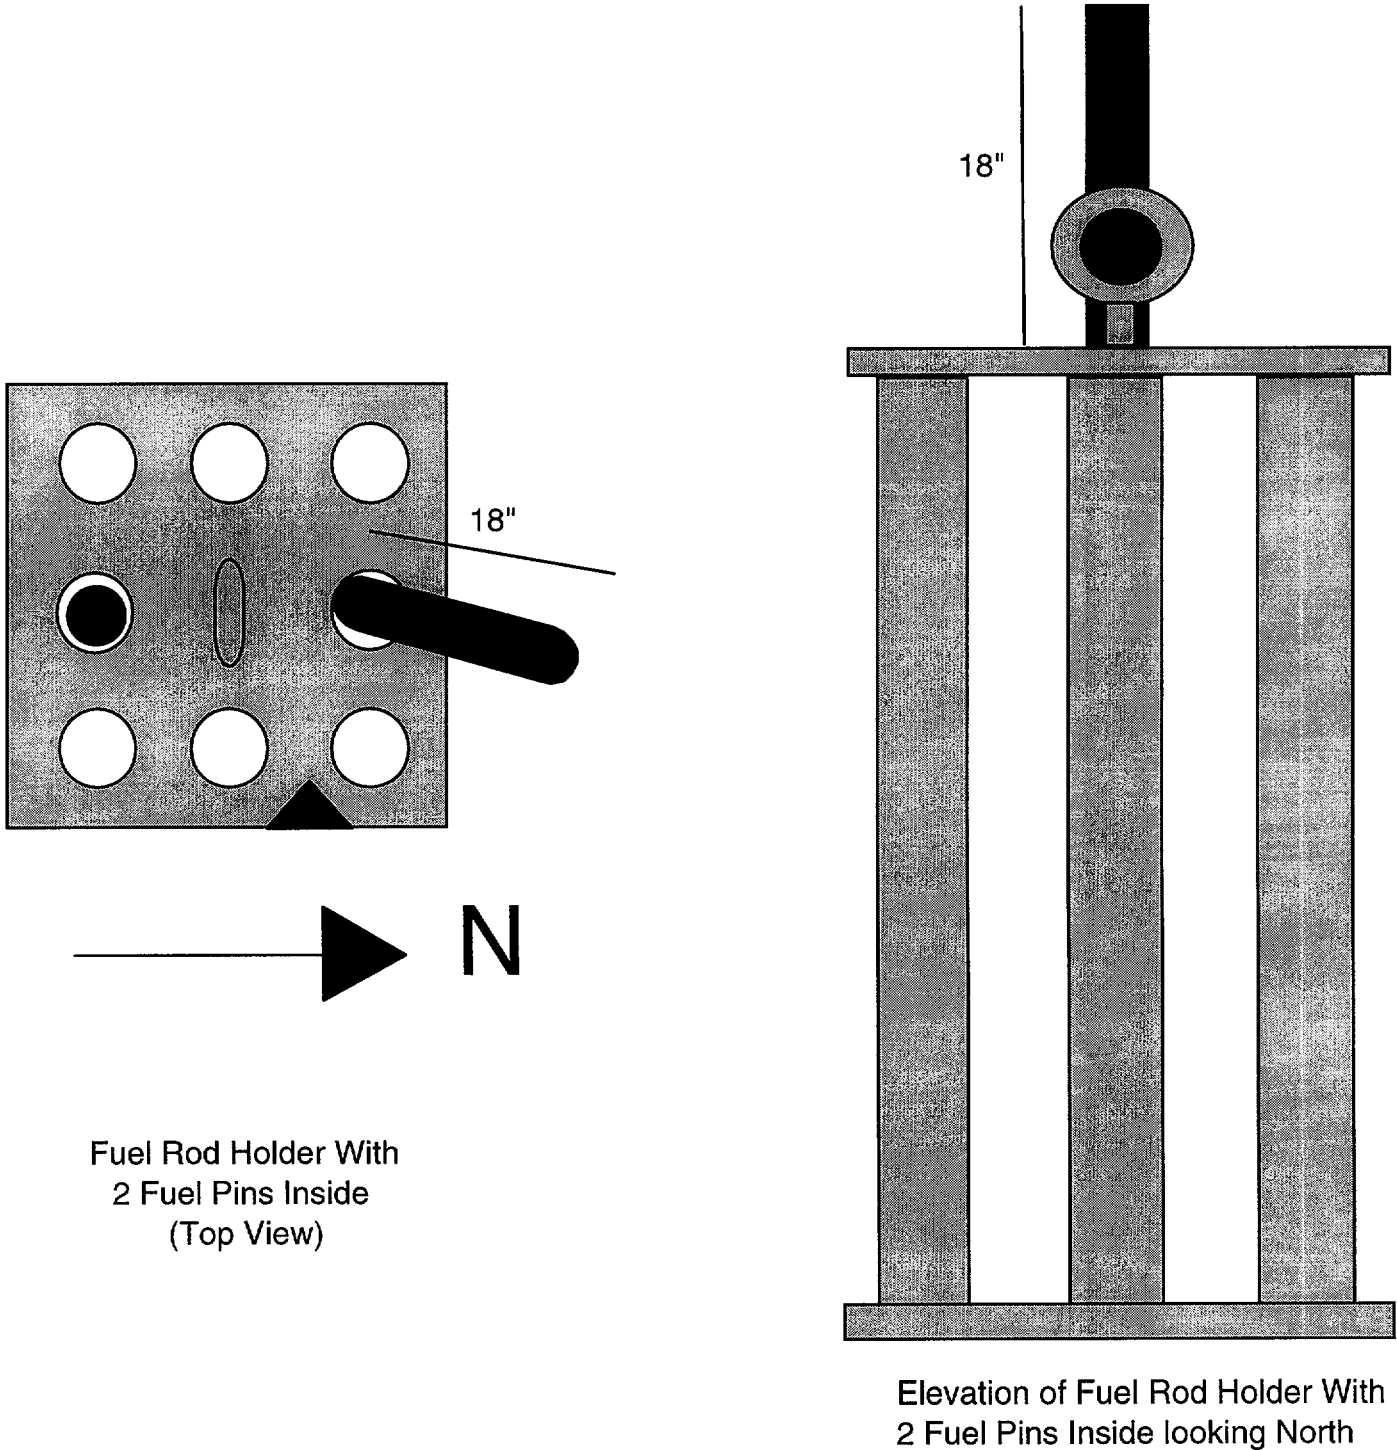
FIGURE 1

Cell SR3-A-2 is approximately three feet away from a defective fuel storage cell (SR3-B-0), which contained a fuel rod storage canister. The canister originally contained two fuel rods that had been removed from a fuel bundle (LYF289) during a fuel bundle reconstitution campaign in May, 1989 (see Figure 1 for an as-found drawing of the canister). The broken fuel rod section was the upper portion of one of these two rods. The storage canister has since been moved to cell SR3-B-1. This is the only storage location that contains individual fuel rods at LaSalle.
