SUBJECT: Summary of Event # 36725 - Incident Involving a NDS 200 Gauge on February 25, 2000

RE: Emergency Response Call to East Galvanize #6 Line on February 25, 2000

Nuclear Gauge Survey Form

SEALED GAMMA/BETA SOURCES - LEAK TEST CERTIFICATE

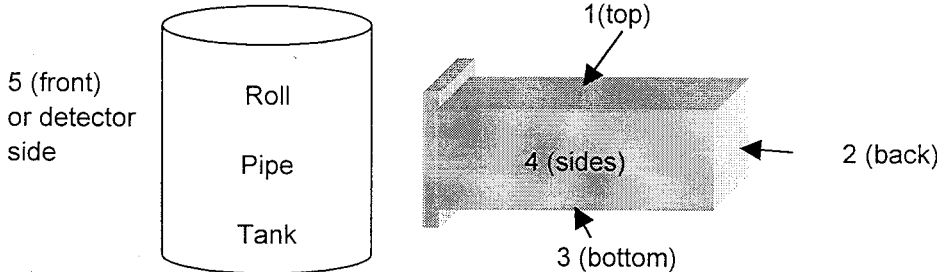
maximum ion chamber reading: 1.6mR/hr

Closed Shutter Readings			Open Shutter Readings		
	Surface mR/hr	@ 1 Foot mR/hr		Surface mR/hr	@ 1 Foot mR/hr
1 Top	0.2	0.18	1 Top	n/a	n/a
2 Back	0.4	0.12	2 Back	n/a	n/a
3 Bottom	0.6	0.4	3 Bottom	n/a	n/a
4 Sides	0.4	0.2	4 Sides	n/a	n/a
5 Front	2	0.2	5 Front	n/a	n/a

Comments: No open shutter readings were taken because gauges were locked out. This survey was taken after the gauge was knocked off of its track (Emergency Response). See report dated 2/25/00 for more info.
