Re: St. Lucie Unit 1
Docket No. 50-335
In-Service-Inspection Plan
Second Ten-Year Interval
Relief Request 17 Closeout Action

ROOT CAUSE ANALYSIS
SOCKET WELD FAILURE, MFW ISOLATION VALVE (V09188) BYPASS LINE

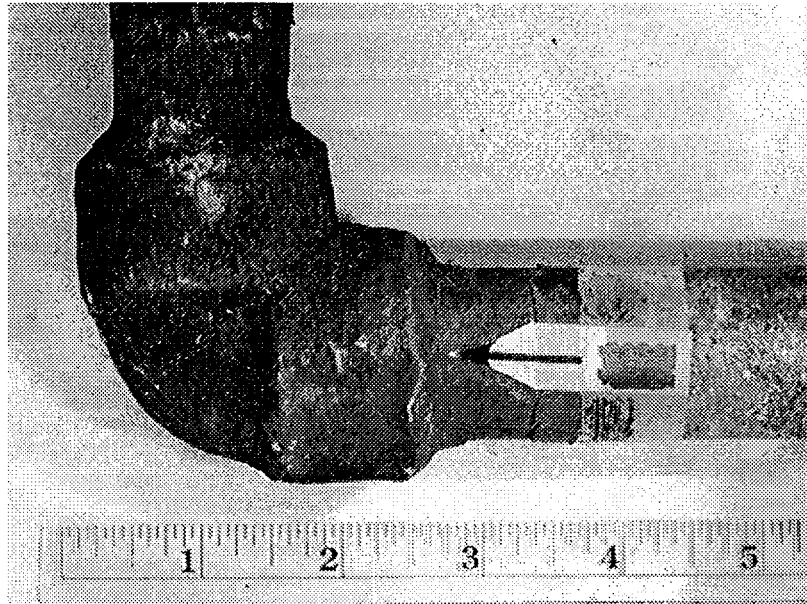
The failed socket weld and associated components are shown in the as-received condition in Figure 1. The outside surfaces were covered with a dark brown corrosion product. There were also remnants of the rubbery injection compound present on the surface. The joint did not display any evidence of plastic deformation.

Figure 1. Photograph showing piping components in the as-received condition. Arrow points to leaking socket weld.

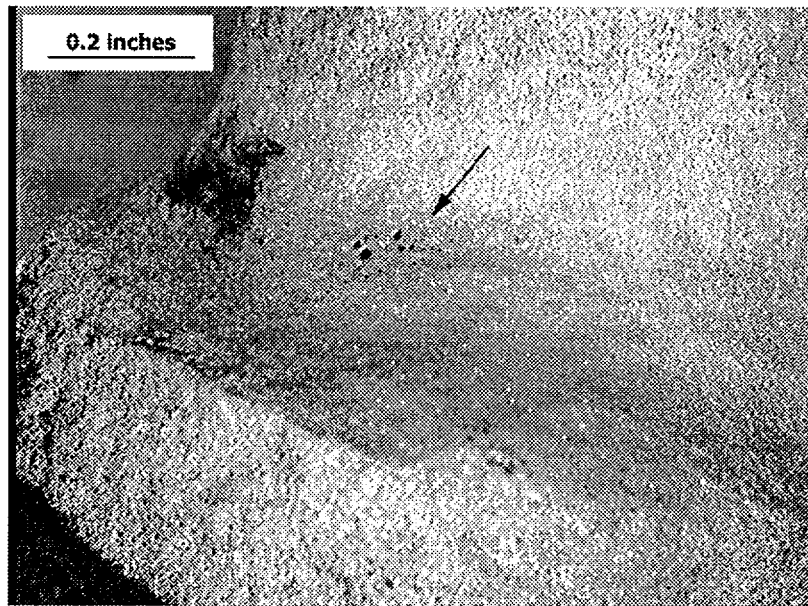
The outside surfaces of the components were lightly sandblasted to facilitate identification of the leak location. Several patches of porosity were noted as shown typically in Figure 2. Additionally, the weld contour was rather irregular in the vicinity of one such patch as shown in Figure 3. There was also a linear type defect, possibly the result of peening, in this region.

Figure 2. Photograph showing patch of porosity on outside surface, at pipe-side toe of socket weld.

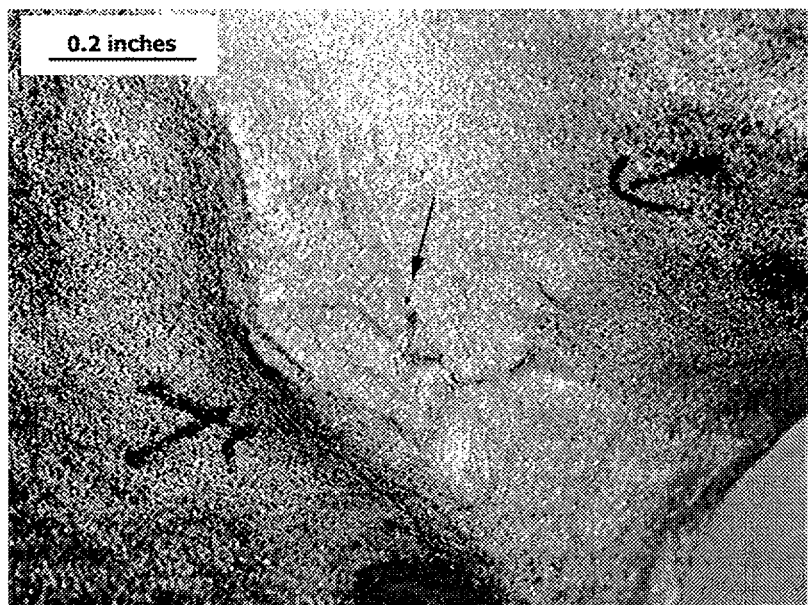
Figure 3. Photograph showing porosity and linear defect on outside surface, at pipe-side toe in another region of socket weld.

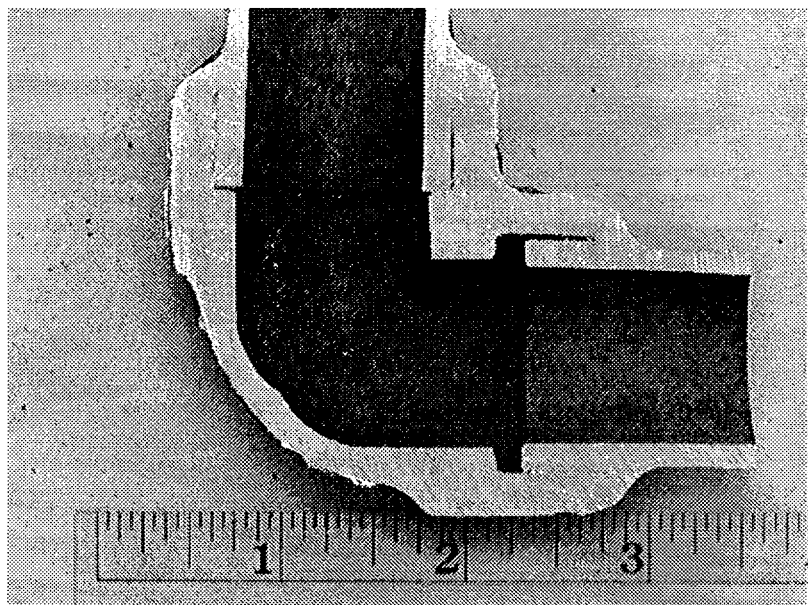
The joint was split axially to facilitate examination of the components' internal surfaces. They were covered with a dark brown corrosion product and did not exhibit any evidence of excessive wastage. The leaking socket weld joint displayed adequate pull-back, however, the non-leaking joint displayed none as shown in Figure 4.

Figure 4. Photograph showing ID surface of components. Note lack of pull-back in vertically oriented weld. Leaking weld is oriented horizontally and exhibits adequate pull-back. Internal surfaces do not exhibit any evidence of excessive wastage.

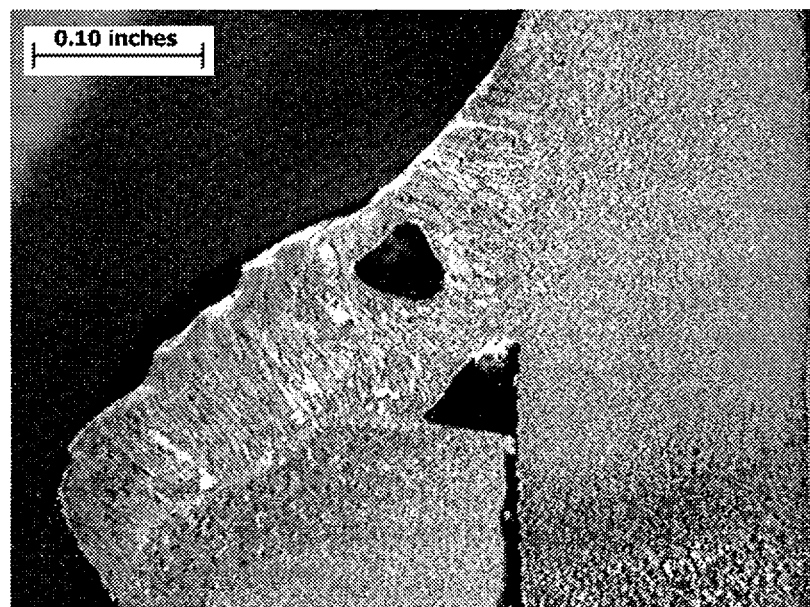
Several axially oriented cuts were made through the aforementioned patches of porosity, and the cut surfaces were prepared metallographically. In the vicinity of the patch previously displayed in Figure 3, there was a significant amount of subsurface porosity and lack of penetration at the weld root as shown in Figure 5. Further grinding in this region revealed the leak path as shown in Figures 6 and 7. The microstructures displayed by the base and weld metals were normal for the plain carbon steel components.

Figure 5. Photomicrograph of axially oriented metallographic specimen showing lack of penetration at root and subsurface porosity in region displayed in Figure 3. Solidification and etching patterns indicate that defects were preservice in nature.

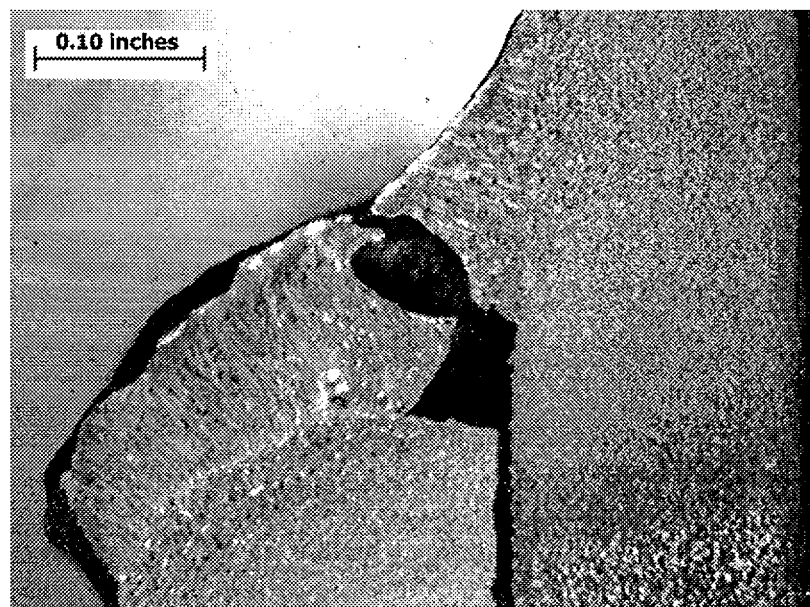
Figure 6. Photomicrograph of axially oriented metallographic specimen showing leak path in plane immediately adjacent to that displayed above.

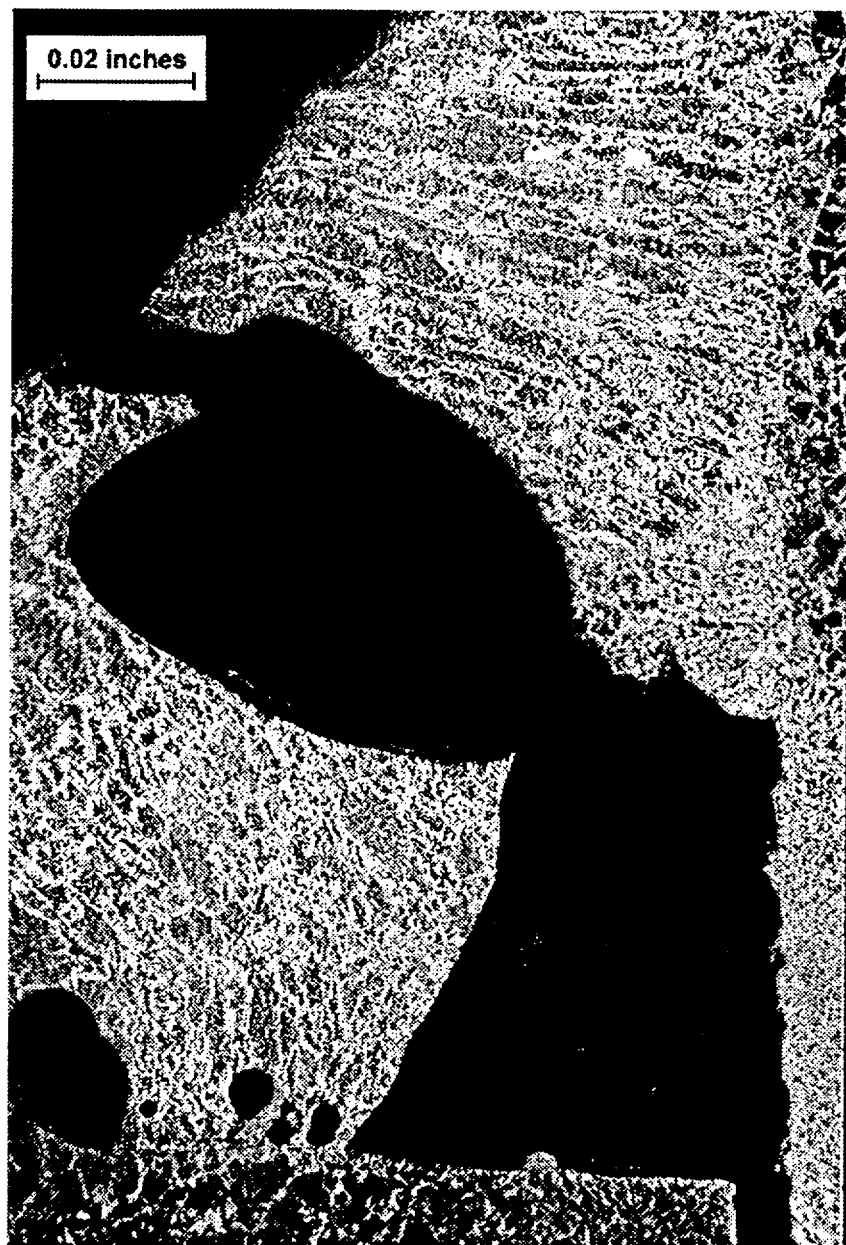
Failure of the subject socket weld joint was initiated by preservice welding defects. Specifically, the presence of excessive porosity and lack of penetration resulted in a very thin ligament of weld metal available for pressure retention. Final ductile fracture of this ligament occurred after minor internal and/or external corrosion reduced its wall thickness below the required load carrying capacity. There was not any evidence of external mechanical loads having contributed to the failure. The likely root cause of the welding defects was poor welder technique.

Figure 7. Photomicrograph showing higher magnification view of leak path region. Excessive porosity and lack of penetration at root are evident. Final ductile fracture of outer ligament likely occurred after its thickness was reduced by minor internal and/or external corrosion.
