Clinton Power Station

Subject: Clinton Power Station
Licensee Event Report No. 2000-002-00

TITLE (4)
Out-of-Phase Synchronization Results in Damage to Division 3 Emergency Diesel Generator and Inadequate Design of Static VAR Compensator Freeze Circuit Results in Overvoltage of Class 1E Divisional Bus

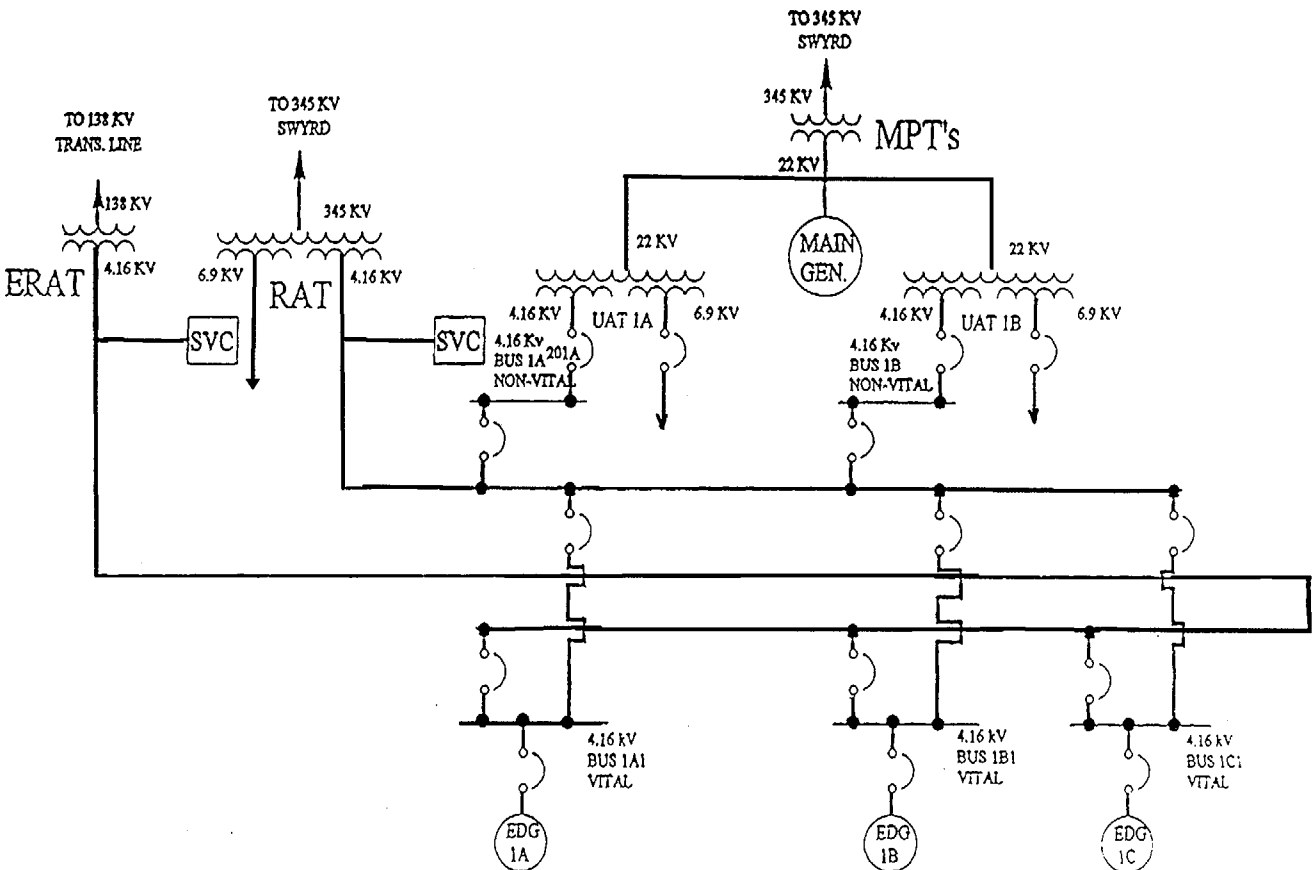
Figure 1

The Clinton Power Station (CPS) Class 1E 4160 VAC electric power system consists of three electrically and physically independent distribution divisions, i.e., the 1A1, 1B1 and 1C1 electrical buses. Each of the three distribution divisions can be supplied with electric power from either of two offsite sources via two physically independent circuits or an EDG that serves as a standby power source, independent of the offsite source. The two physically independent offsite source circuits are the 345 kilovolt (kV) circuit through the Reserve Auxiliary Transformer (RAT) and the 138 kV circuit through the Emergency Reserve Auxiliary Transformer (ERAT). A Static VAR Compensator (SVC) is installed on each of the secondary sides of the RAT and ERAT to assist in maintaining acceptable voltages to the 4160 VAC distribution divisions during normal plant operating conditions and / or accident conditions. Each SVC is rated at +28.5/-14.0 MVAR and includes a thyristor-controlled reactor bank rated at 21.5 MVAR, a thyristor switched capacitor bank rated at 21.0 MVAR, and a capacitive harmonic filter bank rated at 7.5 MVAR. (Figure 1 on page 9 contains a simplified diagram of the 4160 VAC electrical power system.)
