REFERENCE: Docket No. PRM-40-28

SUBJECT: Comments on Proposed Rulemaking

**Department of the Air force  
Robins Airforce Base**

**Report: Repair and Refurbishment of Aircraft  
Counterweights**

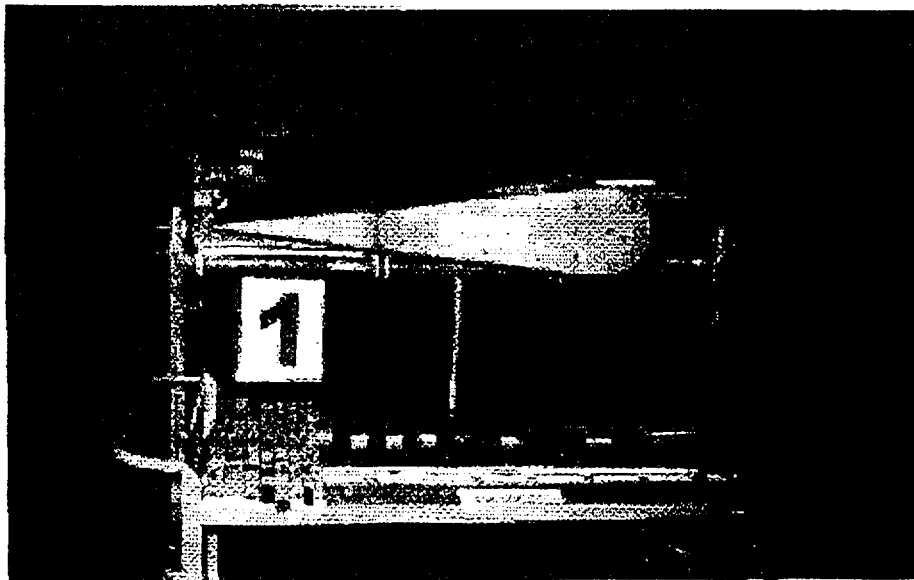
Figure 3, Counterweights Removed From Elevator 1

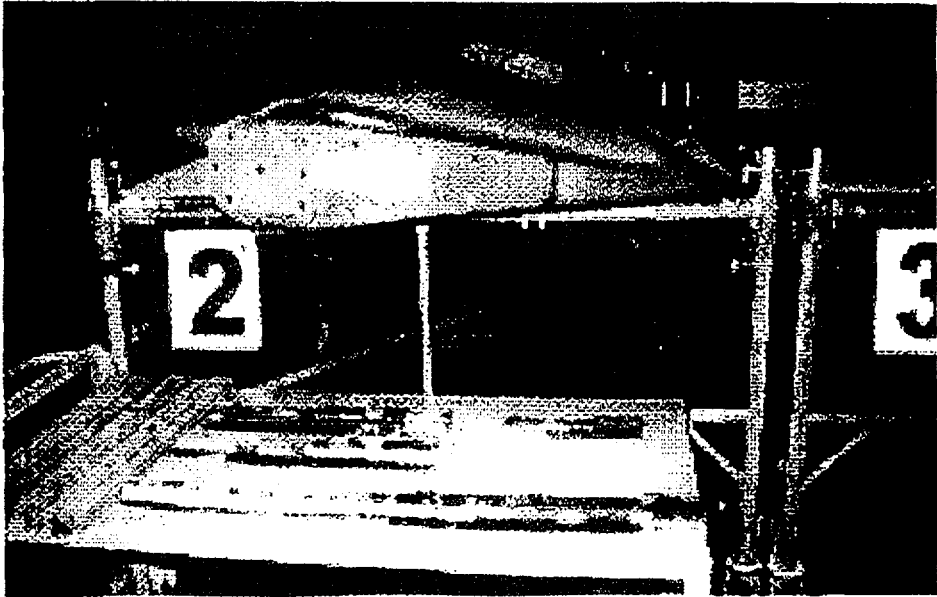
Figure 4, Counterweights Removed From Elevator 2

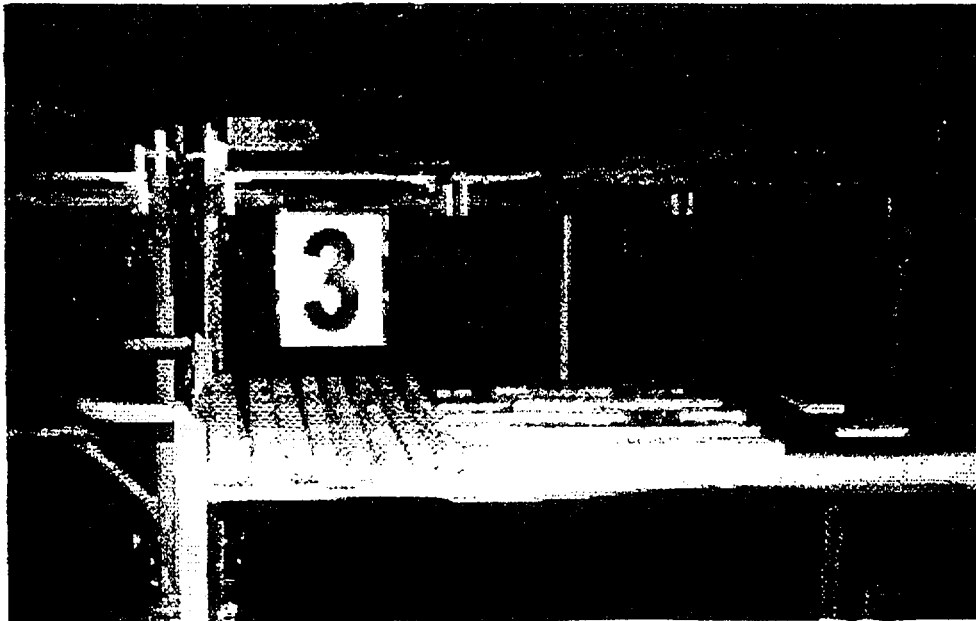
Figure 5, Counterweights Removed From Elevator 3

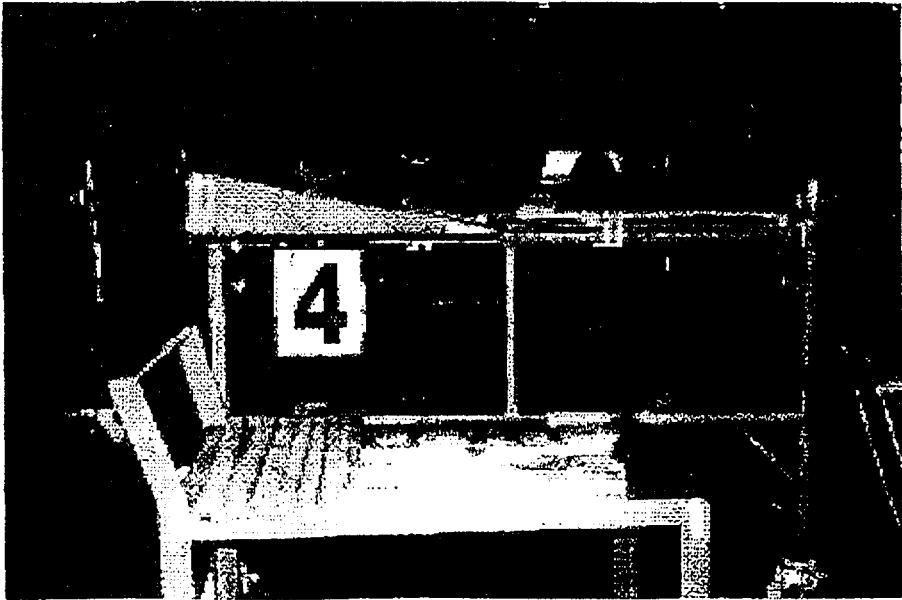
Figure 6, Counterweights Removed From Elevator 4

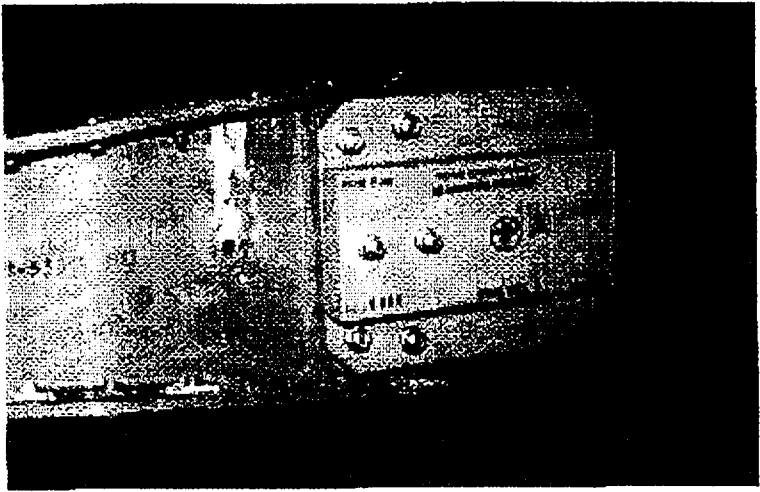
Figure 13, Photograph of Installed Countonweights on End of Flight Control Surface
