Subject: 10CFR21 Reporting of Defects and Non-Compliance -  
Engine Systems, Inc. Report No. 10CFR21-0081

Refurbished Woodward EGB governor/actuators

**Report No. 10CFR21-0081**  
Rev. 0: March 6, 2001

## 10CFR21 REPORTING OF DEFECTS AND NON-COMPLIANCE

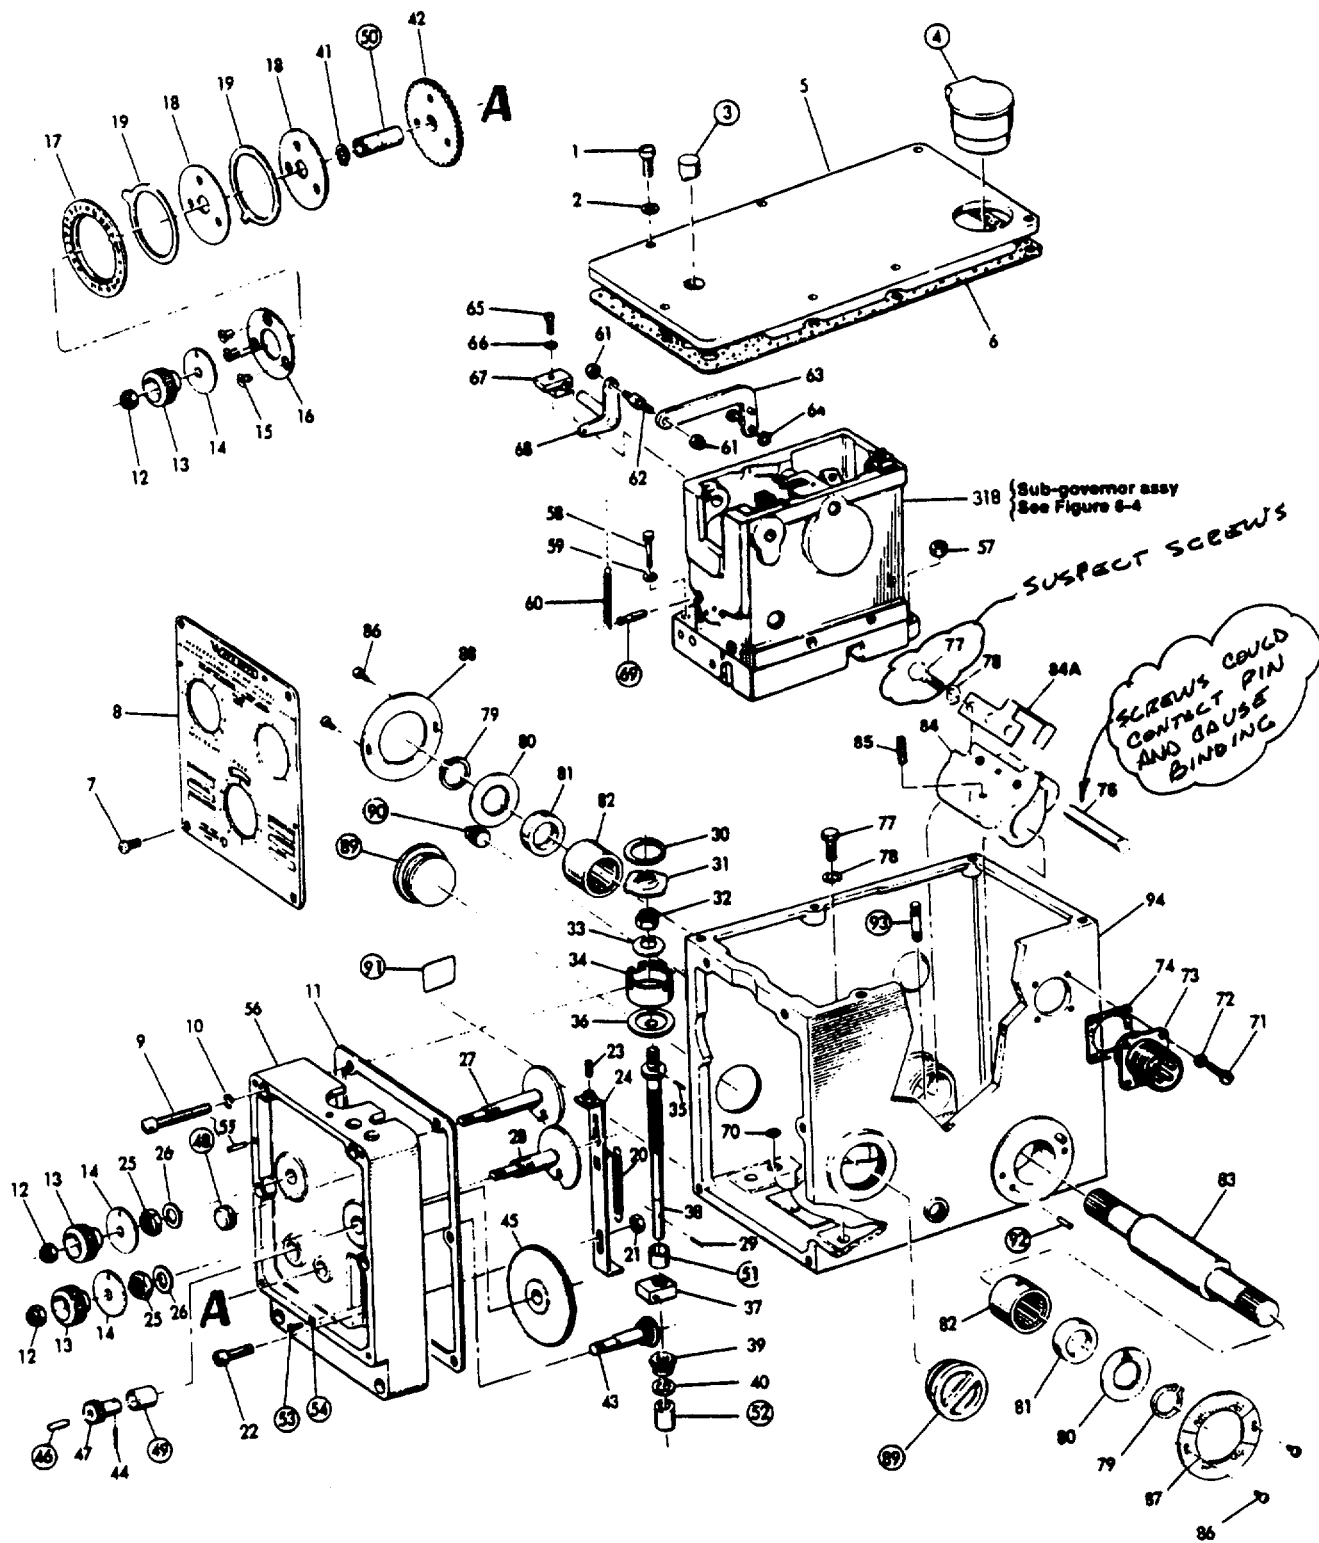
Figure 6-5. Column Assembly Parts for EGB-10P, 13P

Engine Systems Inc. (ESI) has received notification about a potential problem with some refurbished Woodward EGB governor actuators. One problem was recently reported by V.C. Summer Nuclear Station, via Power Reactor Event Number 37788. Apparently, a governor experienced binding of the terminal shaft due to incorrectly applied clamping screws. ESI was not notified about this occurrence until after the Event Report was issue; therefore, ESI was not able to verify/evaluate the actual components involved. Another problem was also reported by J.A. Fitzpatrick Nuclear Plant with this governor. Operability problems were observed and an investigation revealed that the droop lever pivot pin retaining rings were omitted during reassembly of the governor. Due to the missing retaining rings, the pins eventually backed out, releasing the droop lever. This caused the mechanical speed setting to drop and interfere with electric governor operation (limited load carrying capability). A parts breakdown for the EGB is provided in Exhibit 1 with the above parts annotated.

ESI recommends returning the suspect governors to ESI for a completed tear-down inspection. ESI will reassemble and functionally test to Woodward specifications. NOTE: Even though the V.C Summer governor screw length issue was corrected, we still recommend a complete tear-down to verify all refurbishment activity is within specifications. The Fitzpatrick unit (s/n 2185499) was recently returned to ESI to replace the missing terminal shaft retaining rings. A complete tear-down inspection was performed at that time; no further action on this governor is required. Contact ESI's Customer Service Department for return instructions.
