Attention: Mr. Nick Jackiw R-3 38-42697

Subject: Reference Telcon on 4/21/82 at 4:26 p.m.
Between Nick Jackiw of NRC and Rick Haisler,
Manager, Quality Assurance of BPS

Subject: BPS Generators Provided for Nuclear Standby Service -
Alternator to Spider Rotor Torque Value Discrepancies,
Hope Creek Alternator S/N 700510R2

SUBJECT POTENTIAL FAILURE IN DIESEL GENERATOR SETS

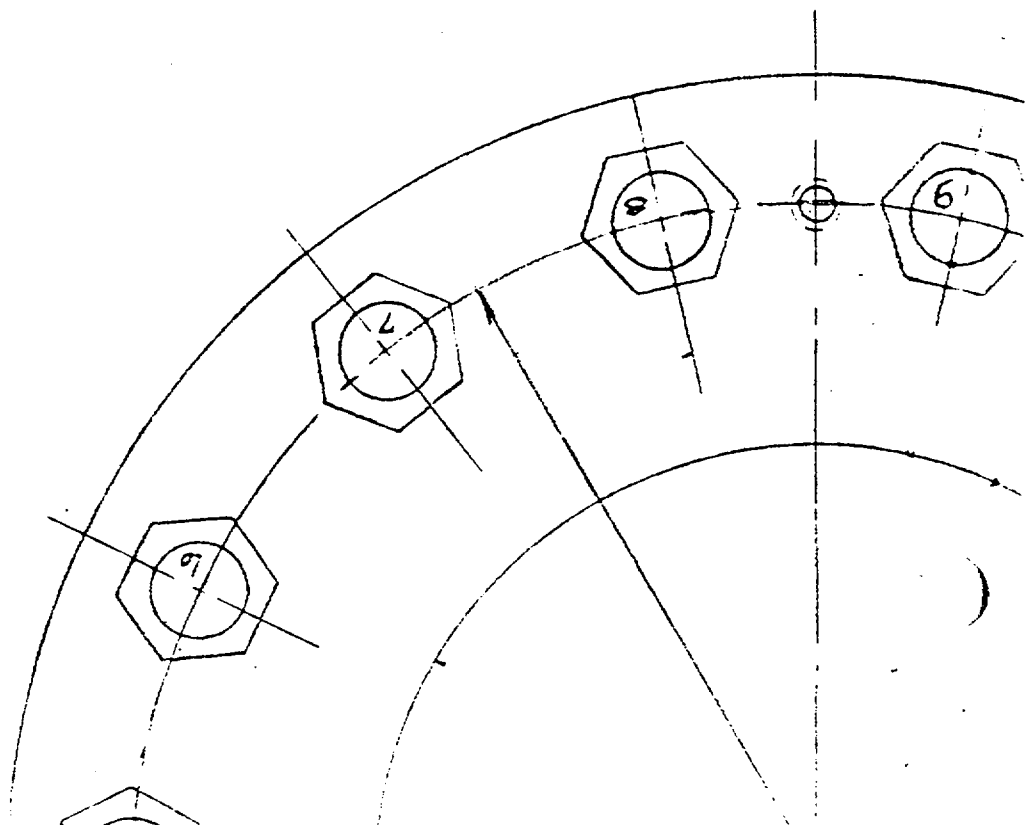
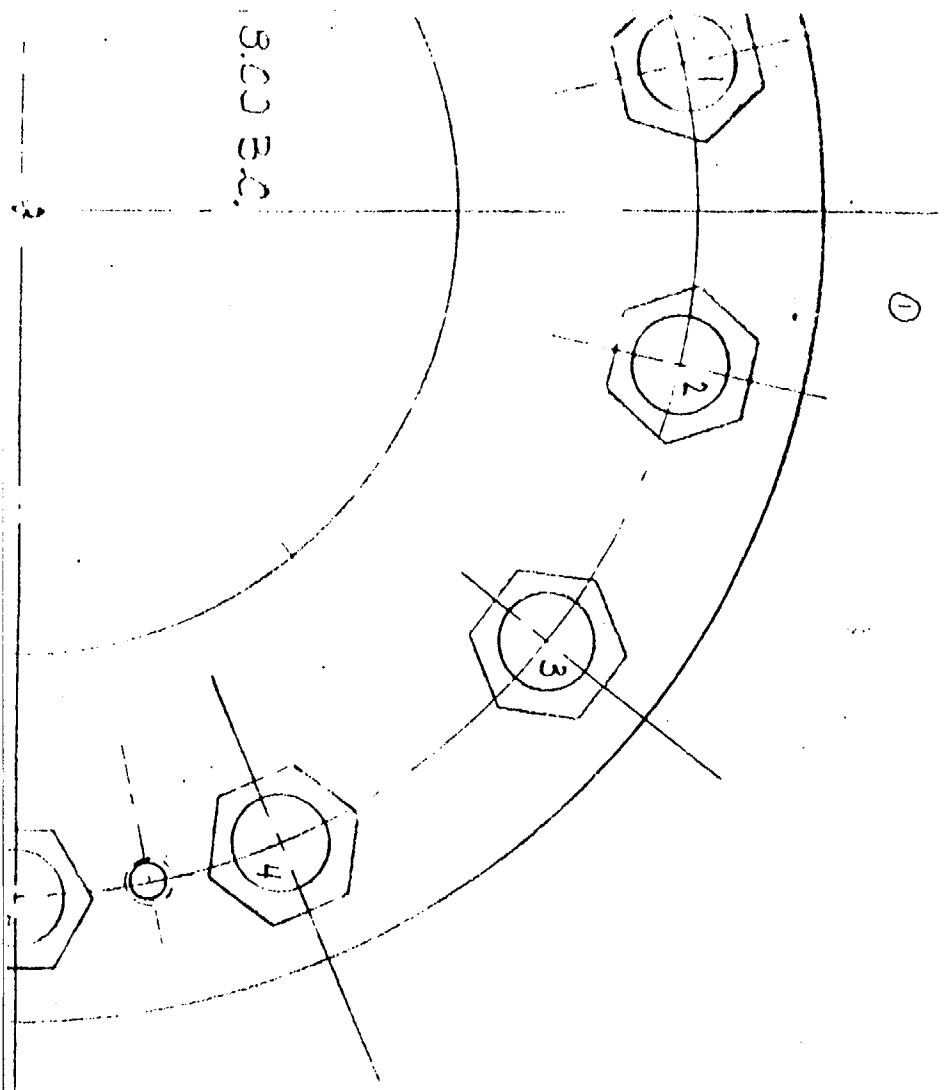
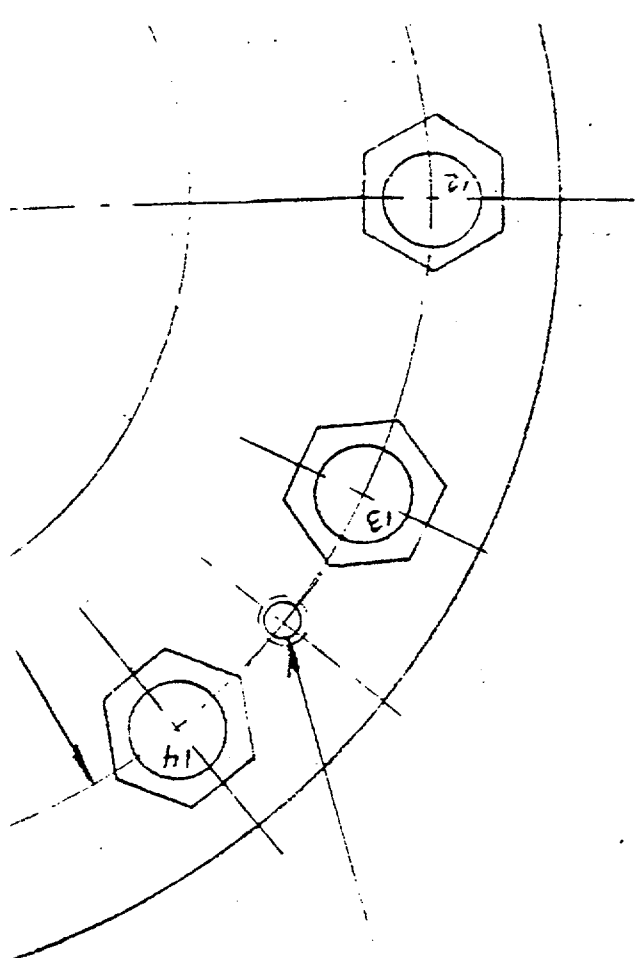
The application of this stud/nut design is shown on Colt Industries Drawing Number 11871439 Attachment (2) submitted for your information.

Colt performed a recheck of generator rotor to spider fastener torque values on March 12, 1982 to verify operation of newly designed tooling for use in the field. During this check, it was revealed that fastener #3 was not loaded at all while three other fasteners were only about 13% tight based on prescribed torque values. This revelation is not consistent with documentation presented to Colt, reference (b).

While estimating bolt load from the applied torque does not yield good accuracy, it is clear that the average load was not what it should have been. Even more disturbing is the one bolt that was not loaded at all and the three that were only about 13% tight. These 4 were certainly potential candidates for further loosening under operating vibration and load cycling.

STEP 4. LOCATE THE STUD NUMBERS, NUMBERED 1-14, MATCH MARK NUT FLATS TO MATING SURFACE SO AMOUNT OF MOVEMENT CAN BE DETERMINED. RETORQUE ALL NUT/STUD COMBINATIONS IN THE FOLLOWING SEQUENCE: 1, 6, 11, 2, 7, 12, 3, 8, 13, 4, 9, 14, 5, 10, AND REPEAT NUMBER 1 TO 5000PSI. MAKE
