SUBJECT: TVA-SEQUOYAH  
ENGINE GOVERNOR ACTUATOR ELECTRICAL CONNECTING PLUG

10CFR21-0027

10CFR21 COMMITTEE MEETING HELD SEPTEMBER 6, 1985

COMPONENT: Engine Governor Actuator Electrical Connecting Plug

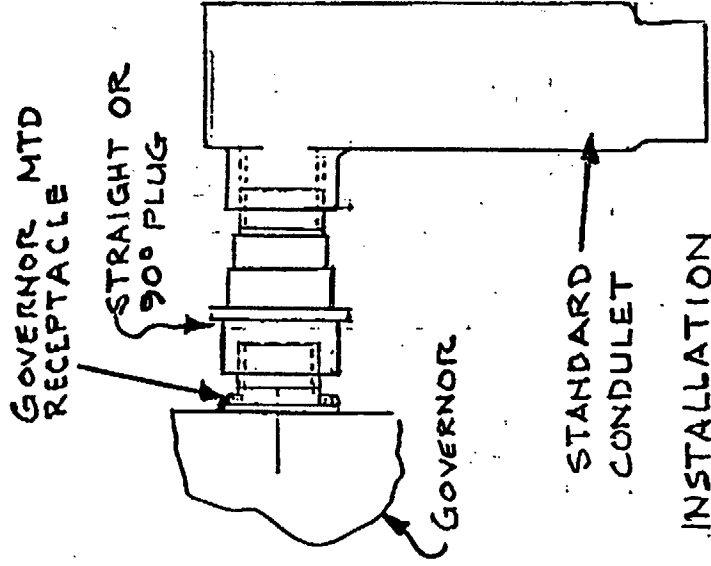
INSTALLATION

For diesel-generators furnished prior to 1976, the arrangement as shown on Fig. 1 "Installation" may have been furnished showing the connections to this receptacle. The problem is that the threads in the conduit are not the same as the mating threads on the plug. While the assembly appeared to be tight, there is a potential for the thread joint to loosen, particularly when subjected to engine operating vibration, with the conduit eventually working free. Then the only support for the flexible conduit that connects the plug to the control panel is the control wires inside. The potential then exists for the possible shorting or breaking of wires as a result of operating vibration; thereby, interrupting the signals to the governor and preventing the diesel-generator from performing its safety function.

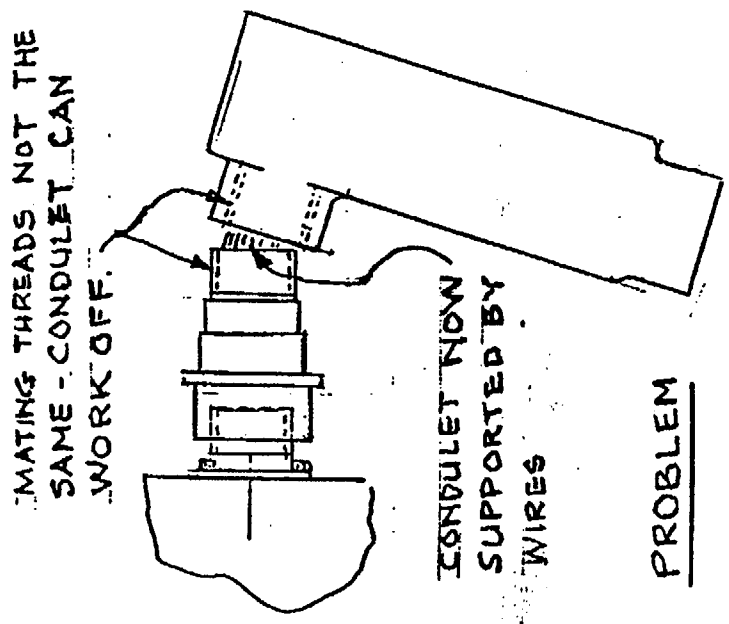
PROBLEM

PROBLEM: Improper threads on electrical thread connectors to flexible conduit.

INSTALL ADAPTER 802020

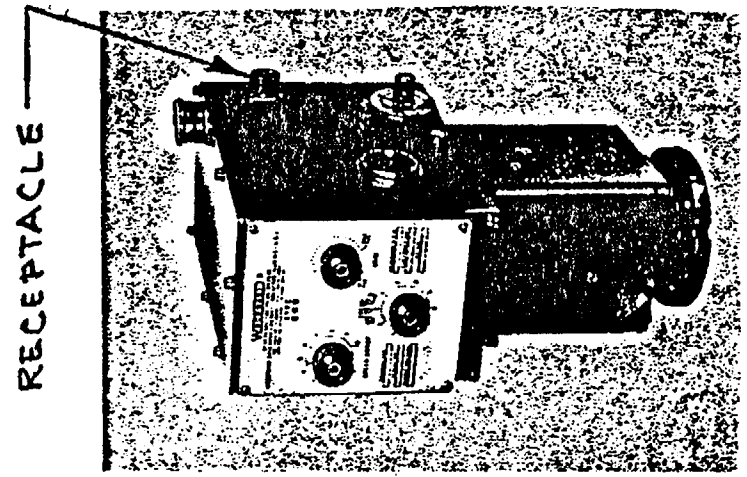
FIG-1

Fig. 1 illustrates the problem. The governor actuator is mounted on the diesel engine. A typical governor is shown in Fig. 1 on which an electrical receptacle is identified. All the electrical signals for the electric portion of the governor, the hydraulic governor speed setting motors, the shutdown solenoid and limit switches are supplied through this receptacle.
