REPORT TO CONGRESS
ON
ABNORMAL OCCURRENCES
FISCAL YEAR 2002

March 2003

Office of Nuclear Regulatory Research
United States Nuclear Regulatory Commission
Washington, DC 20555-0001

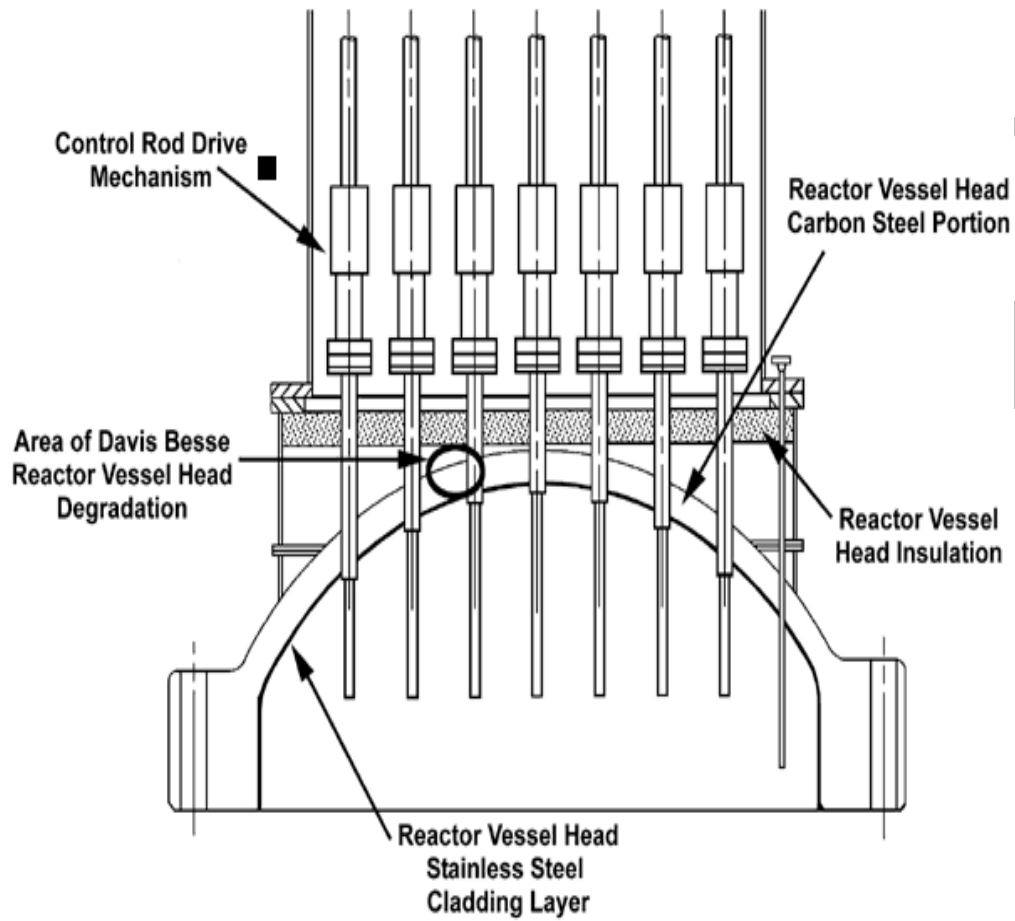
Figure 2. Reactor Vessel Head Degradation Location at Davis-Besse

On February 27, 2002, the licensee notified the NRC that non-destructive examination of CRDM Nozzles 1, 2 and 3 identified that those nozzles contained small through-wall cracks. The licensee decided to repair these three nozzles plus two other nozzles with identified cracks that did not appear to be through-wall. The repair process included machining away the lower portion of the CRDM nozzle to a point above the cracks in the nozzle material. During this activity, CRDM nozzle 3 loosened in the head and on March 6, 2002, the licensee began an investigation to identify the cause. At the same time, activities were underway to remove boric acid deposits from the top of the RPV head caused by leakage of reactor coolant from the cracks and past leaking CRDM flanges. After removing the boric acid deposits, the licensee identified a large corrosion cavity in the head material adjacent to CRDM Nozzle 3 (Figure 2). The cavity was approximately 6 inches in length and four to 5 inches in width. Within this area the 6.63 inch thick low alloy steel head was corroded away leaving only the stainless steel cladding layer on the inside. The remaining cladding layer ranged in thickness from 0.20 to 0.31 inches. Subsequent metallurgical examination of this section of cladding identified a shallow crack approximately 3/8 inch in length. This cladding layer is designed as a corrosion resistant layer and is not designed to retain reactor operating pressure. In addition to the cavity adjacent

Cause or Causes — On April 18, 2002, the licensee submitted its Root Cause Analysis Report to the NRC. In this report, the licensee concluded that the most probable technical cause of the RPV head degradation was boric acid corrosion resulting from leakage through a crack in the CRDM penetration nozzle attributable to primary water stress corrosion cracking. Further, this corrosion had occurred over a period of several years. Absent more definitive information, the licensee's technical root cause analysis represents a plausible scenario for the degradation.

Licensee — The licensee elected to replace the damaged head with one procured from the owners of the cancelled Midland nuclear power plant located in Michigan. The licensee has also completed a number of activities designed to identify the management and human performance deficiencies which contributed to the degradation of the reactor vessel head and implemented a series of inspections and evaluations to identify and correct any other potentially problematic plant issues.
