**EXAMINATION OF THE REACTOR VESSEL (RV) HEAD DEGRADATION
AT DAVIS-BESSE**

**FRAMATOME ANP, INC.
DOCUMENT 31-5029337-02**

**PREPARED FOR
FRAMATOME ANP, INC.**

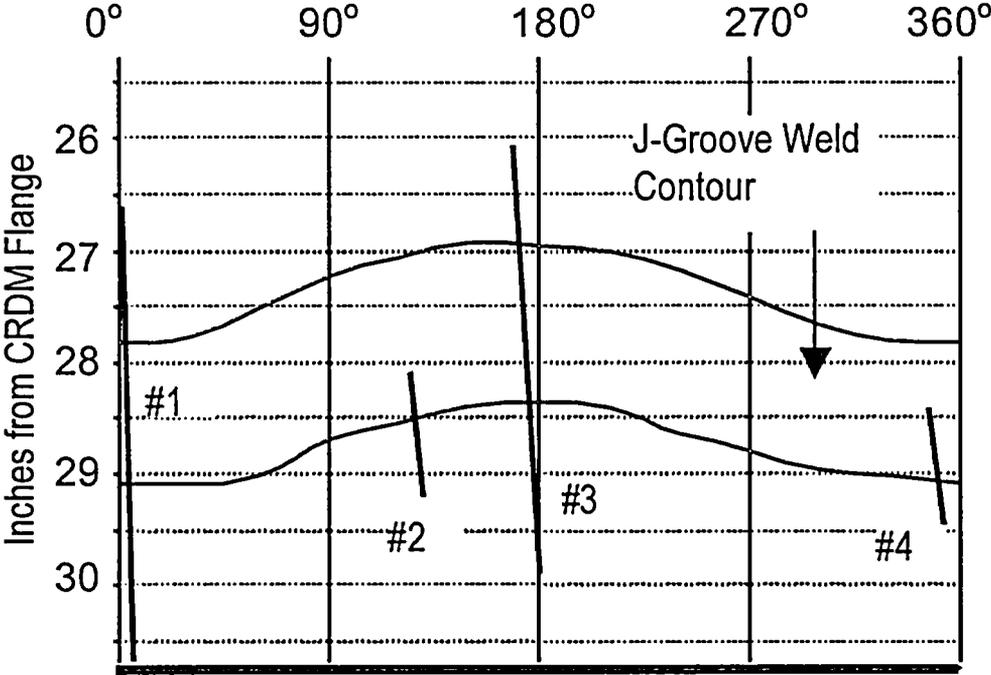
Figure 1.1.2: On-site NDE of nozzle #3 showed 4 axial cracks. Cracks #1 and #3 were through-wall, while cracks #2 and #4 were partially through-wall.

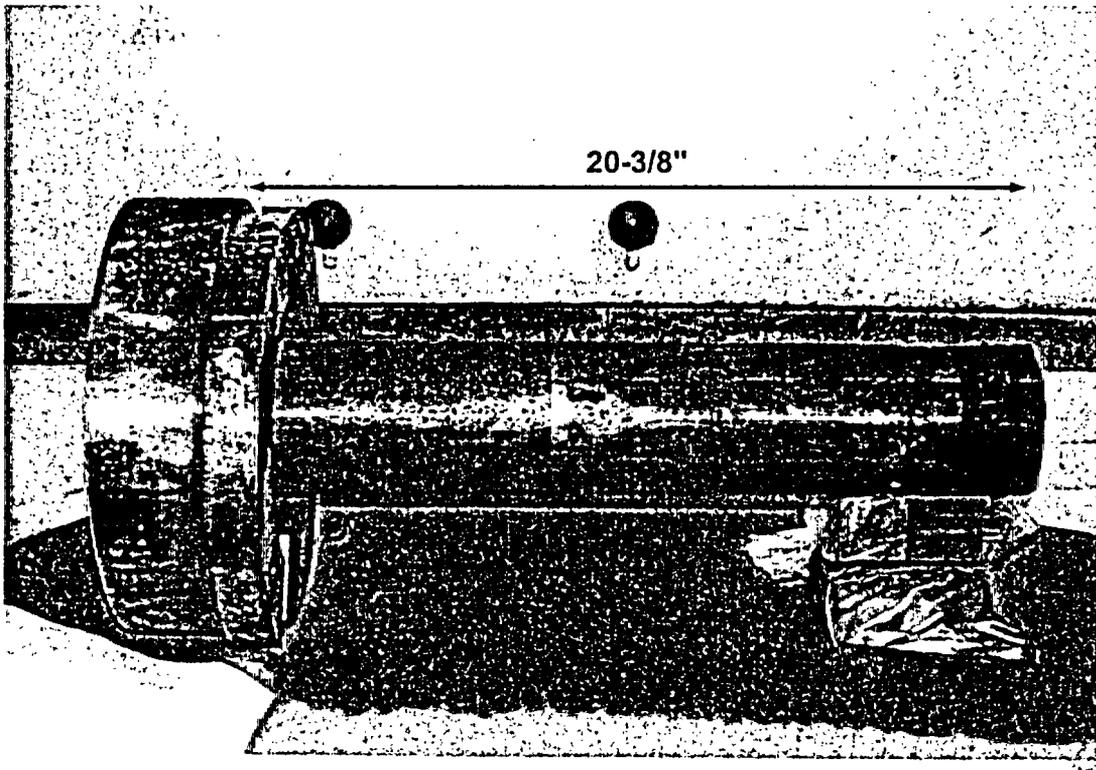
Figure 2.1.1 provides a side view macro photograph showing the as-received condition of nozzle #2. The measured distance from the underside of the flange to the end of the nozzle was $20\text{-}3/8$ " and the reduced diameter portion of the nozzle end measured $3\text{-}3/8$ ". These measurements indicated approximately $7\text{-}5/8$ " of the nozzle end was bored away during the nozzle removal process from the RV head. Figure 2.1.2 shows the end view of nozzle #2. It was determined that the boring tool extended approximately 3" up into the lower end of the nozzle. Visual inspections on the lower end of this nozzle revealed no evidence of cracking; it is believed that the cracks were bored out during the removal process.

Figure 2.1.1: Nozzle #2 side view. Approximately 7-5/8" was bored away during the removal process.

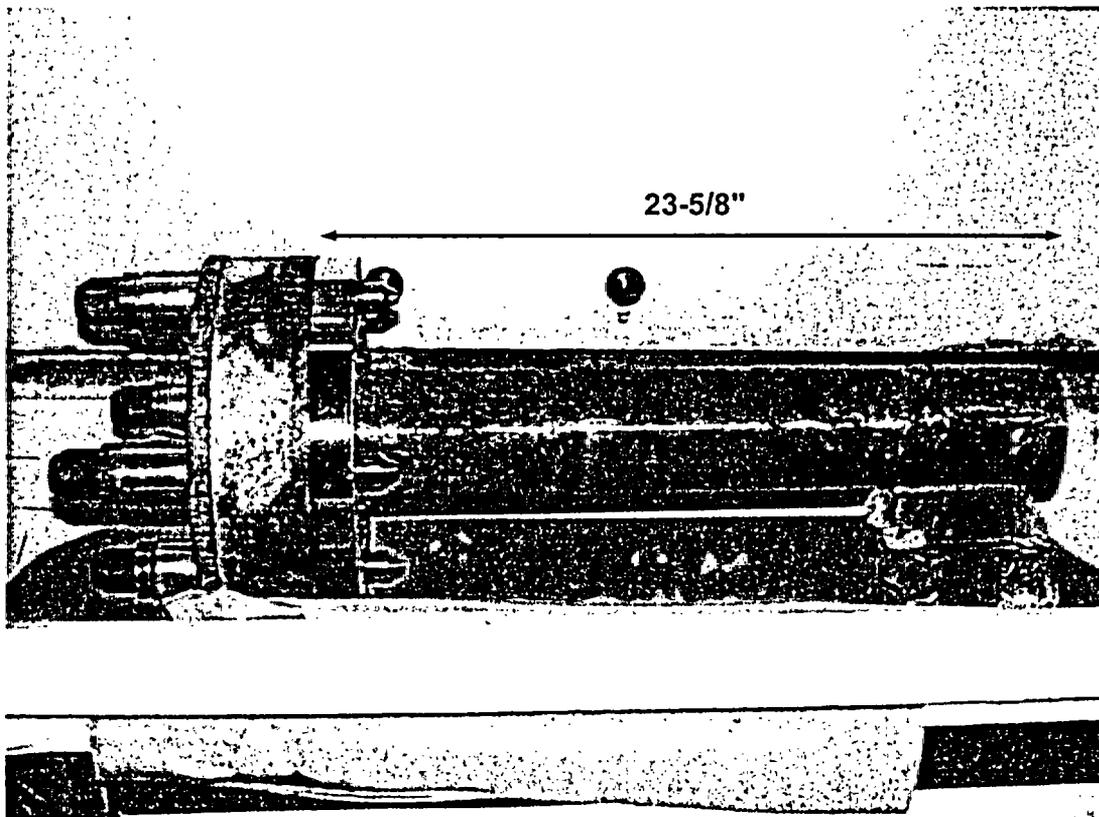
An overall photograph showing the as-received condition of nozzle #3 is presented in Figure 2.2.1. The measured distance from the underside of the flange to the end of the nozzle was $23\text{-}5/8$ " and the reduced diameter portion of the nozzle end measured $6\text{-}1/2$ ". These measurements indicated approximately $4\text{-}1/2$ " of the nozzle end was bored away

Figure 2.2.1: Nozzle #3 side view. Approximately 4-1/2" was bored away during the removal process. 0° orientation is upward in photo.

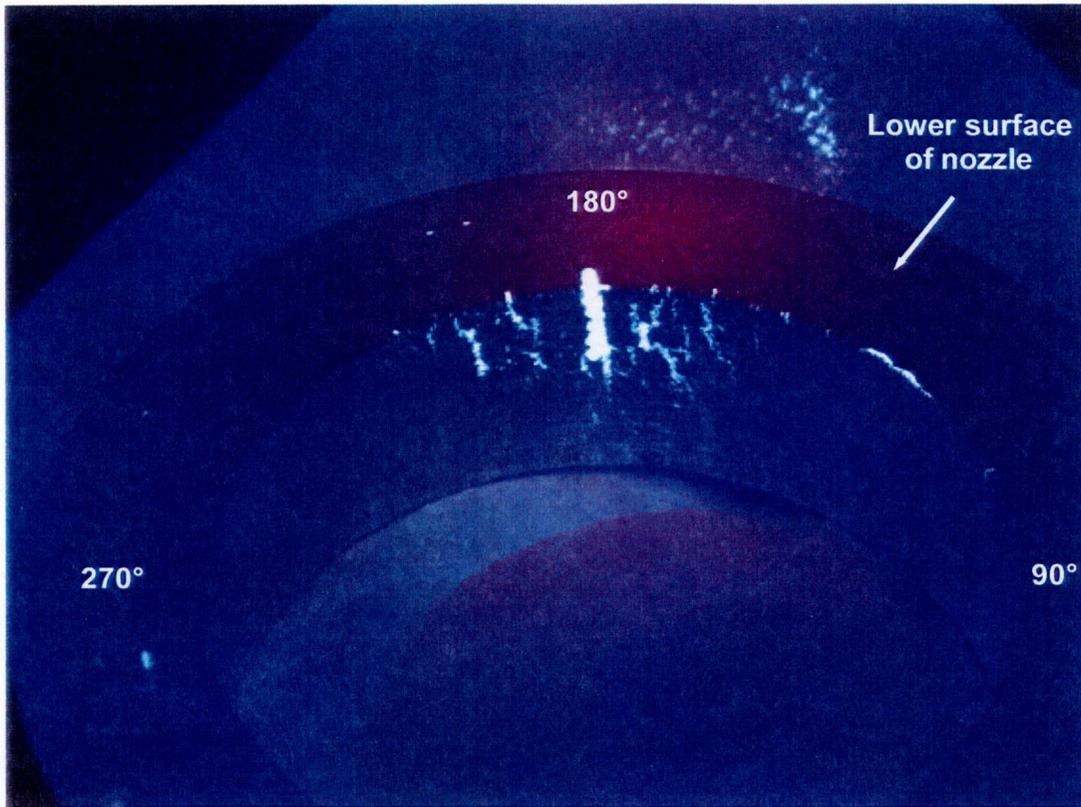
A fluorescent dye penetrant test was performed on the exposed surfaces of piece C. This test revealed several axial cracks present on the lower portion of the nozzle inner diameter (ID) surface near the 180° orientation (i.e., uphill side of nozzle opposite the cavity). Refer to Figure 2.4.1 for the results of this examination. The largest crack in this area extended approximately 0.5" in length axially and ~0.125" deep radially from the ID surface of the nozzle. No other indications were found. It is evident that all other cracks identified by on-site NDE were within the 4-1/2" section bored away during the CRDM nozzle removal process.

Figure 2.4.1: Photograph taken under a black light showing the PT results for nozzle #3. Several axial cracks were present near 180°; the largest crack extended ~0.5" in length axially and ~0.125" deep radially from the ID surface.

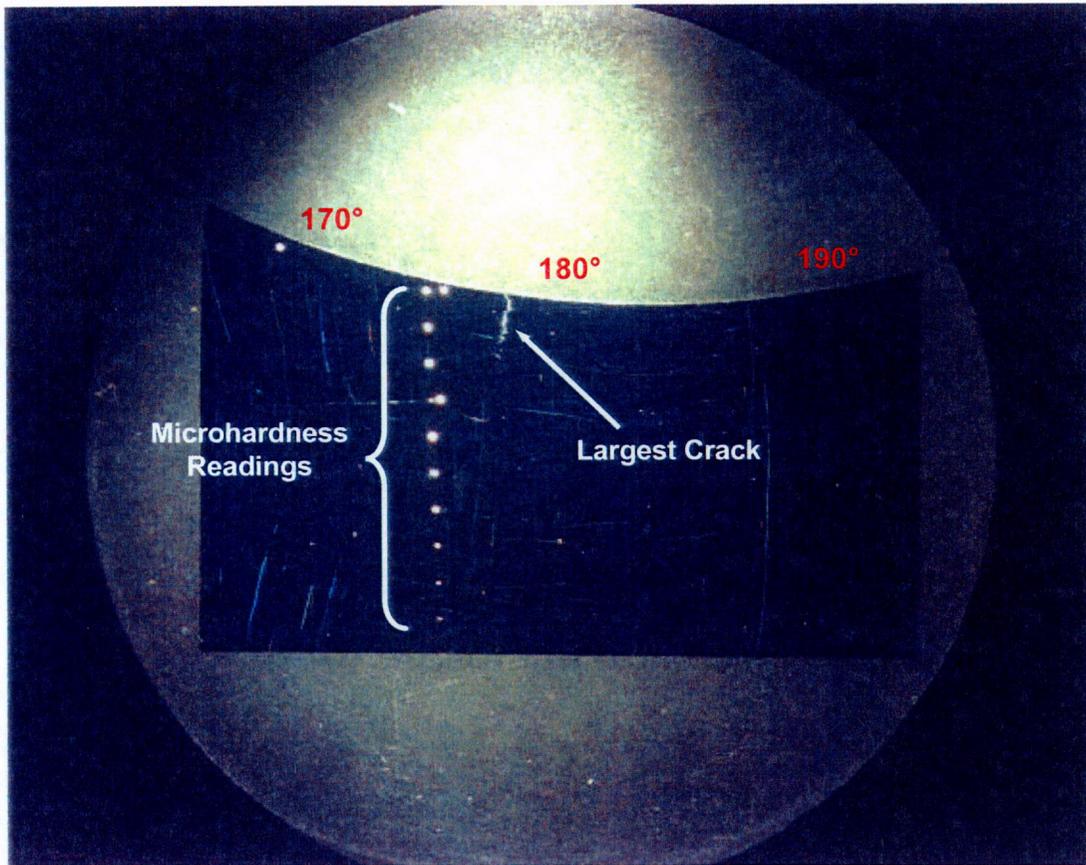
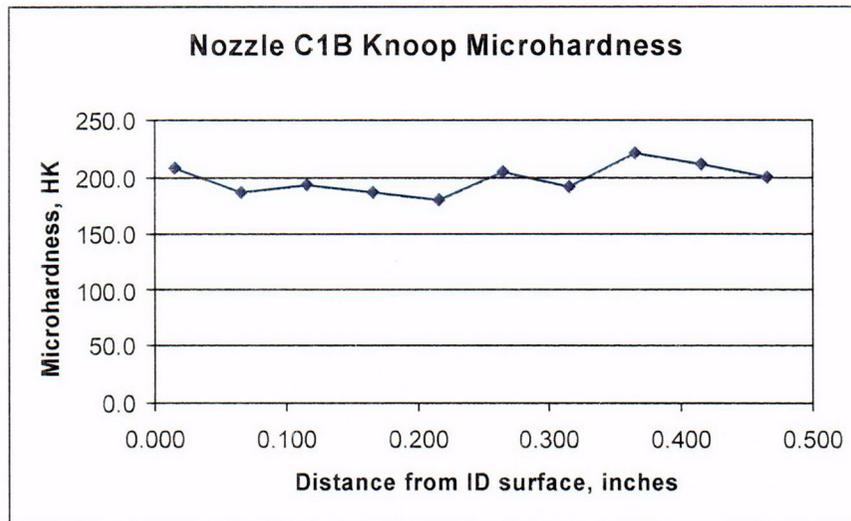
Figure 2.6.1 provides a low magnification photograph of the mounted sample C1B. In this photograph, the largest crack is visible near 180° along with the string of Knoop microhardness indents near 175°. The base material hardness was generally uniform across the nozzle wall in the area tested and ranged from HK 179.1 to 221.3 (refer to the table in Figure 2.6.1).

Figure 2.6.1: Low magnification photograph of the nozzle #3 C1B metallographic mount showing location of largest crack and Knoop microhardness indents (top) and microhardness results (bottom).

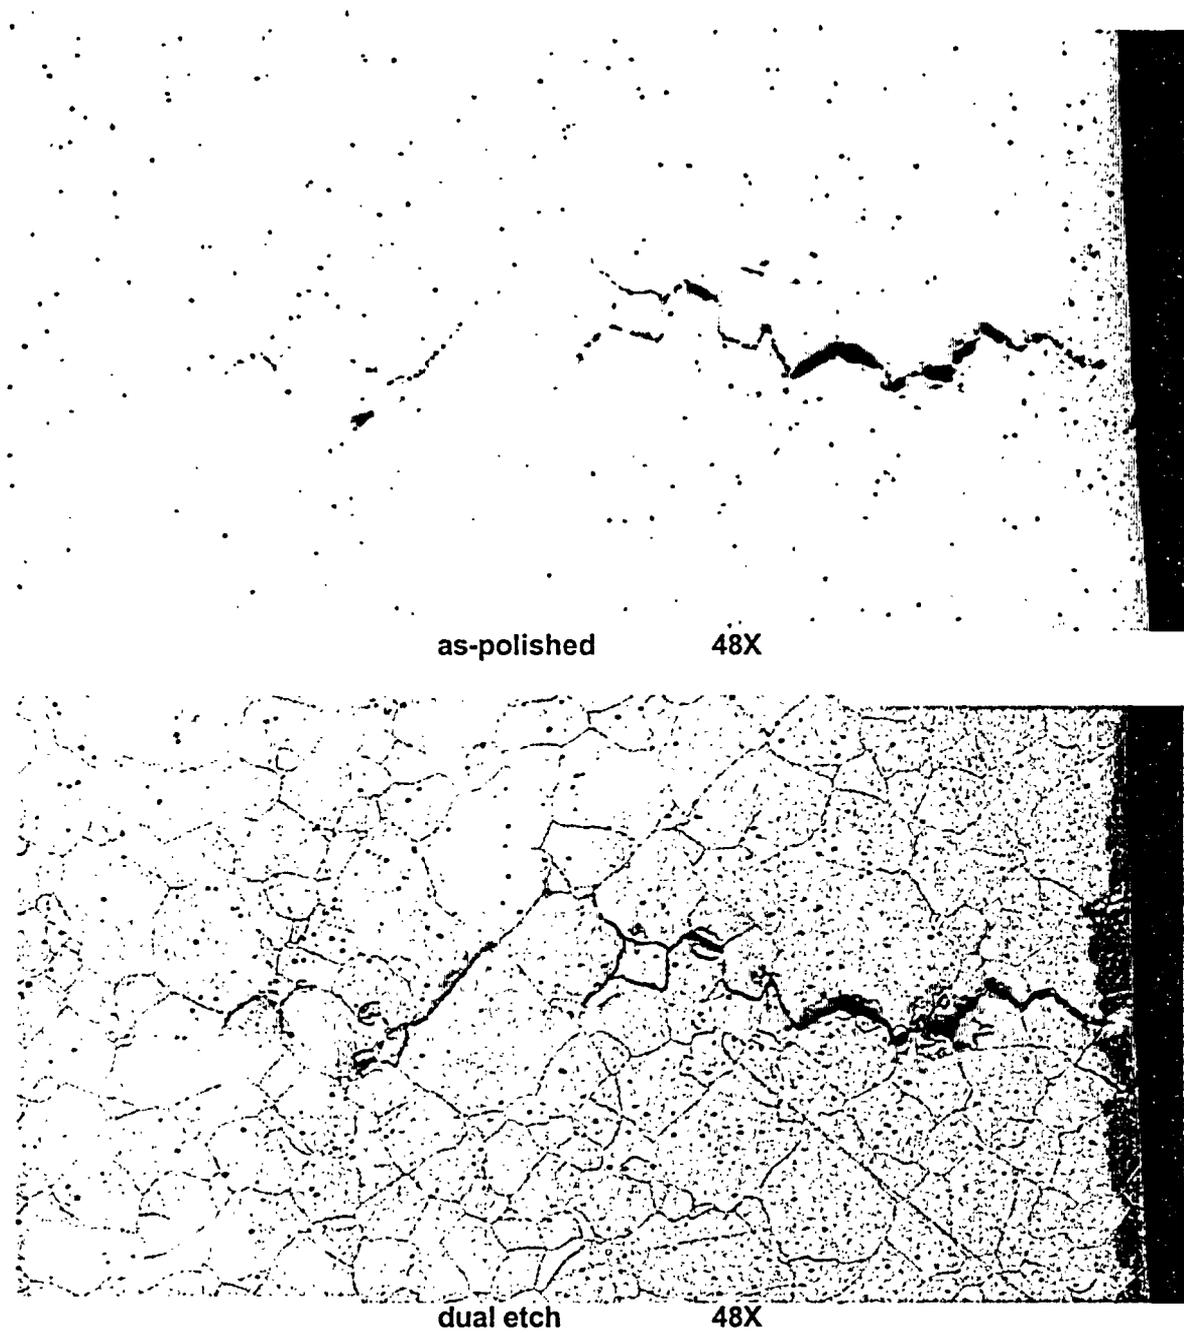
Figure 2.6.2 provides higher magnification micrographs of the largest crack at 180°, which extended approximately 0.1" below the nozzle ID surface. The crack path is clearly intergranular in nature. The same crack morphology was observed for a smaller crack located near 170° (Figure 2.6.3). This crack extended approximately 0.05" below the nozzle ID surface. Micrographs showing the typical appearance of the nozzle base material microstructure are provided in Figure 2.6.4 (100X) and Figure 2.6.5 (375X). The microstructure consisted of equiaxed grains ranging in size from ASTM 1 to 6, with an average size of ASTM 3. Also observed throughout the microstructure were titanium or niobium carbonitrides (large yellow-to-orange color particles in Figure 2.6.6) and a semi-continuous to discontinuous network of grain boundary carbides.

Figure 2.6.2: Micrographs showing the intergranular nature of the largest crack near 180°. The crack extended approximately 0.1" below the nozzle ID surface (located to the right in these micrographs).

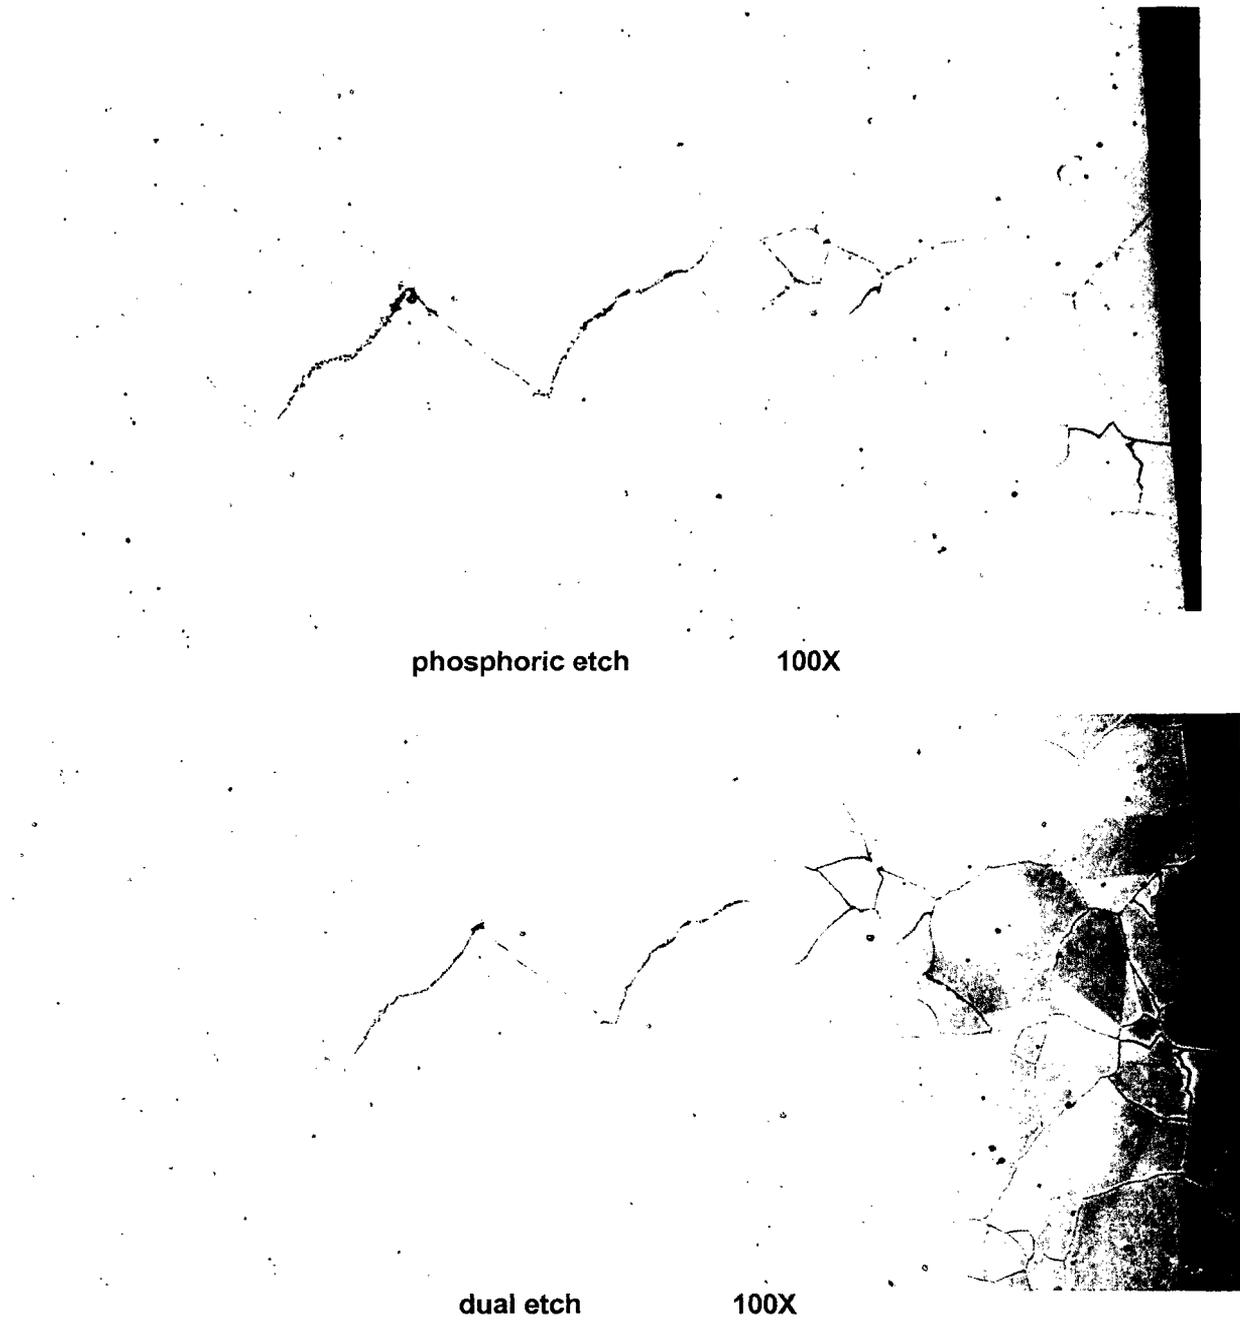
Figure 2.6.3: Micrograph showing the intergranular nature of a smaller nozzle crack located near 170°. This crack penetrated approximately 0.05" below the nozzle ID surface (located to the right in these micrographs).

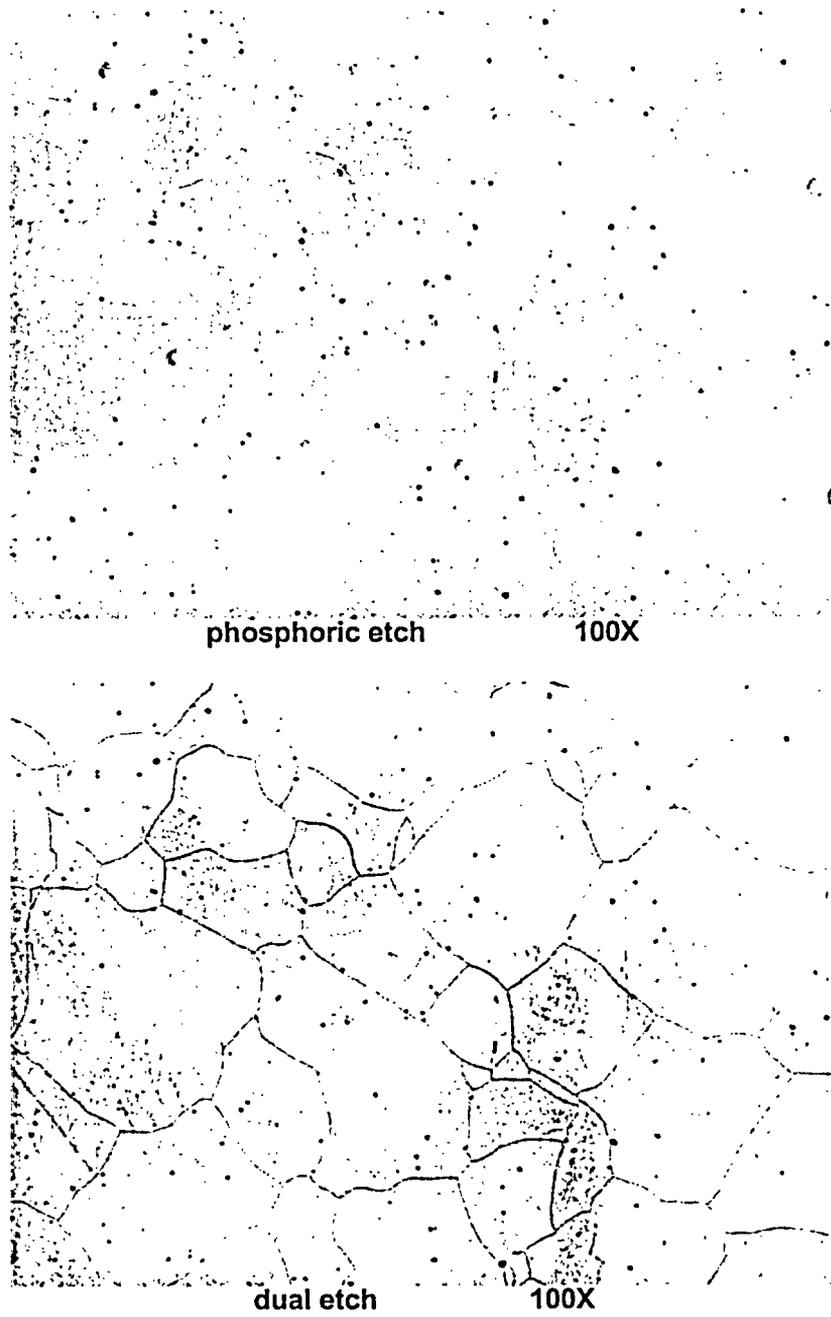
Figure 2.6.4: Typical micrographs of the nozzle base material. The grain size ranged from ASTM 1-6 and averaged ASTM 3.

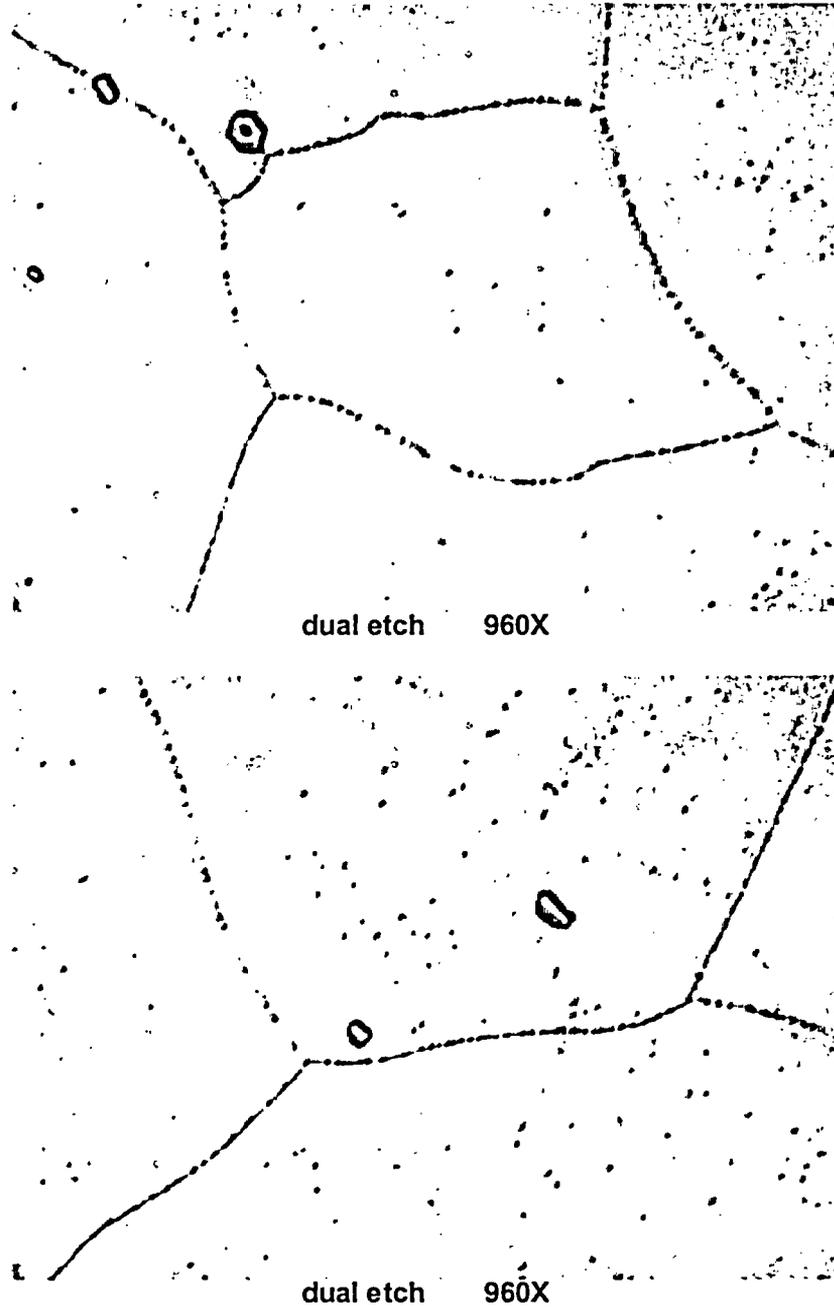
Figure 2.6.6: Higher magnification micrographs showing the discontinuous nature of the carbides at the grain boundaries.

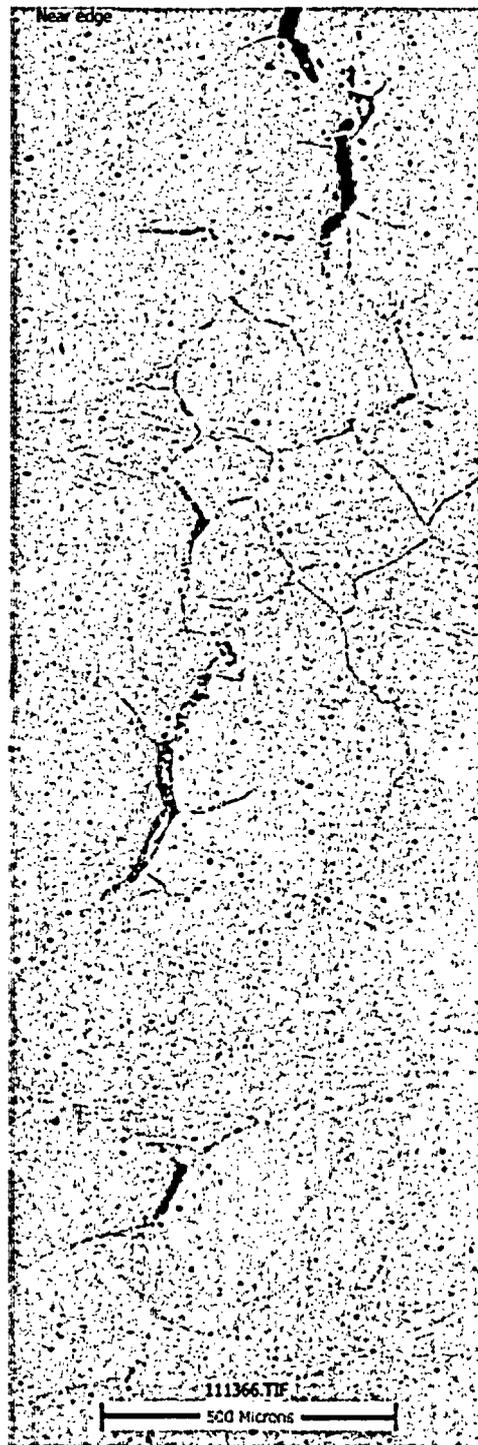
Figure 2.7.2: Mosaic showing full crack length (BSE), which was approximately 0.08" below the ID surface. Cracking was intergranular. ~82X

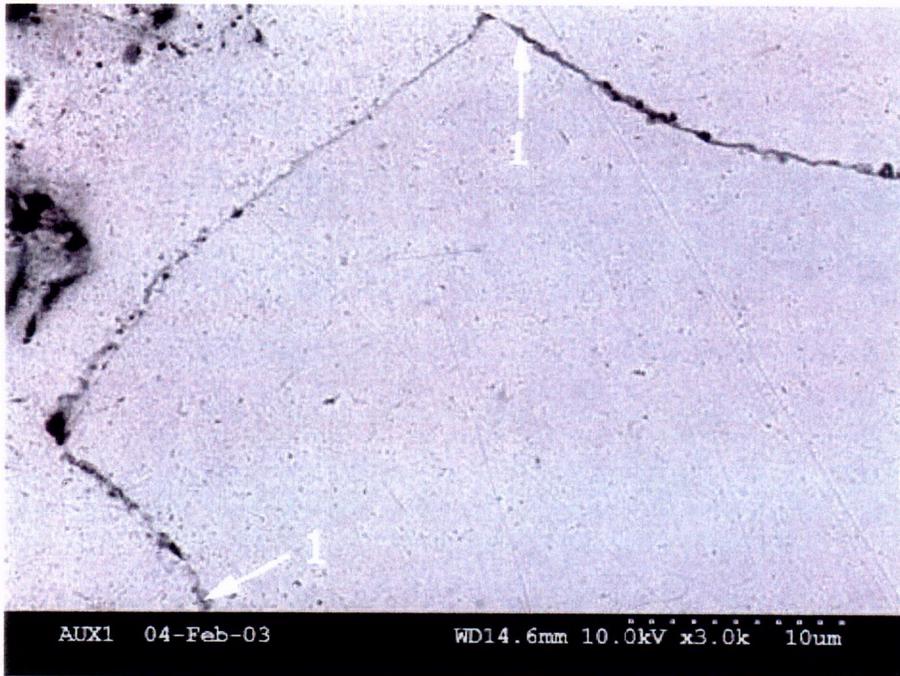
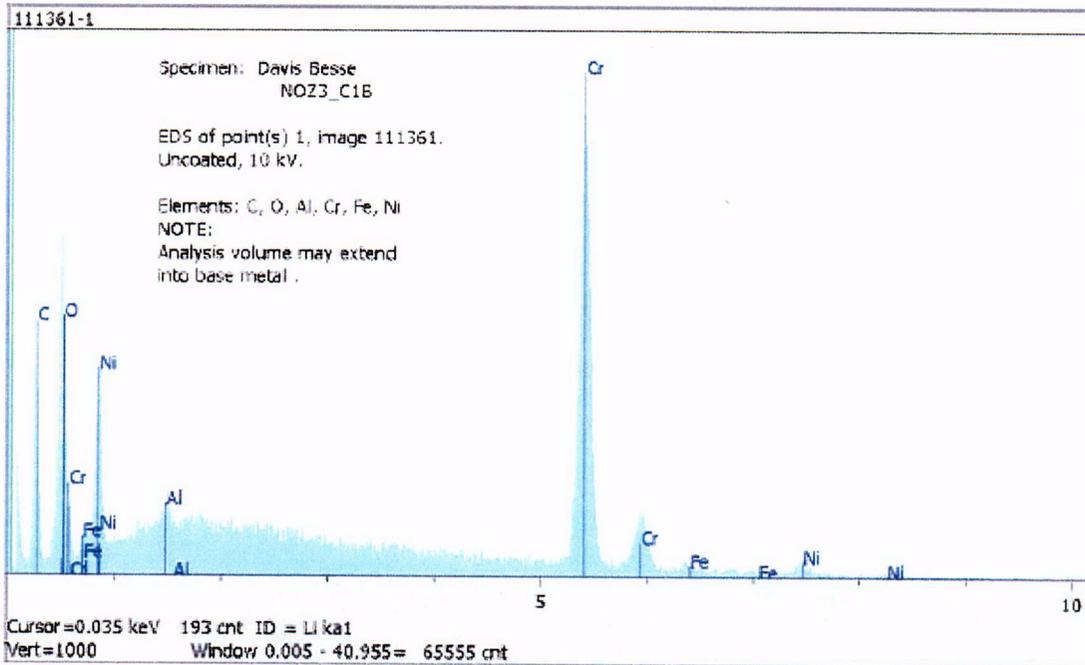
Figure 2.7.3: The grain boundary (points designated "1") contained carbon, oxygen, aluminum, chromium and nickel.

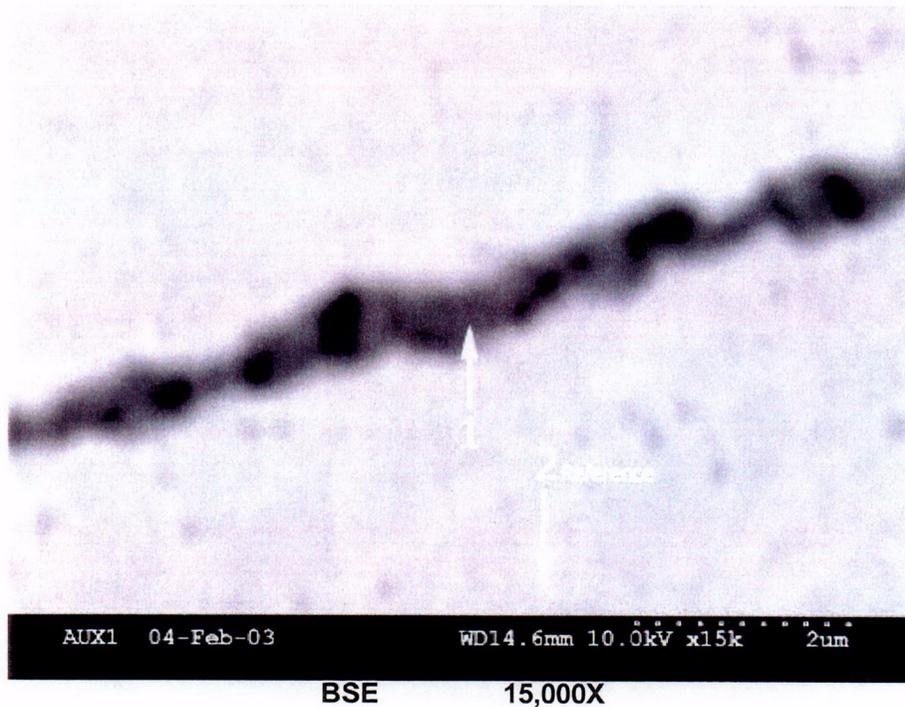
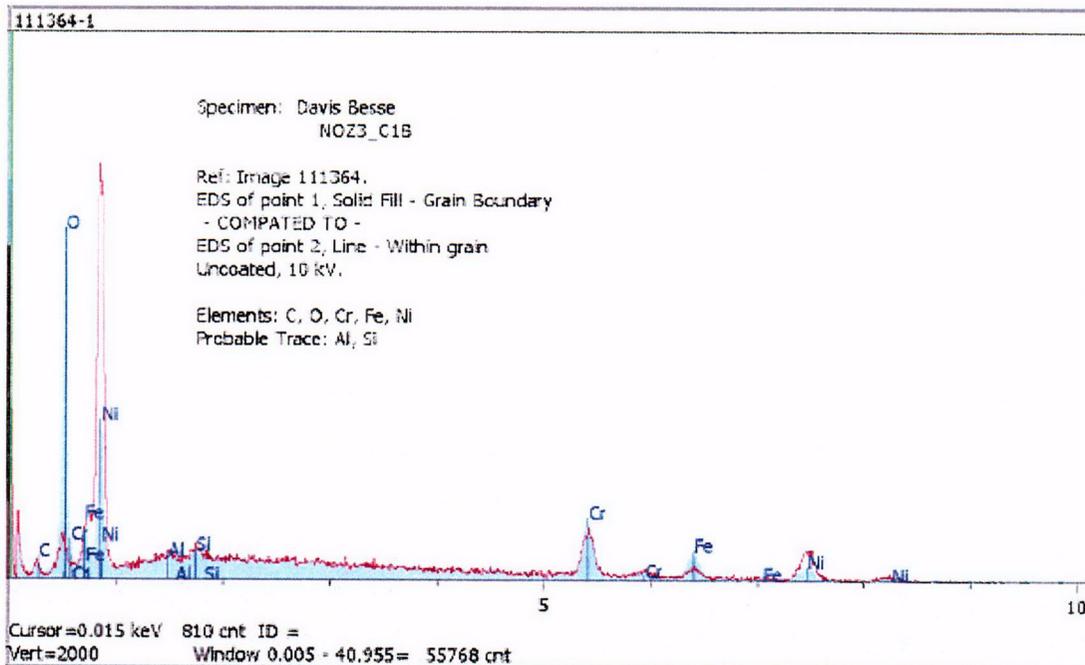
Figure 2.7.4: The grain boundary (solid fill) contained higher oxygen and chromium compared to the bulk grain (line spectrum) (Note: The BSE image was defocused in order to optimize the EDS count rate.)

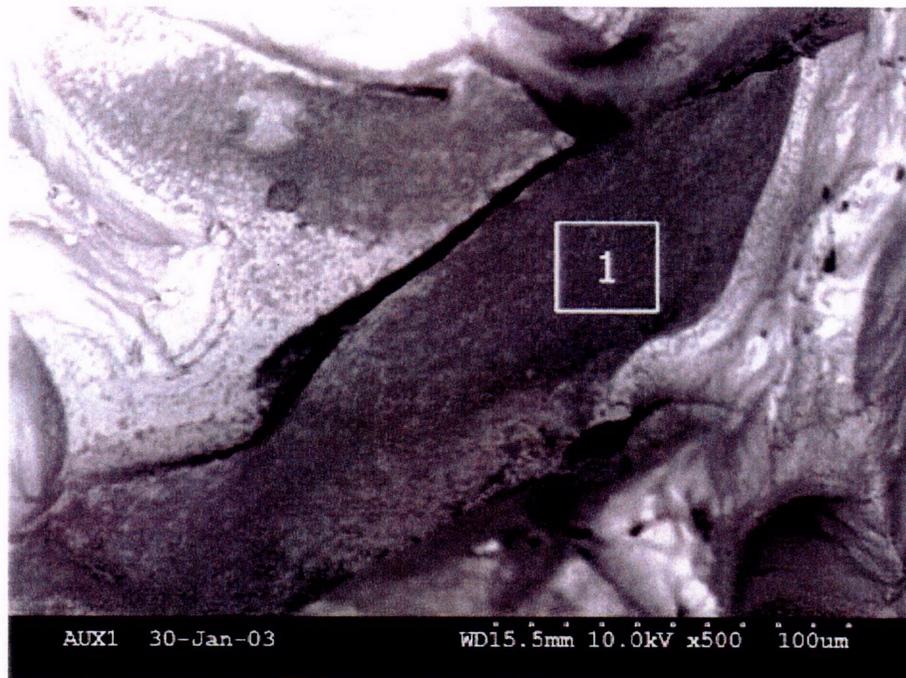
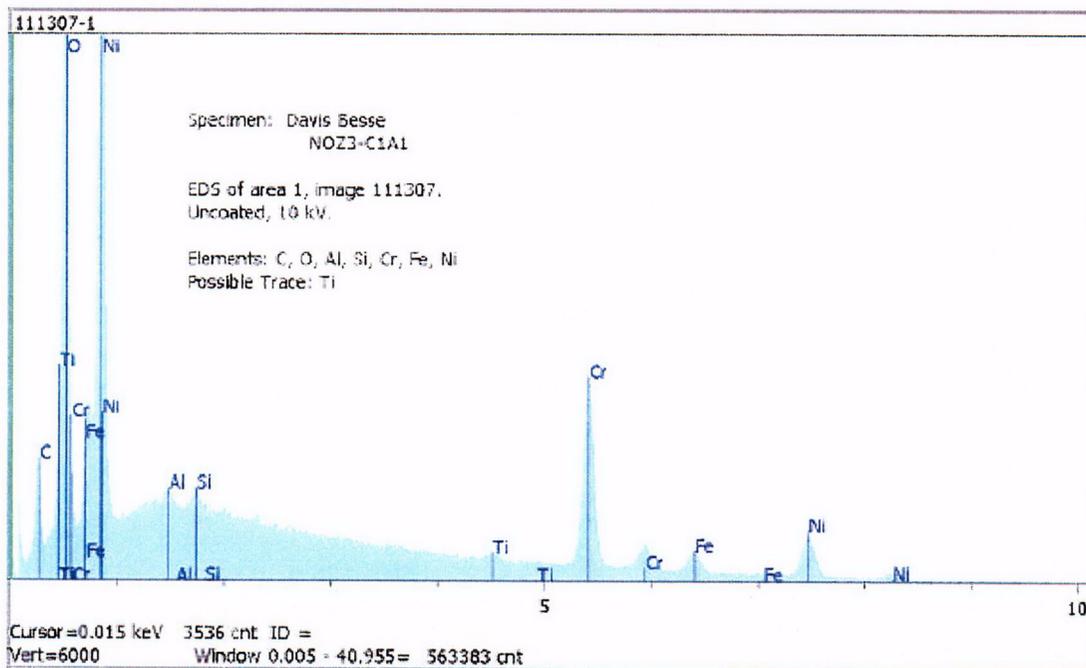
Figure 2.7.9: EDS spectrum collected from area 1 above. This area contained carbon, oxygen, aluminum, silicon, chromium, iron, and nickel, along with a trace amount of titanium.
