BWR steam dryer integrity

SIL No. 644 Revision 1

November 9, 2004

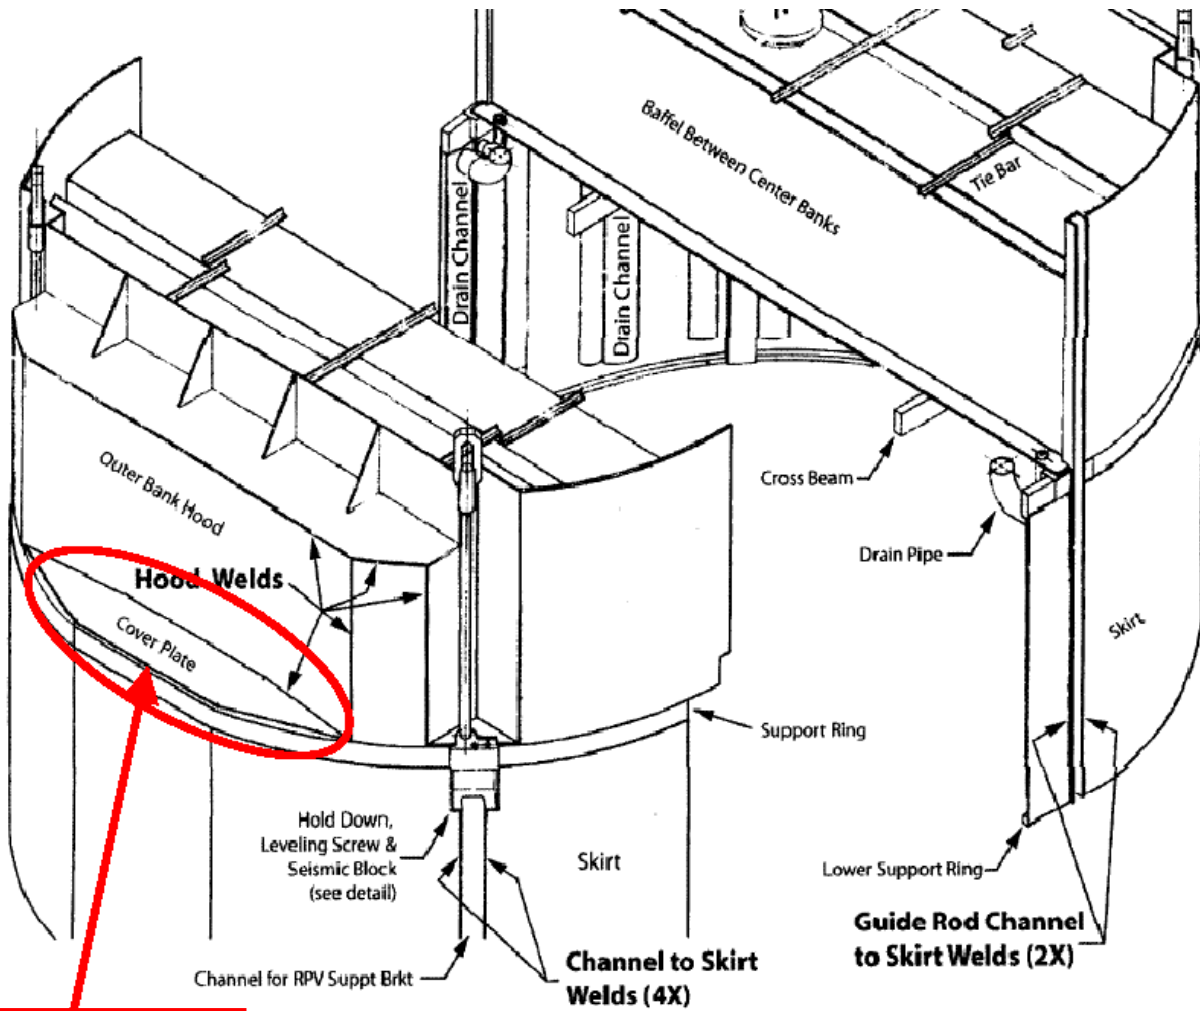
Figure A-1: Location of the 2002 Lower Cover Plate Failure

Inspection of the steam dryer revealed that a ¼-inch stainless steel cover plate measuring approximately 120” x 15” had failed near the MSL “A” and “B” nozzles (Figure A-1). The failure of this cover plate allowed steam to bypass the dryer banks and exit through the reactor MSL nozzles, causing the observed increase in moisture content. The majority of the cover plate was found as a single piece on top of steam separators. However, a piece of the cover plate (approximately 16”x 6”) had failed and was found lodged in and partially blocking the MSL “A” flow venturi contributing to the MSL flow imbalance and water level perturbations. Several smaller loose pieces (believed to have come from a startup pressure sensor bracket which may have been knocked off by the cover plate) were located at the turbine stop valve strainer basket. Minor gouges and scratches from the transport of foreign material were noted in the “A” steam nozzle cladding, the main steam piping and the MSL “A” flow venturi. All loose pieces were recovered. No collateral damage to other reactor vessel components was observed.

Preliminary laboratory analysis has been completed. The main crack originated from the bottom side of the cover plate and propagated upward through both the plate base metal and weld metal. The transgranular, as opposed to intergranular, nature of the fracture surface and the relative lack of crack branching indicated that the failure was not caused by stress-corrosion cracking. The lack of macro and micro ductility features in and near the fracture indicated the cracking occurred over a period of time and not due to a mechanical overload. Additionally, there was no evidence that the failure was a result of an original manufacturing defect. Based on the available evidence, the most probable cause of the cover plate cracking was mechanical, high cycle fatigue.

The results of the metallurgical analysis confirmed that the failure mechanism is high cycle fatigue. The cause of this high cycle fatigue is believed to be flow induced vibration. At this time there are two probable root causes of the cover plate failure:

1. Increased pressure oscillations on the steam dryer due to the increased steam flows at extended power uprate conditions, aggravated by the potential presence of a pre-existing crack in the cover plate.
2. A flow regime instability that results in localized, high cycle pressure loadings near the MSL nozzles. When the natural frequency of the installed cover plate coincides or nearly coincides with the frequency of the cyclic pressure forcing function, and the acoustic natural frequency of the steam zone, the resulting resonance or resonances can lead to high vibratory stresses and eventual high cycle fatigue failure of the cover plate.

Missing Cover Plate

The cover plates on both sides of the dryer have been replaced with ½-inch continuous plates (this eliminates two intermediate welds on the original plates). The fillet weld connecting the plate to the support ring was increased to ¾-inch and the weld to the vertical face of the dryer hood was increased to ½-inch. The plant has been returned to service with interim, enhanced monitoring of moisture content, reactor steam dome pressure, MSL flow rates and reactor water level. As an additional measure, the plant has implemented dynamic response monitoring of the MSLs to determine if higher flow induced vibration occurs as the steam flow is increased.

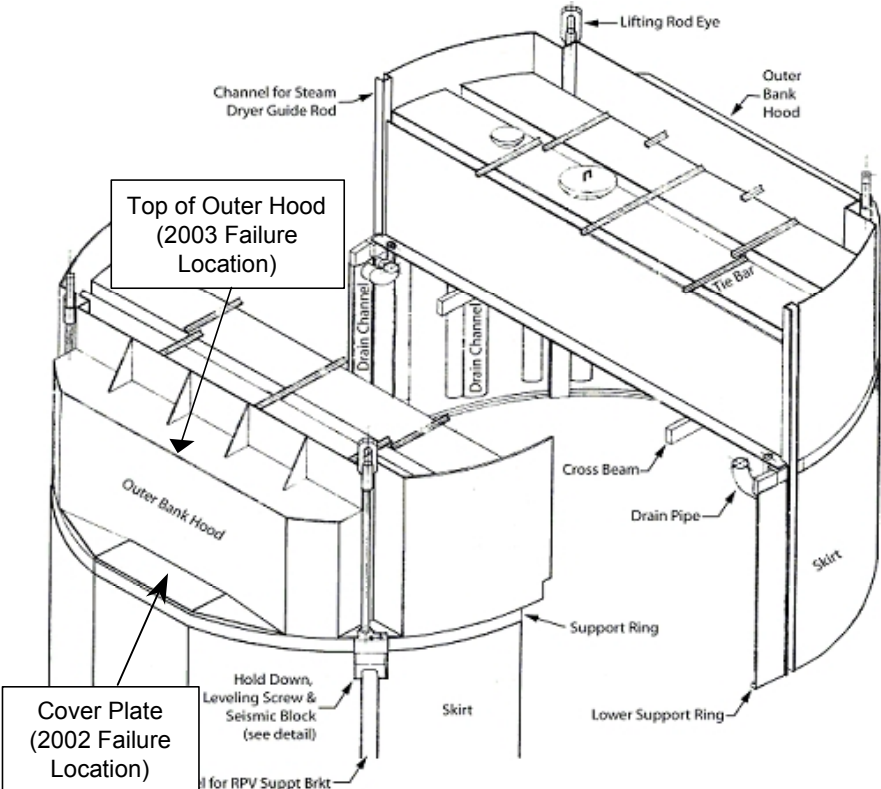
Figure B-1: Location of the 2003 Outer Hood Failure

A detailed visual inspection of the accessible external and internal areas of the steam dryer revealed significant steam dryer damage. The damage was most severe on the 90-degree side of the steam dryer, the side that was closest to the PORV that had opened. On the 90-degree side, a through-wall crack approximately 90 inches long and up to three inches wide was observed in the top of the outer hood cover plate and the top of the vertical hood plate (refer to Figures B-1 and B-2). Three internal braces in the outer hood were detached and one internal brace in the outer hood was severed. The detached braces were found on top of the steam separator. All detached parts were accounted for and retrieved. On the opposite side of the steam dryer (270-degree side), incipient cracking was observed on the inside of the outer hood cover plate and one vertical brace in the outer hood was cracked. No damage was found in the cover plates that had been replaced following the first steam dryer failure in 2002.

1. replaced damaged ½ inch outer hood plates with 1 inch plates
2. removed the internal brackets that attached the internal braces to the outer hood
3. added gussets at the outer vertical hood plate and cover plate junction
4. added stiffeners to the vertical welds and horizontal welds on the outer hood

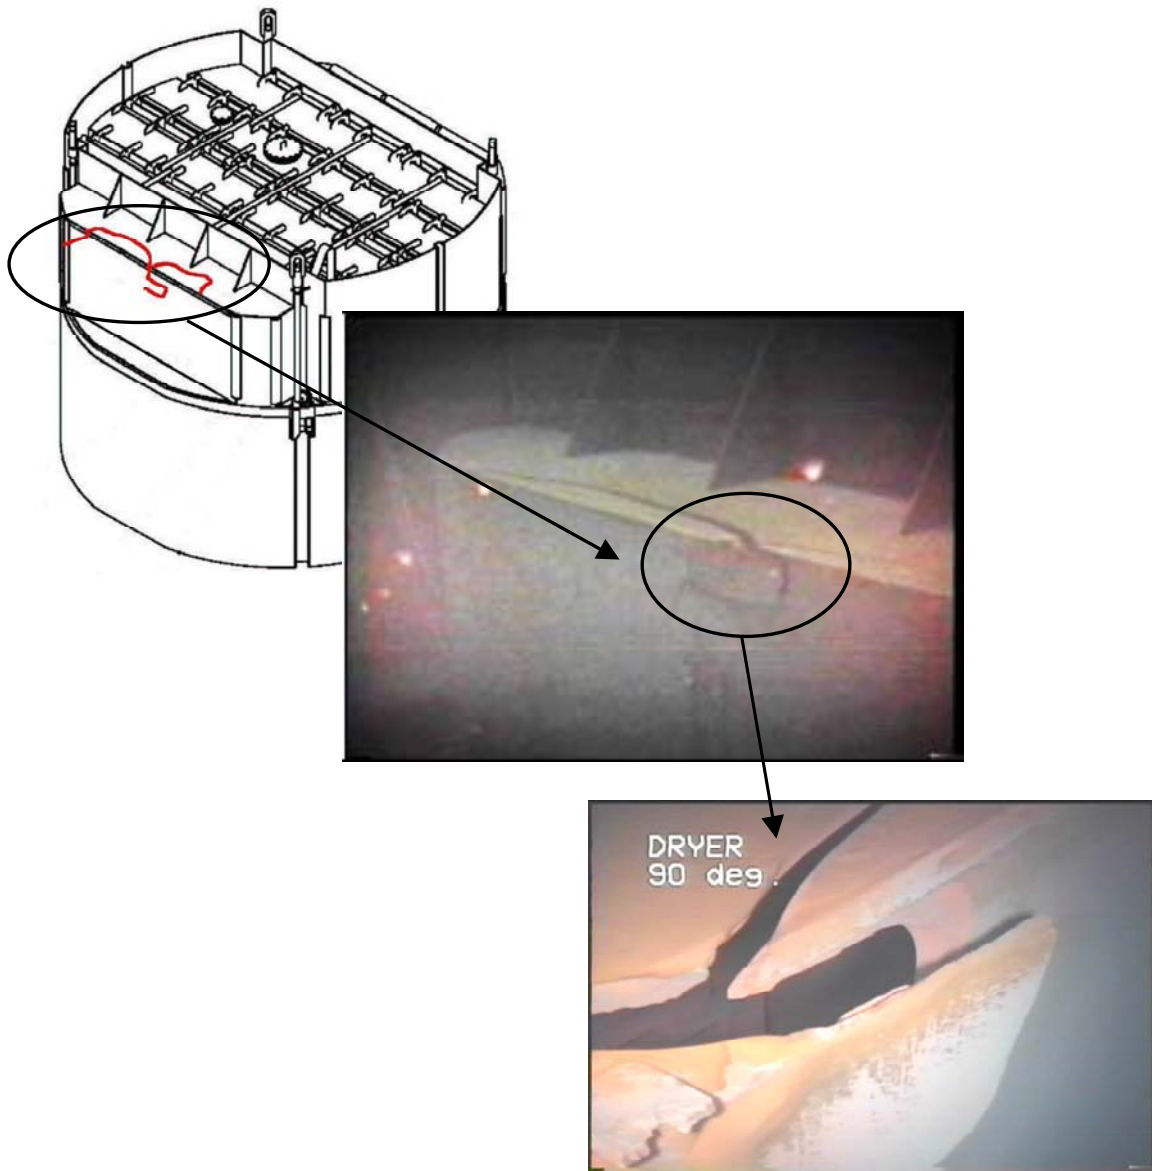
Figure B-2: Steam Dryer Damage 90 Degree Side

Extensive metallurgical and analytical evaluations (e.g., detailed finite element analyses, flow induced vibration analyses, computational fluids dynamics analyses, 1/16th scale model testing and acoustic circuit analyses) concluded that the root cause of the steam dryer failure was high cycle fatigue resulting from low frequency pressure loading. There are two potential contributing factors to the failure:

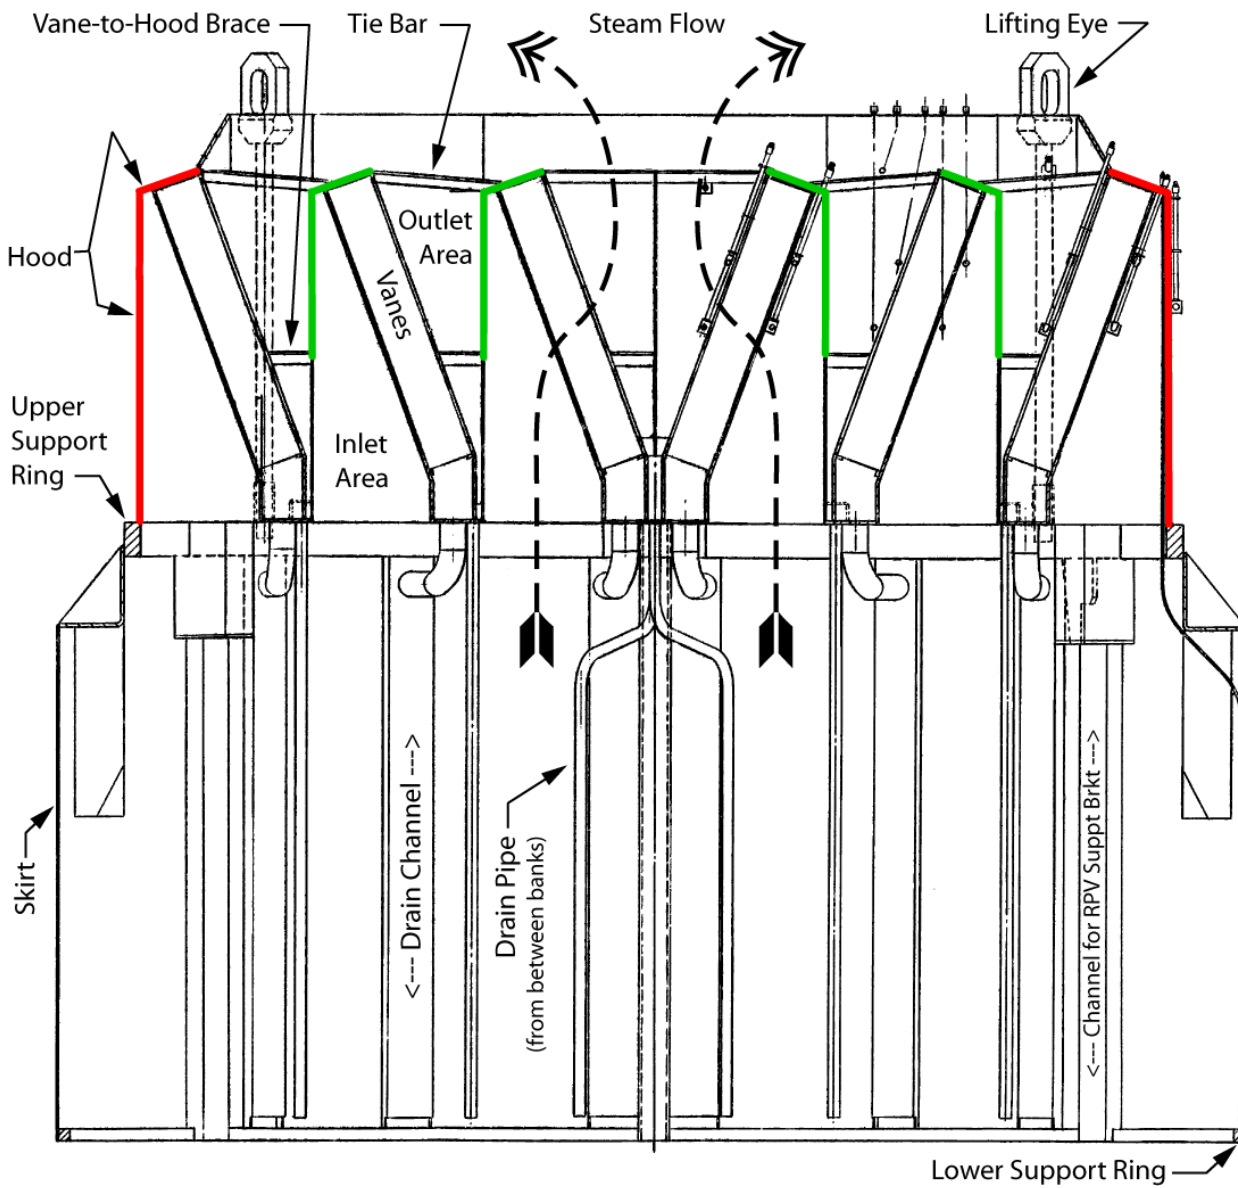
Figure C-2: Cross-Section of BWR/2 Steam Dryer

The other locations of interest are primarily associated with IGSCC in drain channels (shown for information in Figures C-7 and C-8). These components will be part of the internal examination. While these indications have been historically associated with BWR/4 through BWR/6 plants (SIL No. 474 “Steam Dryer Drain Channel Cracking” issued October 26, 1988), recent findings indicate that cracking can occur in these locations in square hood dryers. The additional weld seams associated with the outer side of the next set of inner banks should also be inspected in that this represents a steam path through the dryer. These areas are shown in green in Figure C-1. Cracking has been detected in these end panels in later design dryers. Finally, cracking at the steam dams as indicated in green in Figure C-6 has occurred in one BWR/4. These locations need to be included in the inspection plan for all of these plants. Finally, bank inner surface welds have cracked in the BWR/2. These locations, shown in Figure C-2 in green, also need to be inspected.
