South Texas Project
Unit 1
Docket No. STN 50-498
Request for Relief from ASME Boiler and Pressure Vessel Code,
Section XI Requirements for the Essential Cooling Water System (ECW Train 1B)
(Relief Request RR-ENG-2-39) (TAC No. MC-5191)

**SOUTH TEXAS PROJECT
REQUEST FOR RELIEF FROM ASME BOILER AND PRESSURE VESSEL CODE,
SECTION XI REQUIREMENTS FOR THE ESSENTIAL COOLING WATER SYSTEM
(ECW TRAIN 1B) (RELIEF REQUEST RR-ENG-2-39)**

Unit 1 Train B Essential Cooling Water 30-inch piping (Line Number 30" EW 1205-WT3) immediately downstream of valve EW-0064 from component cooling water heat exchanger 1B.

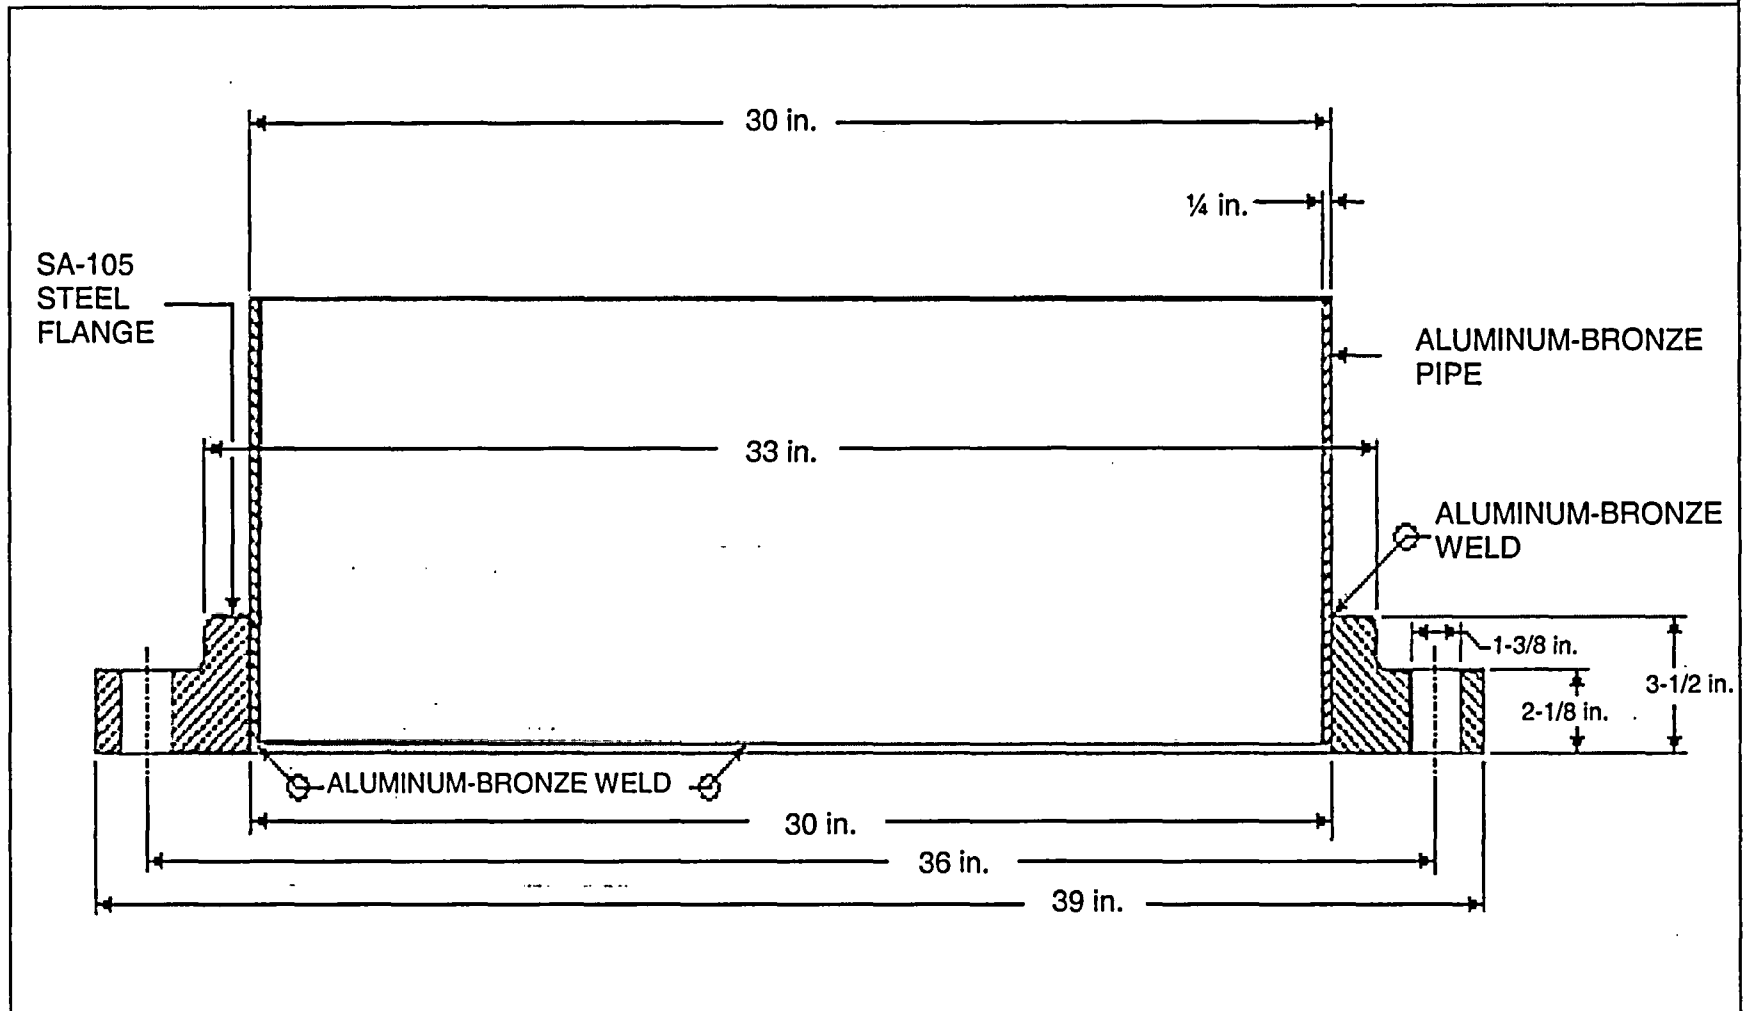
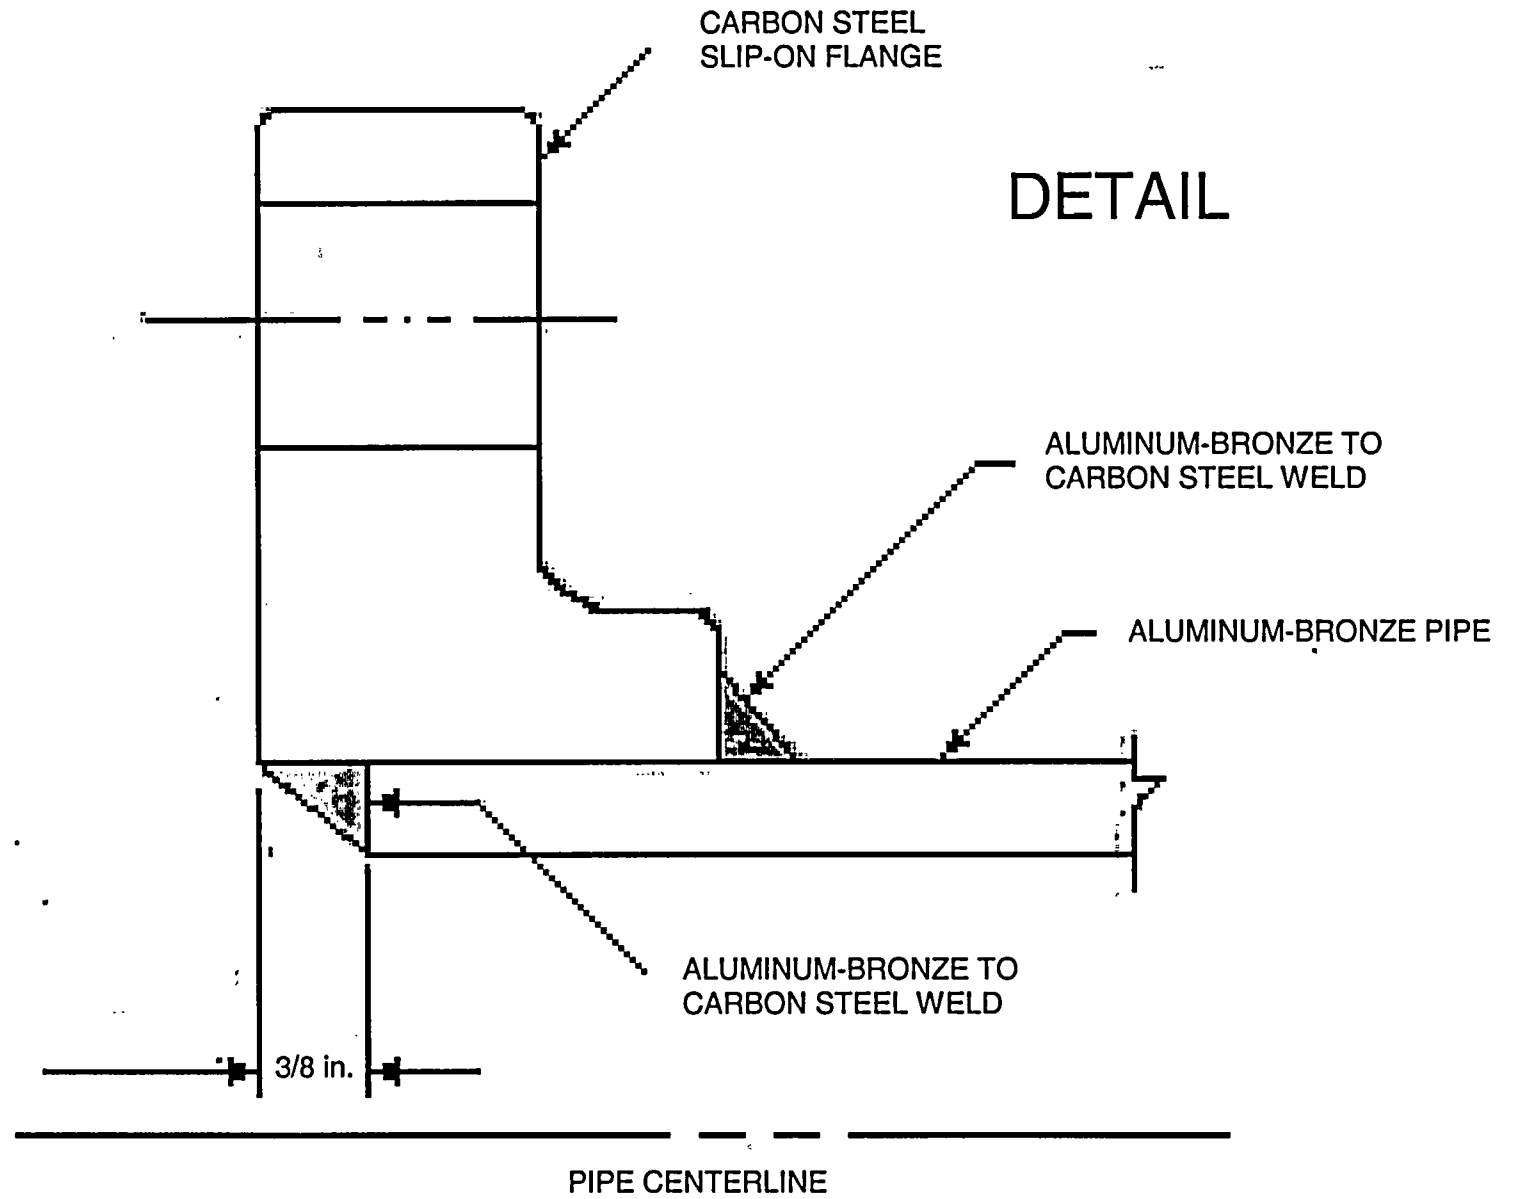
SLIP-ON FLANGE

Through-wall indications have been identified on the 30-inch pipe of the "B" train ECW system downstream of ECW valve EW-0064. Damage consists of pitting located immediately downstream of throttle valve EW-0064 on the inside wall of the pipe in an area covered outside the pipe by a slip-on flange. Some pitting has a maximum depth of 0.75 inch with corrosion extending into the flange. While there is some damage to the slip-on flange, the slip-on flange and the attendant welds prevent leakage from the ECW system.

Pitting is along the rim of the pipe in two discrete regions separated by approximately 11 inches. The regions are approximately 6 inches long and 6-1/2 inches long, respectively.

The root cause of the damage was apparent cavitation resulting from required throttling of the upstream valve.

The aluminum-bronze pipe has a nominal diameter of 30 inches and a nominal thickness of 0.25 inch. The pipe material is SB 169 CA-614 rolled and welded plate (6-8 percent aluminum) fabricated to SA-155 tolerances. The slip-on flange material is SA-105 carbon steel. The slip-on flange is welded to the 30-inch aluminum bronze pipe with fillet welds at both ends. The configuration is depicted in the attached figures.

Voids and imperfections on wetted surfaces of the 30" ECW return line from CCW Heat Exchanger 1B (Line Number 30" EW 1205WT3) downstream of Valve 1-EW0064 were filled with Belzona 1111 to minimize further degradation. The Belzona application is not intended to repair the pressure boundary parts to satisfy the piping minimum wall thickness requirements. Belzona will serve solely as a barrier against erosion and corrosion until code repairs can be implemented.
