**U.S. DEPARTMENT OF ENERGY  
NEVADA OPERATIONS OFFICE**

**REPORT OF THE INVESTIGATION  
OF THE ACCIDENT AT THE  
MIDAS MYTH/MILAGRO TRAILER PARK  
ON RAINIER MESA AT NEVADA TEST SITE  
ON FEB. 15, 1984**

**DATE OF INVESTIGATION REPORT  
APRIL 9, 1984**

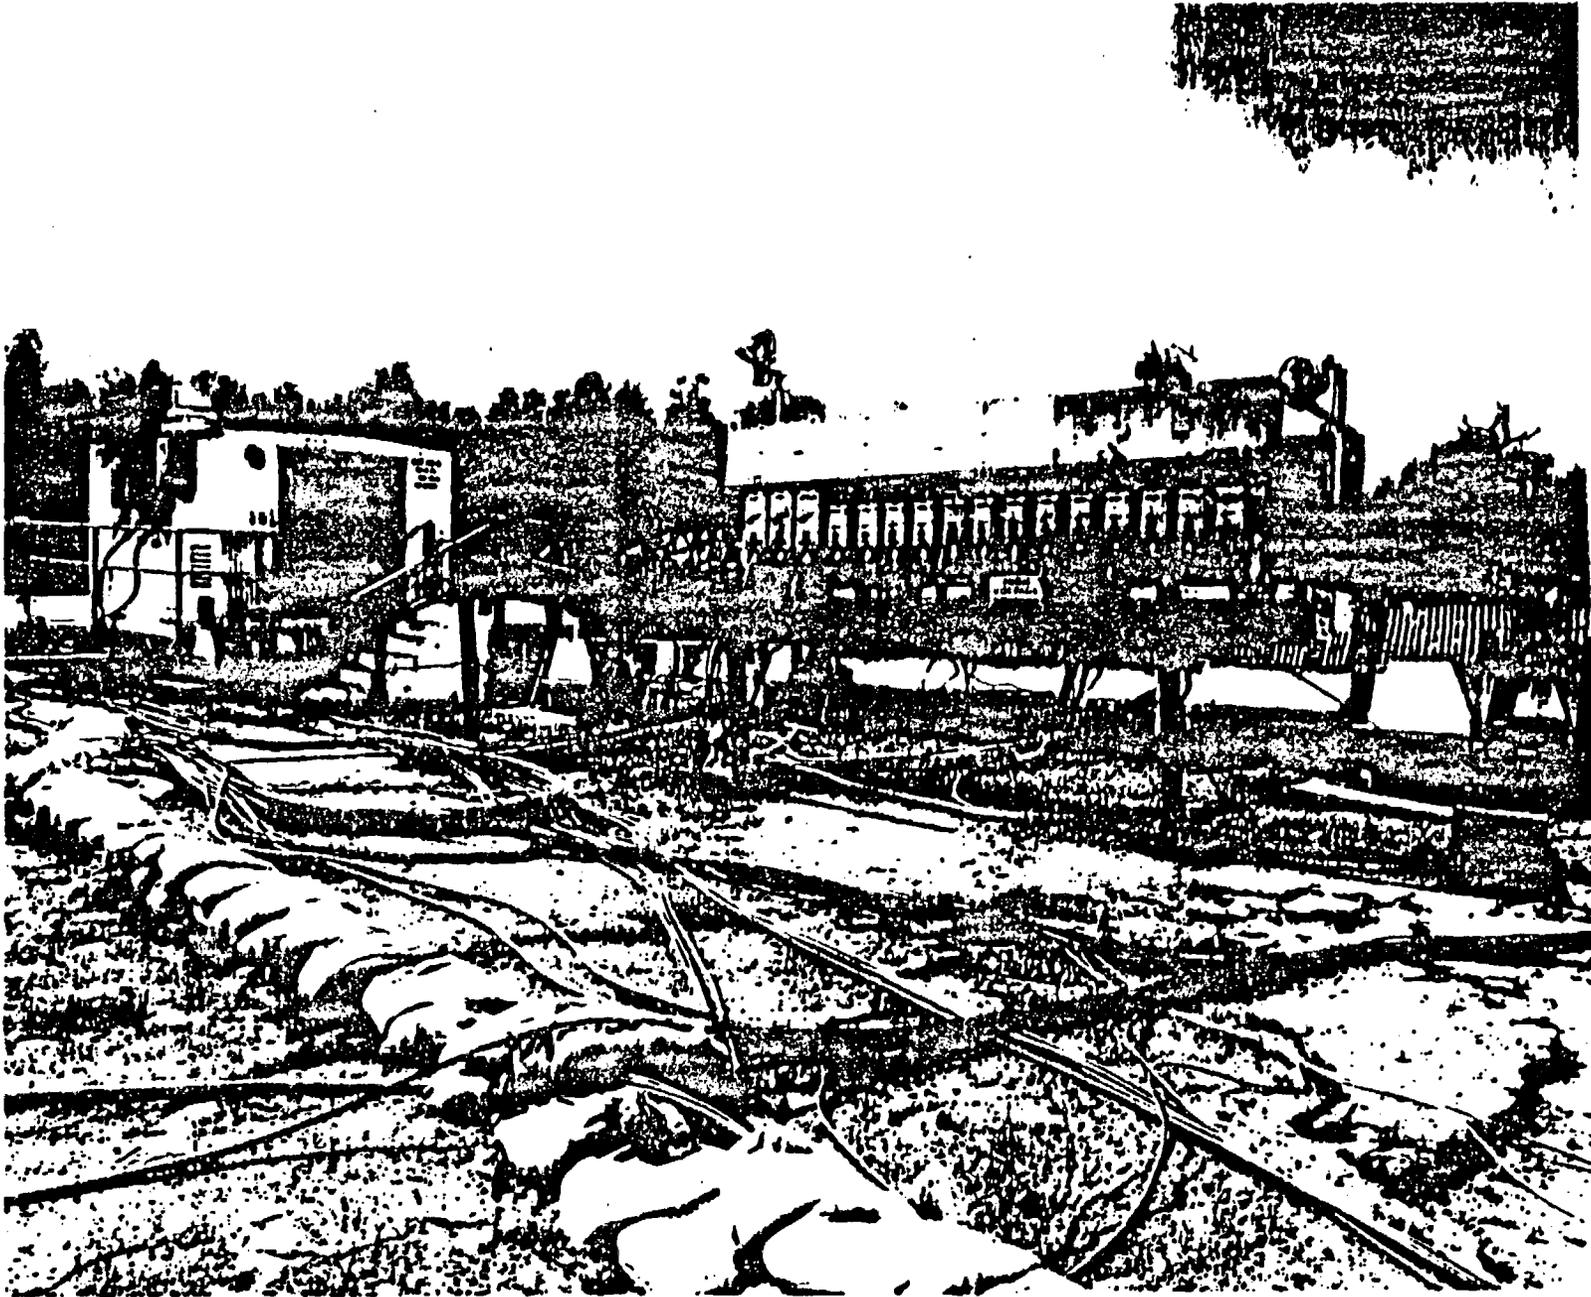
**Figure 10 — MILAGRO Trailer Park Power Panel,  
West End of Trailer P-14-101, Postshot, Prior to Collapse**

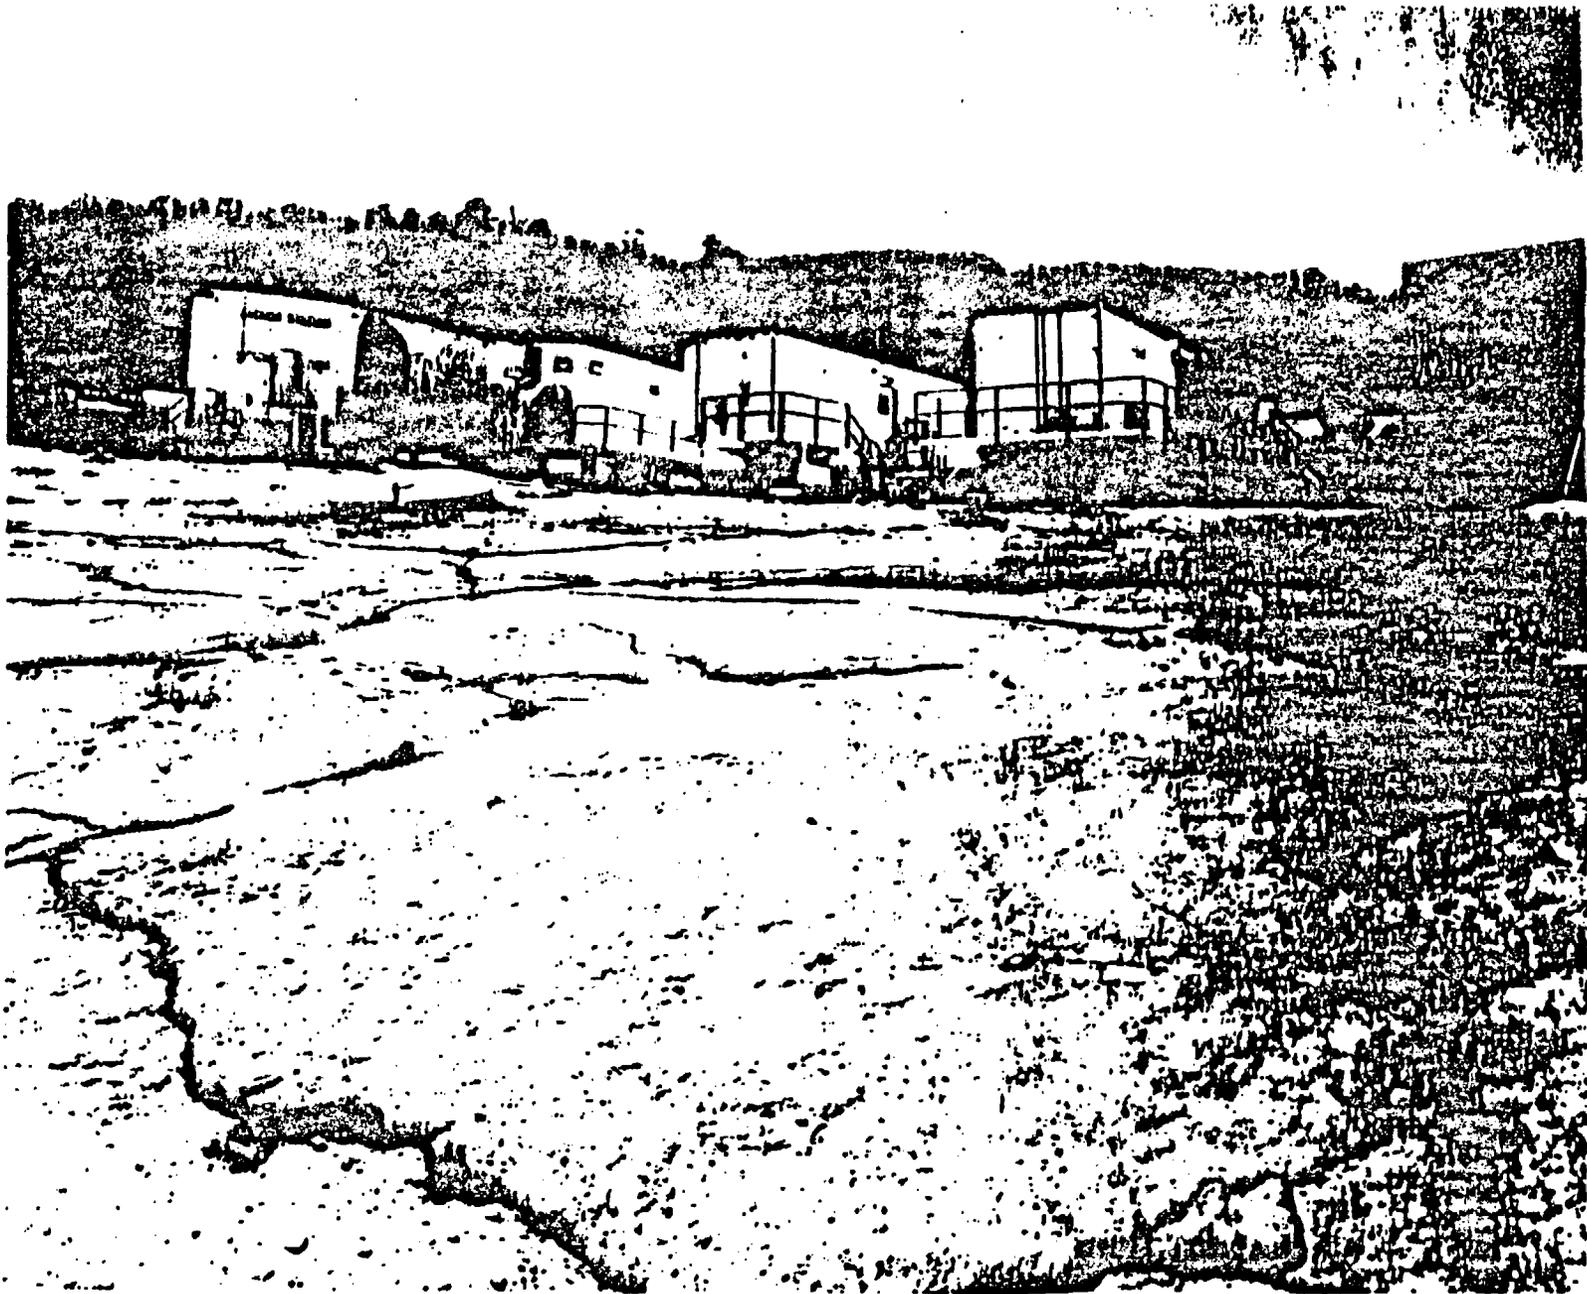
Figure 17 — MILAGRO Trailer Park,  
Post Collapse Damage, East Ends of Trailers

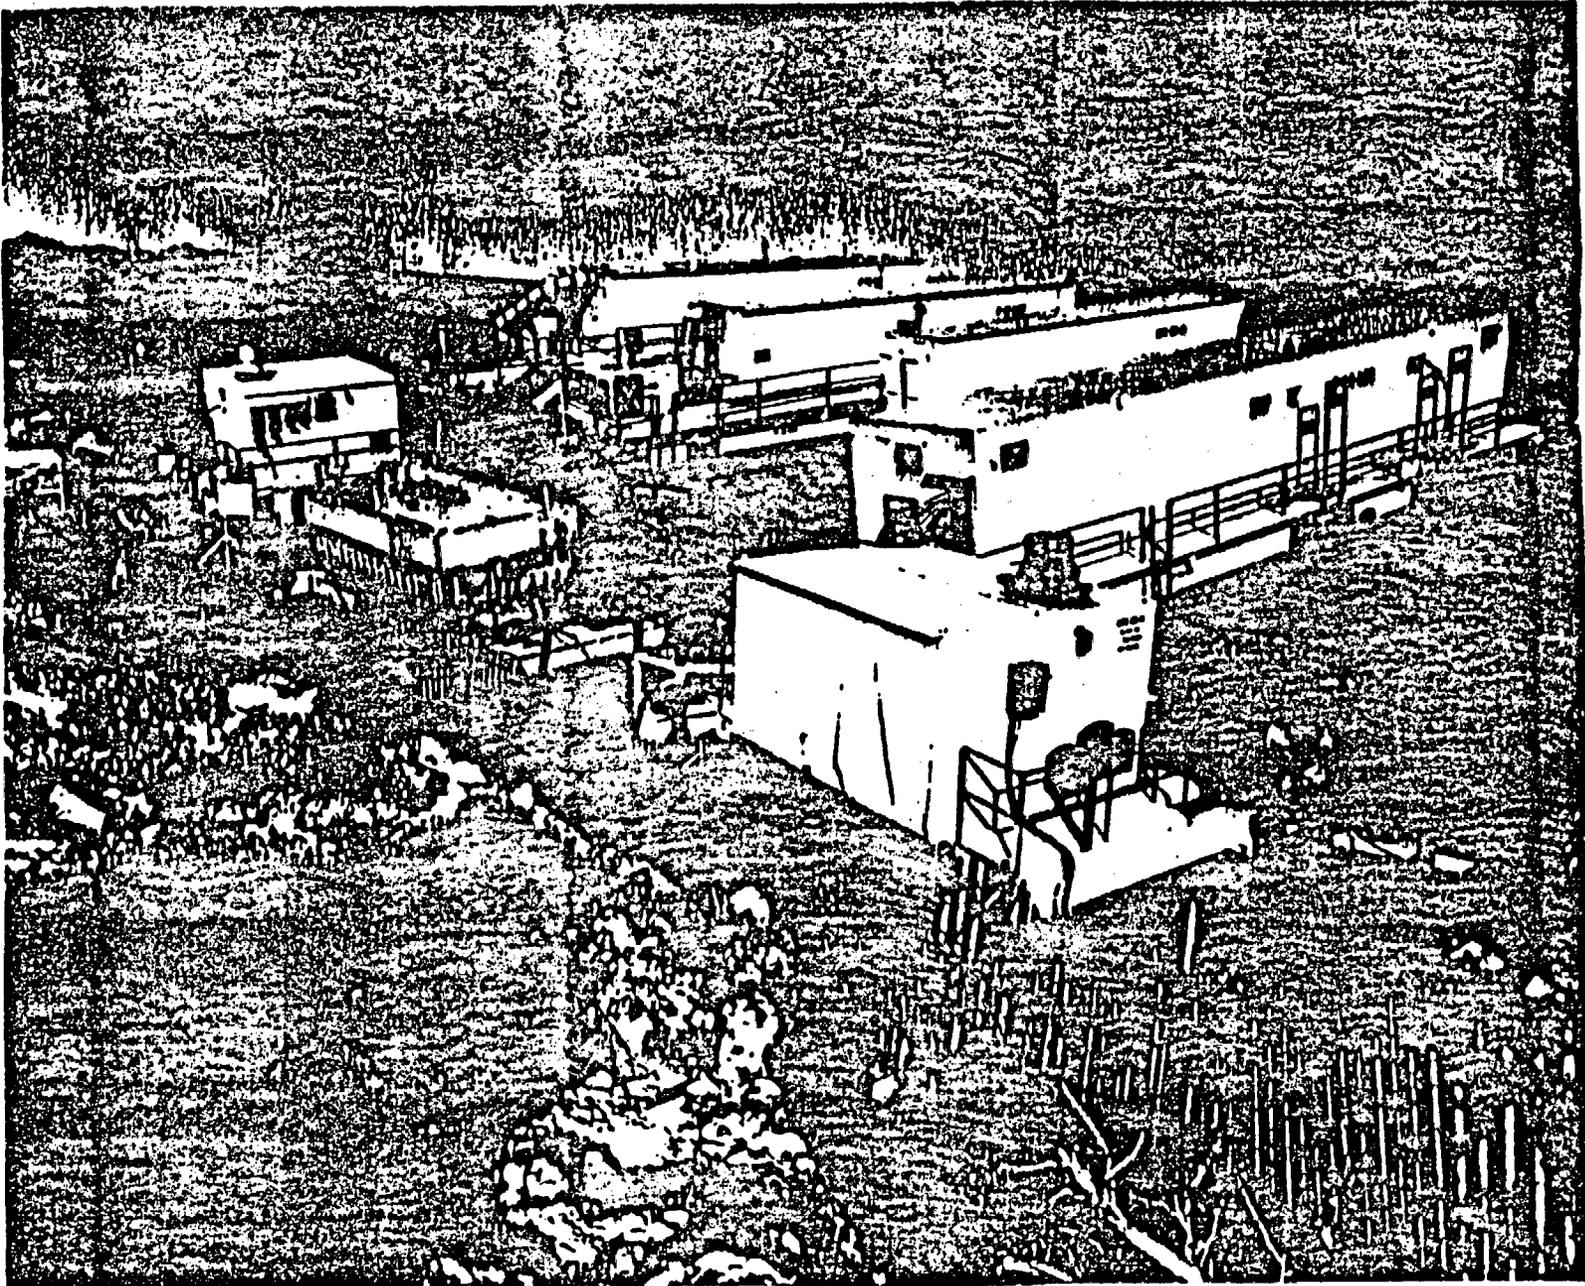
Figure 20 — MILAGRO Trailer Park, Post Collapse Damage,  
West Ends of Trailers and Cable Hole Area

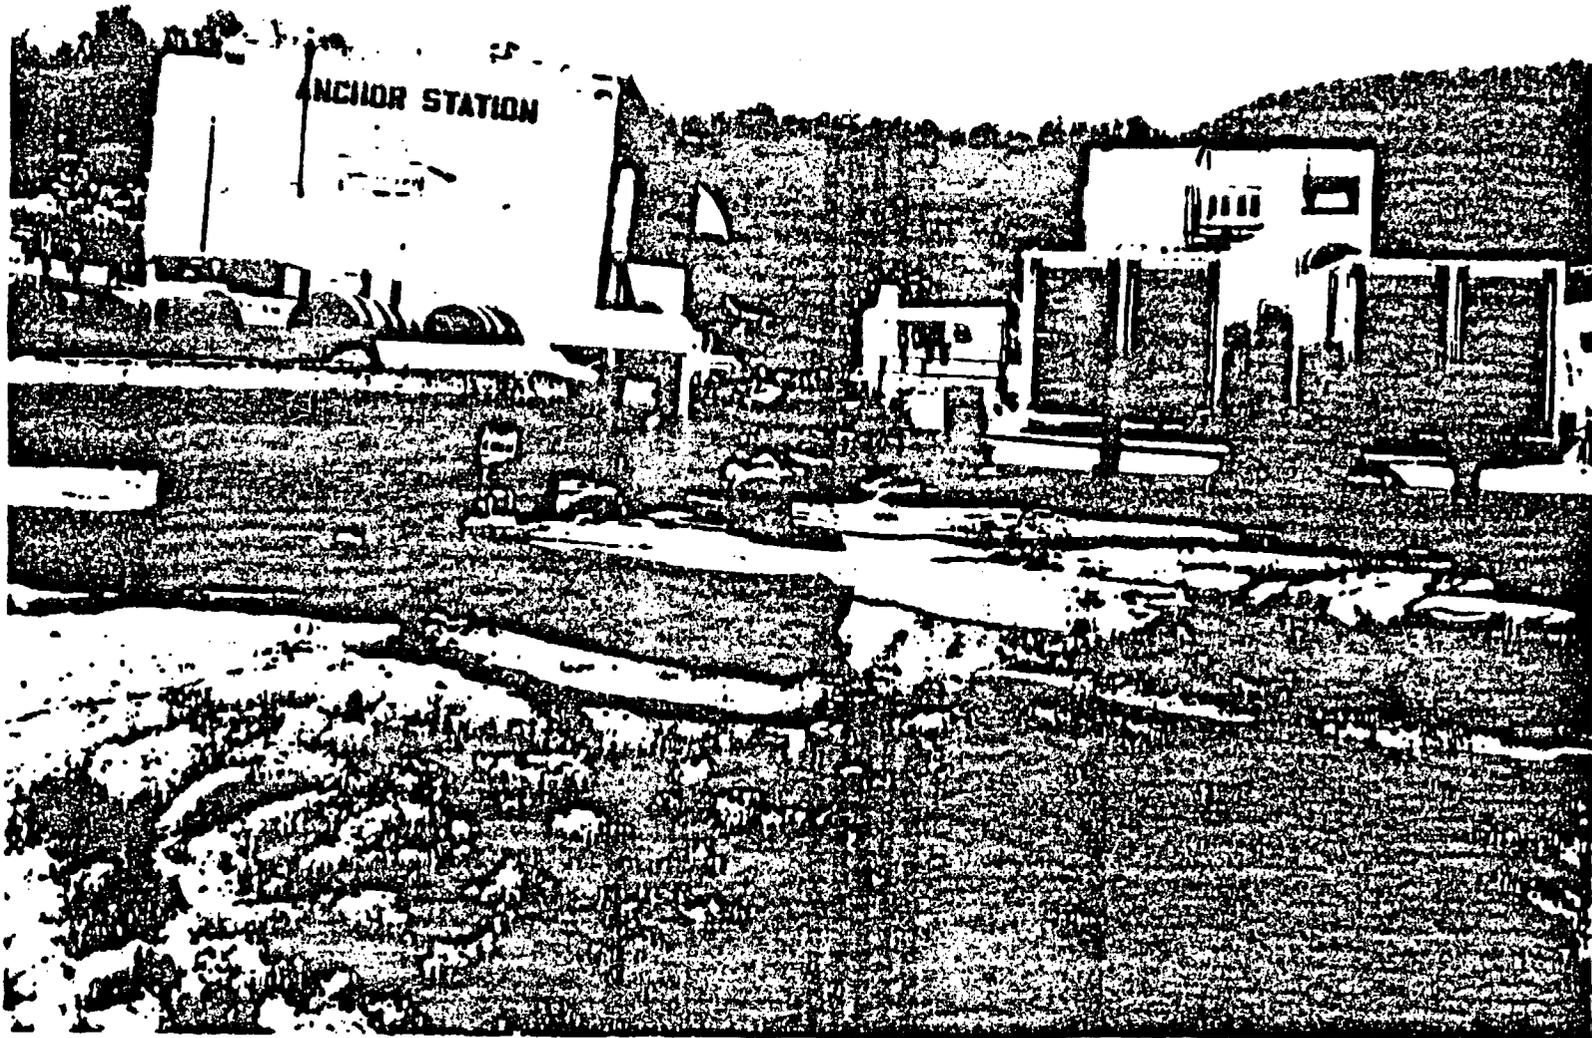
Figure 21 — MILAGRO Trailer Park, Post Collapse Damage,  
Cable Hole Area Between Anchor Station and P-14-101

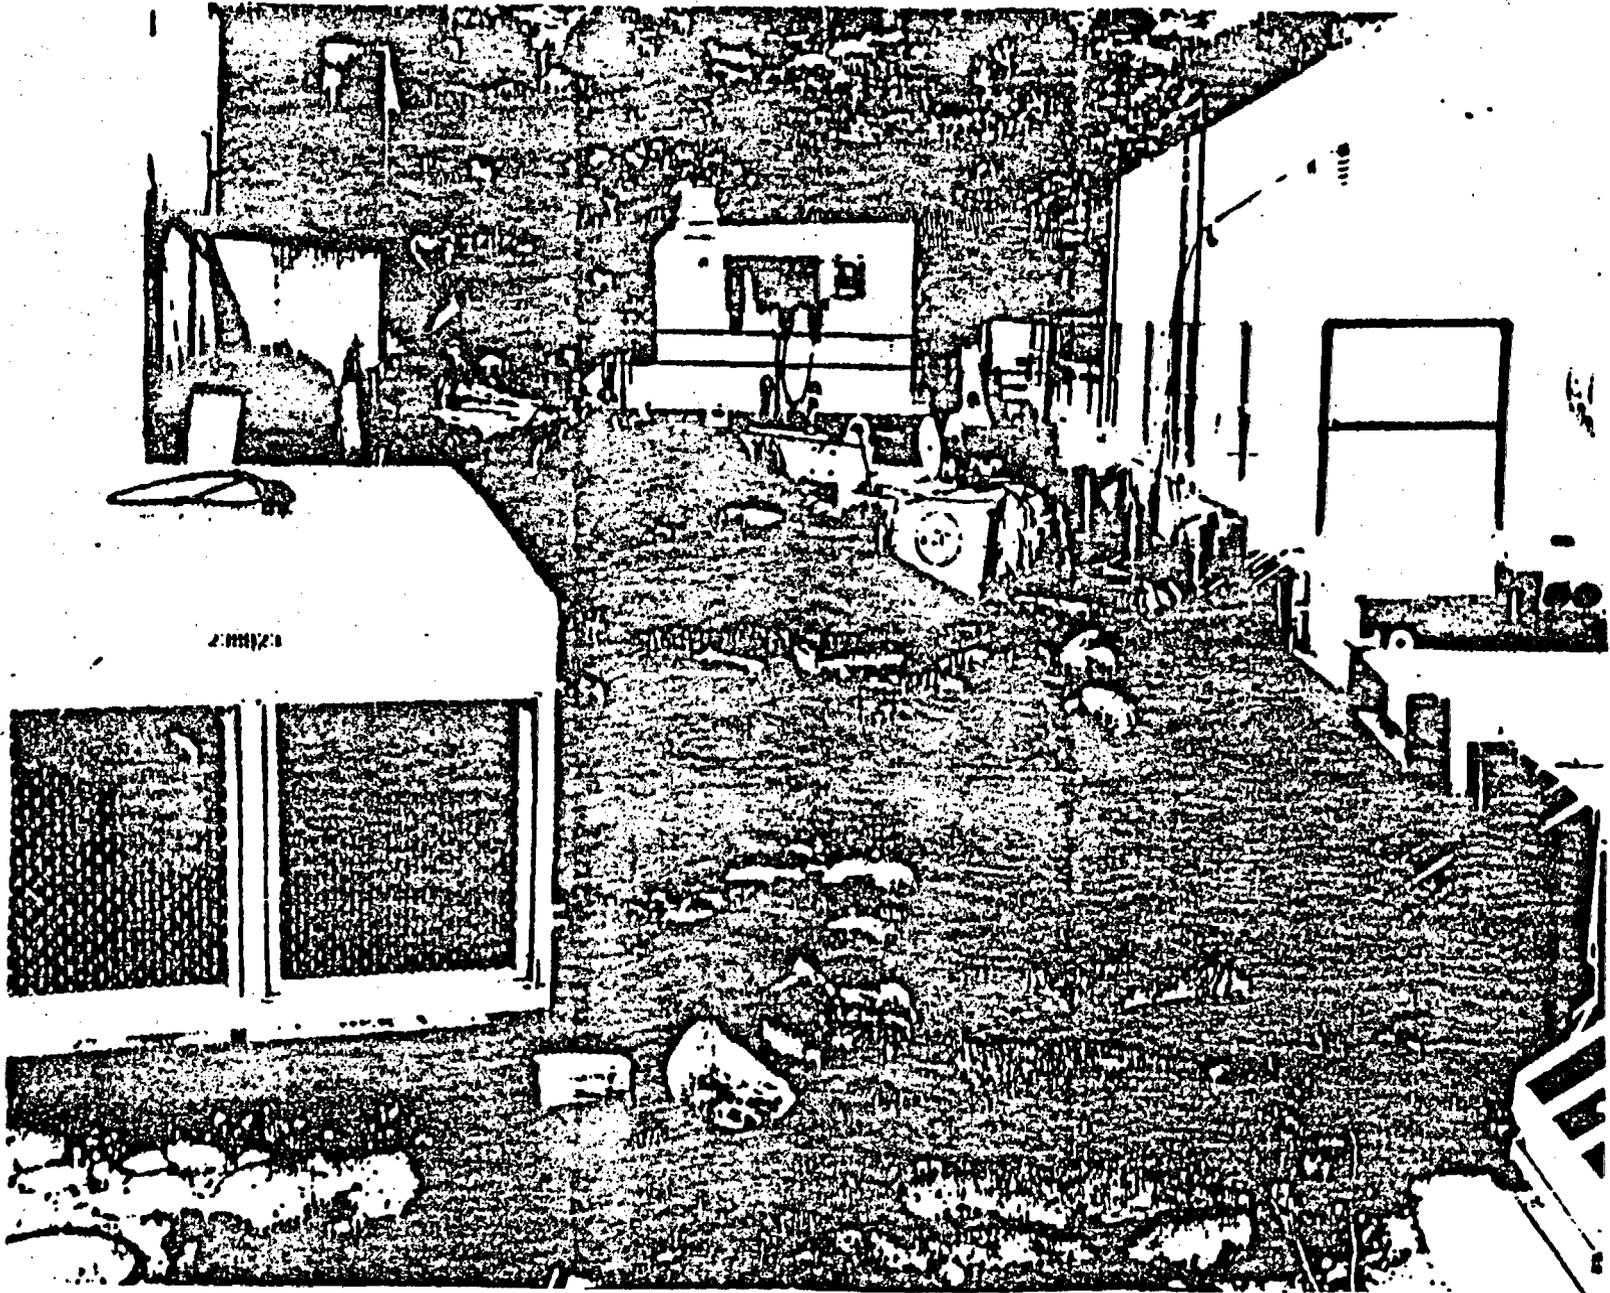
Figure 22 — MILAGRO Trailer Park, Post Collapse Damage,  
Cable Hole Area

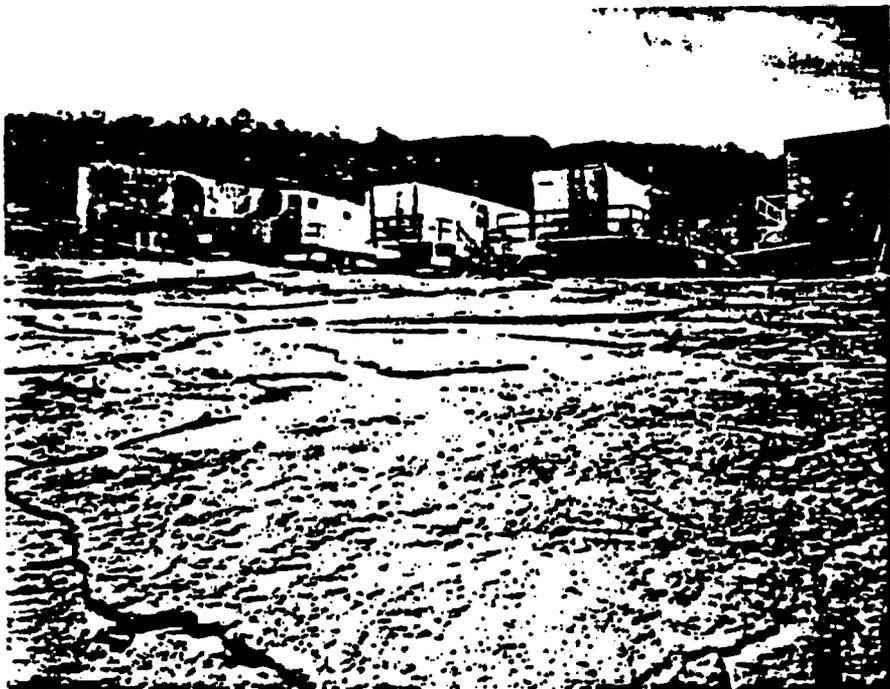
Some of the non-concentric fractures have a west-northwest trend which parallels the trends of other fractures formed off the pad. Figure 5, Photo F shows a typical view of non-subsidence-related

**PHOTO F.** - Non-subsidence-related cracks on the *MILAGRO* pad. View looking west.
