BOP/FP/HVAC System Health Reports

System Health Reports Document what is currently significant and what will be significantly challenging in the next 5 to 10 years.

Doug Tamplin
4th quarter 2005

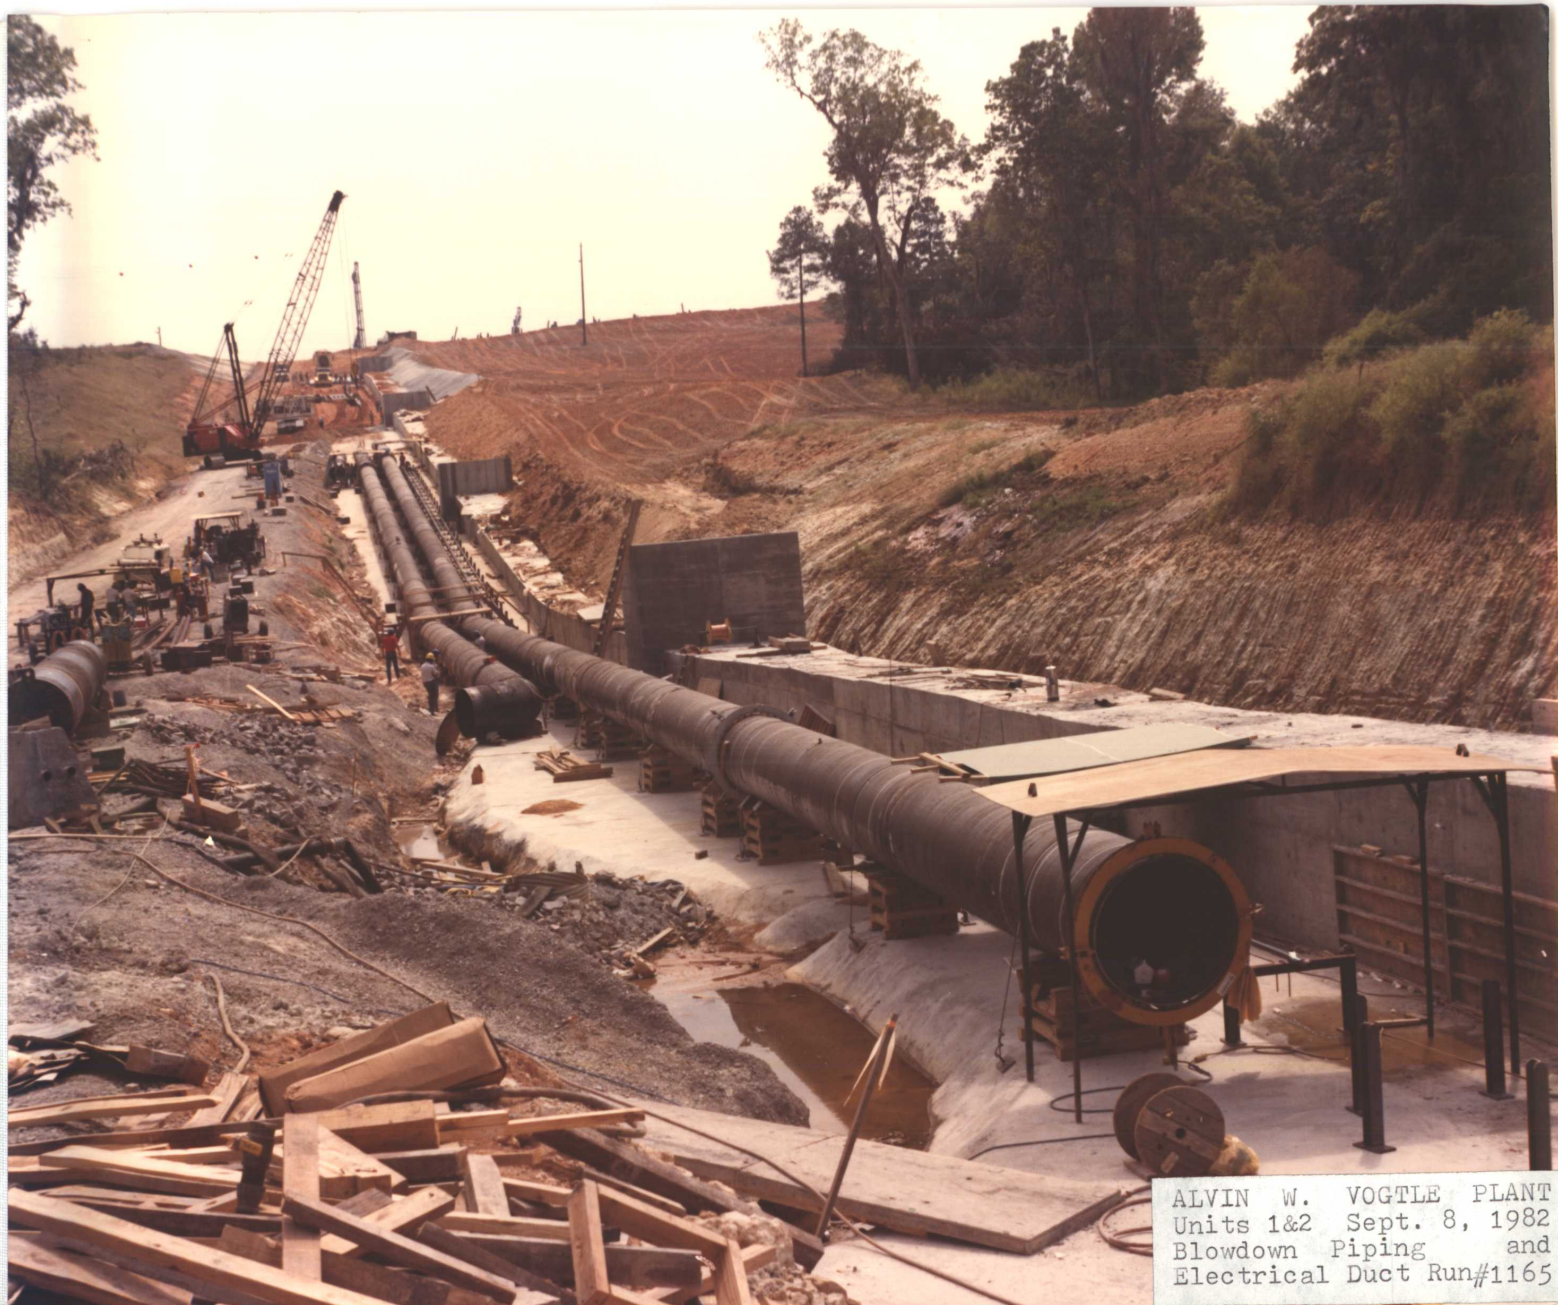
ALVIN W. VOGTLE PLANT
Units 1&2 Sept. 8, 1982
Blowdown Piping and
Electrical Duct Run#1165

- Complete packing rework on knife gate valves.
- Refurbished traveling screen # 2 & 3 one per year per current plan.
- Pin hole leaks discovered in the river intake to blowdown sump 12 inch piping.
- RER A054393001 Corporate Engineering to develop a contingency plan to limit plant susceptibility to the buried river water make-up lines that run from the river intake to the NSCW towers, the Natural Draft Cooling Towers, and cooling tower blowdown sump.
