# Harris Nuclear Plant

## A Essential Services Chilled Water Compressor Inoperability

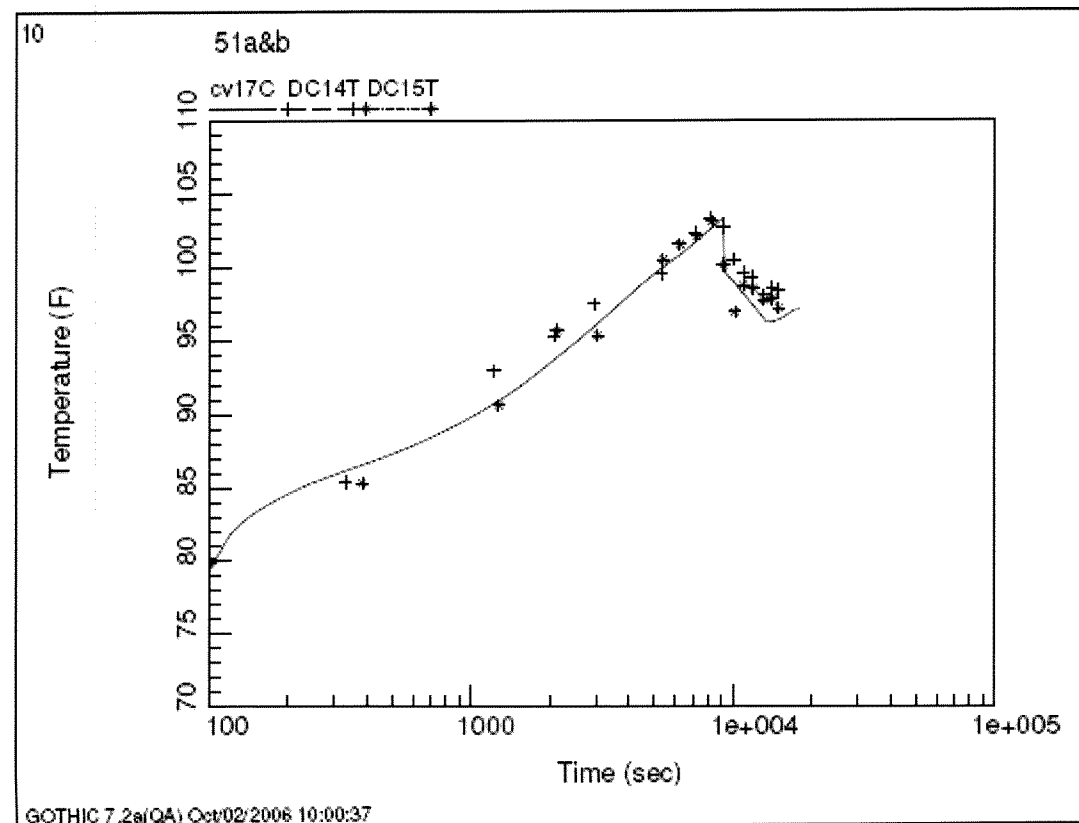
- CSIP room heat up validation
  - ▶ Operated the A CSIP without the A chiller to validate the temperature response
  - ▶ Placed alternate cooling fan in service
  - ▶ Benchmarked the industry standard computer model with actual field data taken from the CSIP room
  - ▶ Adjusted model for accident assumptions

- Model correlation

Figure 3: Location 51 (W. motor endbell) test and model temperatures

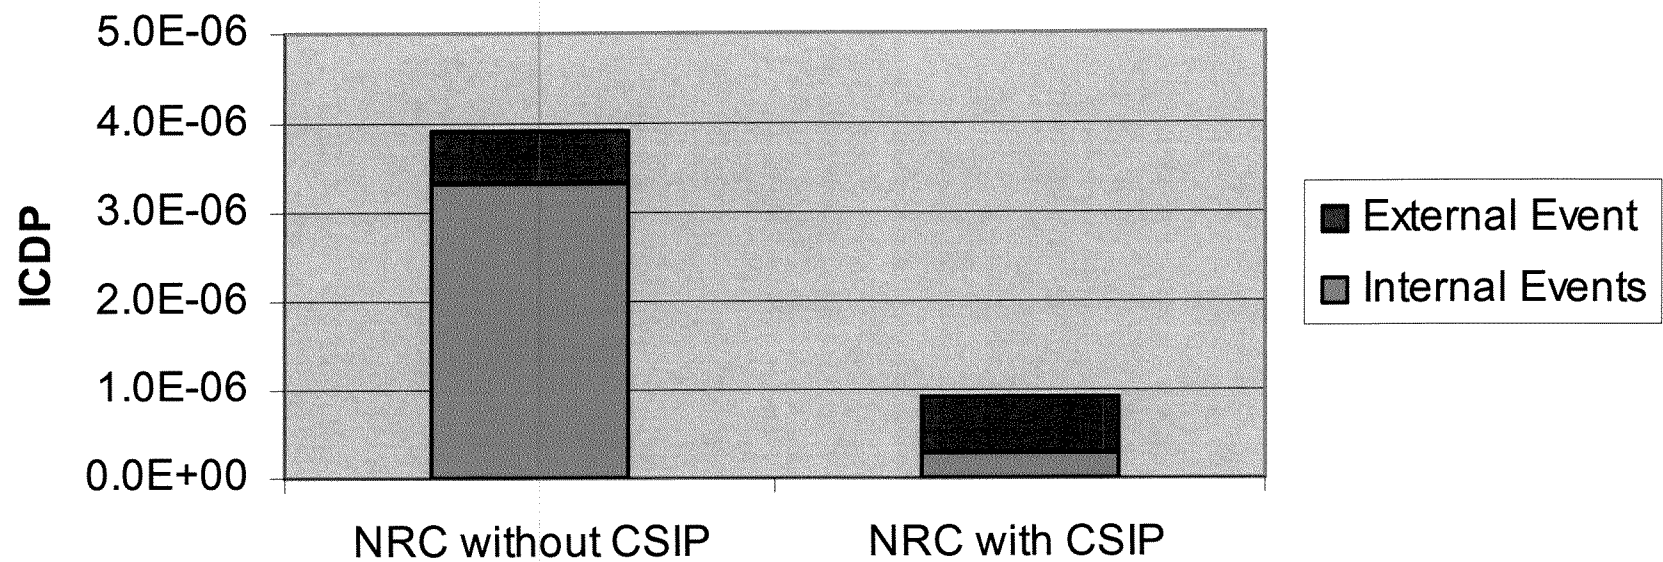
## NRC ICDP Results for HNP Chiller

- NRC risk assessment preliminary risk assessment
  - Risk increase is White with no credit given for the CSIP
  - NRC Risk increase is Green with credit for CSIP alone with no other considerations

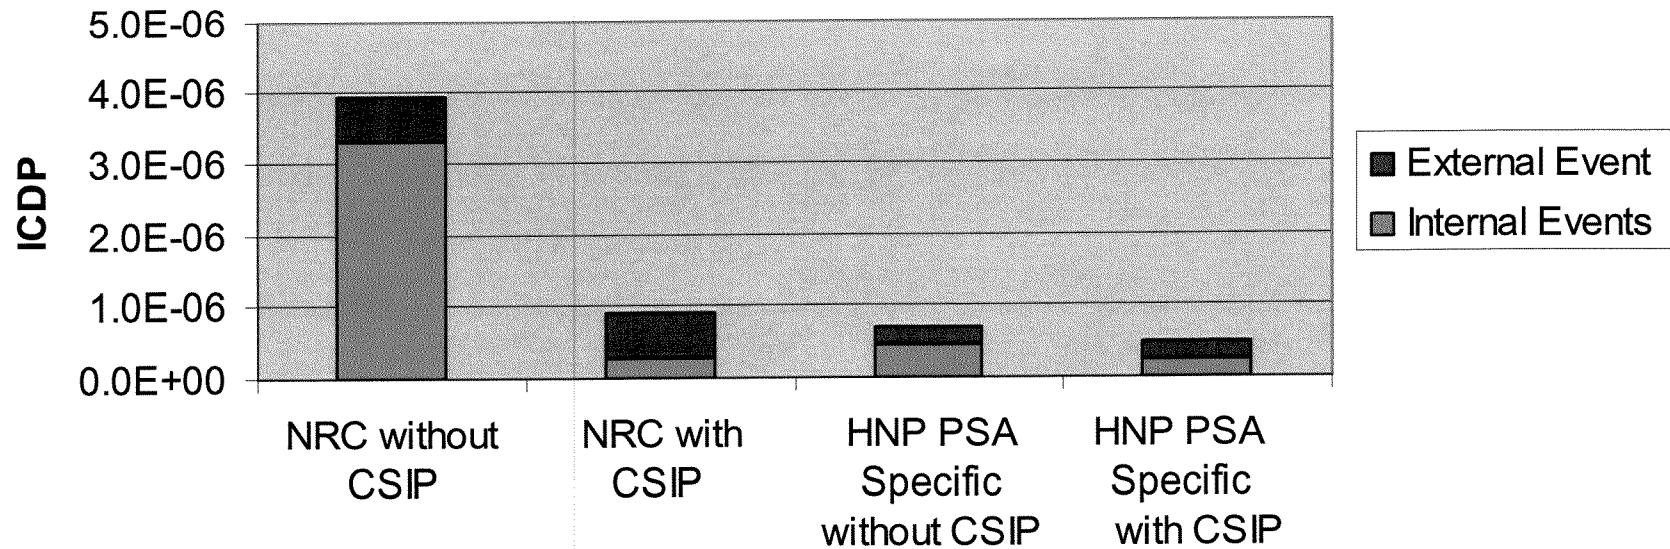
## HNP Chiller Comparison of ICDP Results

- Additional PSA inputs that show risk reduction (not included in NRC analysis)
  - ▶ Plant specific fire ignition frequency
  - ▶ Loss of emergency bus frequency
  - ▶ “Protected train” assumption
