EXAMINATION OF STRONTIUM-90 SOURCE CAPSULES FROM
U. S. ARMY CALIBRATION DEVICES

K. W. Haff and F. N. Case
Isotopes Technology

OAK RIDGE NATIONAL LABORATORY

August 1980

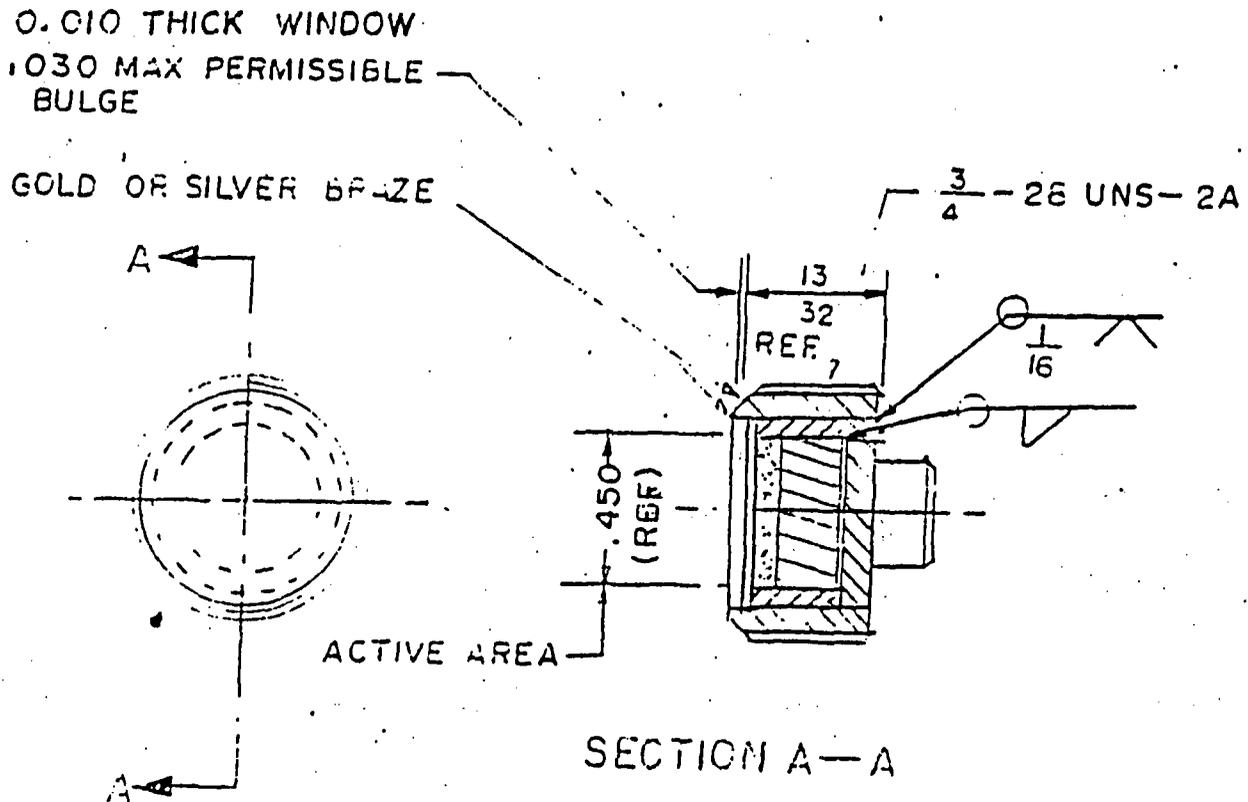
Fig. 4. Sketch of Strontium-90 Source Used in
 U. S. Army Calibrator Set, Radiac AN/UDM-2

A sketch of the encapsulated ^{90}Sr sources is shown in Figure 4. The sources are right circular cylinders and are doubly encapsulated in stainless steel with 10 mil windows which are brazed to a heavier stainless steel wall. The final closure of the source is by gas-tungsten arc welding. The outer capsule is threaded and screwed into the calibrator shields.

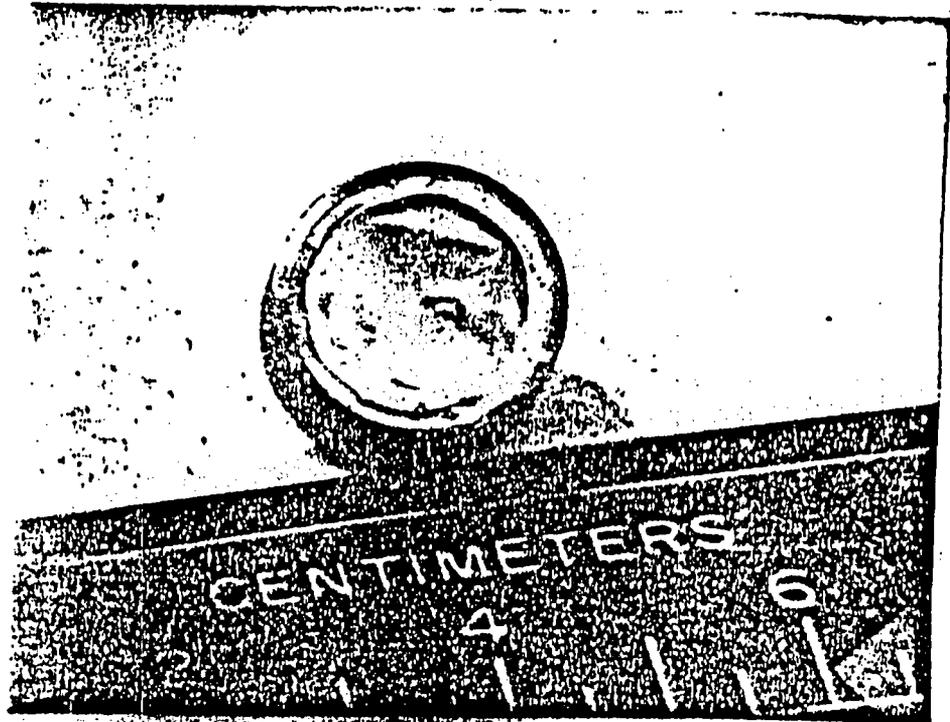
Fig. 5. Source Number 212-1

The outer capsule of each source was visually inspected and photographed using a 100X magnification, leak tested, and smeared for transferrable activity. The outer capsule on one source was found to be leaking. This source had a hole burned in the outer window, apparently by electrical discharge, during the welding operation; however, the inner capsule was leak free and the source did not leak radioactivity. Three other sources also had arc burns (discoloration) on the outer windows but were free of leaks.

ORNL Source No.	Back Side of Source ^a	Window Side of Source	Mfg. Source No.	Results of Hot Water Leak Test
212-1	Red dot on weld	Arc hole in window - outer capsule	SRB 1192	Leaked - outer source window
212-2	Yellow dot on weld	Arc burn - no hole in window	SRS 325	No leak
212-3	Red dot on weld	Arc burn	SRB 1197	No leak - Bulge in window
212-4	Red dot on weld	Window slightly concave	SRB 1201	No leak
212-5	Red dot on weld	Window slightly concave	SRB 1196	No leak
276-1	Yellow dot-good weld	Good window-water spot on window	SRS 317	No leak
276-2	Red dot-good weld	Good window-very small bulge in window-does not appear to be from pressure	SRB 1126	No leak
276-3	Good weld-red dot	Very small concave-good window	SRB 1066	No leak
276-4	Red dot-good weld	Window slightly wrinkled-small arc burn	SRB 1067	No leak
276-5	Red dot-good weld	Window slightly concave-small dirt or grease spot on window	SRB 1068	No leak
375-1	Yellow dot-good weld	Window slightly wrinkled	SRS 1272	No leak

If sources of this design are required in the future, fabrication specifications should include consideration for elimination of the holes and arc burns of the type observed on the windows of the sources examined.

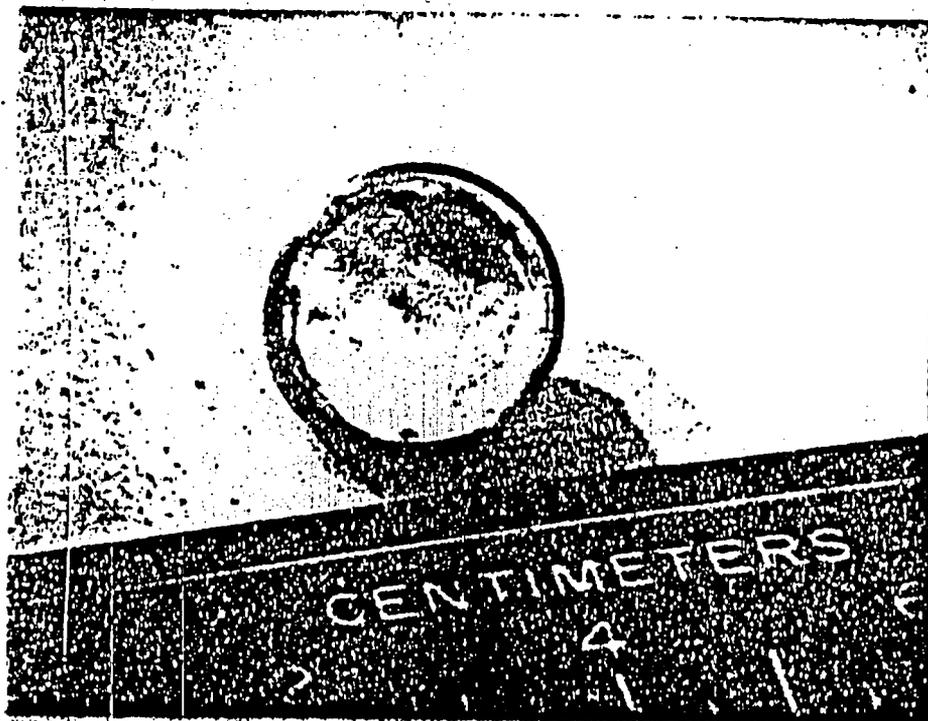
Fig. 16. Source Number 375-2

375-2	Red dot-weld rough at end	Window smooth except for small dent	SRB 1090	No leak
375-3	Red dot-bubble in weld (struck electrode)	Window smooth-very small concave	SRB 1030	No leak
375-4	Red dot-good weld	Slight wrinkling otherwise window perfect	SRB 1031	No leak
375-5	Red dot-good weld	Very small concave	SRB 1032	No leak
448-1	Red dot on weld-weld not smooth	Window concave-2 dents in window	SRB 487	No leak
448-2	Red dot-good weld	Window slightly concave small water spot in center	SRB 486	No leak
448-3	Red dot-good weld	Small arc burn-window wrinkled-slightly concave	SRB 485	No leak
448-4	Red dot-good weld	Window concave-has scratch mark-may have been done at ORNL	SRB 435	No leak
448-5	Yellow dot-good weld	Window slightly concave-wrinkled	SRS 155	No leak
