ANO1 Steam Generators

NRC Presentation
Results of the First ISI

Entergy/AREVA NP
August 2007

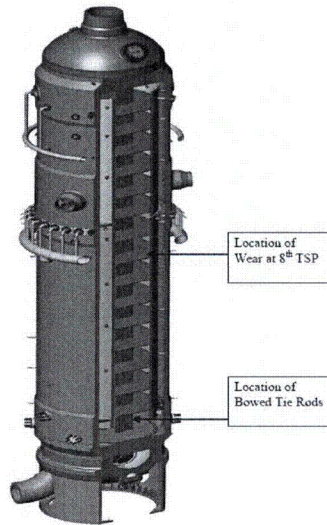
Bowed Tie Rods

Proximity Detected with Bobbin

Row 88 Seemed to Be the Bounding Bow

No Wear Associated with Bowed Tie Rods/Tubes

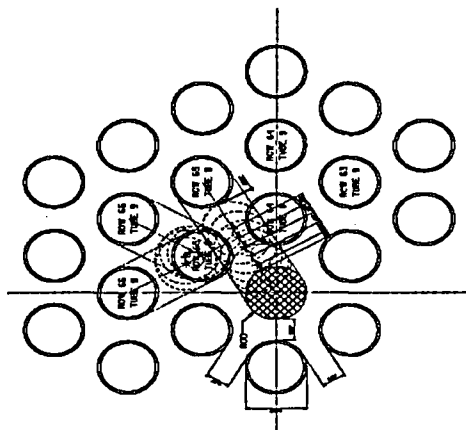
Tie Rod Tube Interaction at Location Row 64

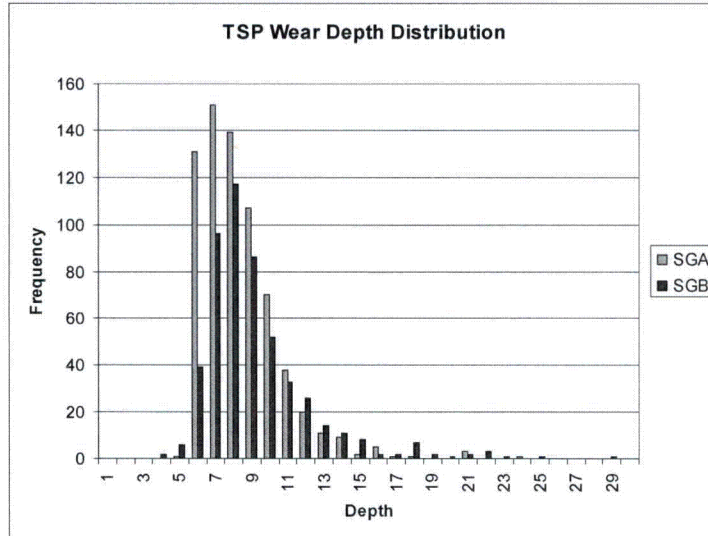
SGA	SGB
Outage	1R20	1R20
Total Number of Tubes	15595	15597
# of Wear Indications	690	512
# of Tubes with Wear	651	435
% of Tubes with Wear	4.20%	2.80%
Average Depth	7.40%	8.30%
Maximum Depth	23	28
# of Indications \geq 40% TW	0	0
# of Indications \geq 20% but \leq 39%	4	8
# of Indications \geq 1% but \leq 19%	686	504
EPFY for Cycle	1.31	1.31
Average Growth	7.40%	8.30%
95/50 Growth	12%	15%
Maximum Growth per EPFY	17.70%	21.50%
# Tubes Plugged in 1R20	0	1
Total Number of Tubes Plugged	2	1
