GPU Nuclear
Technical Data Report

Project: Oyster Creek Drywell Vessel Corrosion Mitigation

Document Title:
Summary Report of Corrective Action Taken from Operating Cycle 12 through 14R

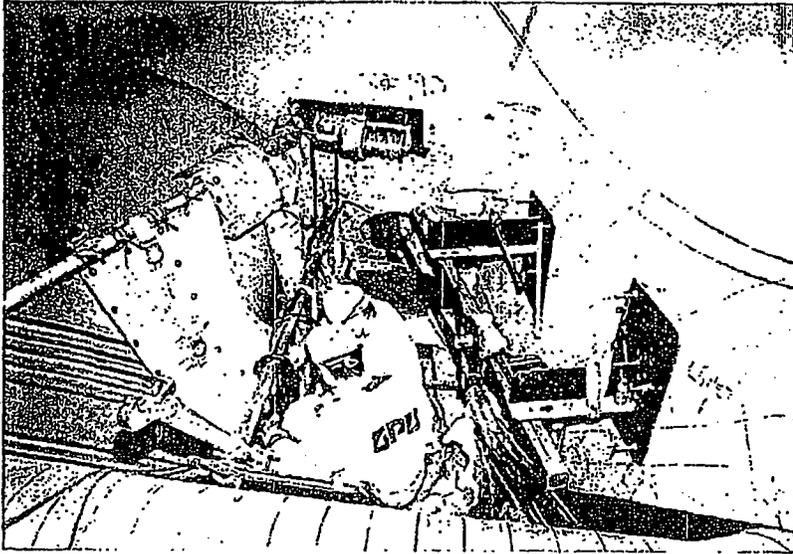
Figure 1

Access hole drilling set up view from the top of the Torus.

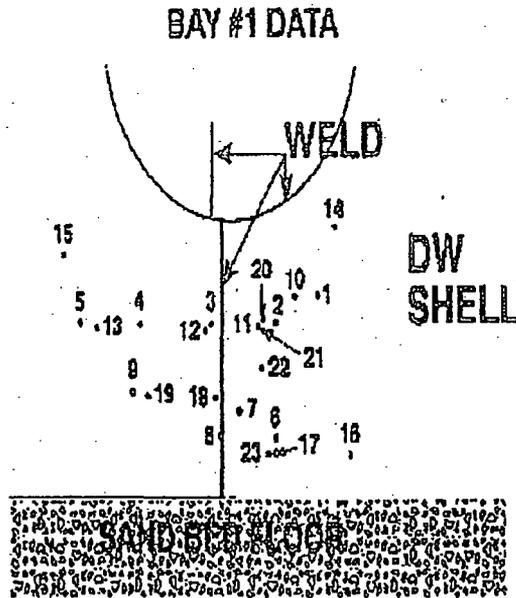
Figure 10

The shell in bay 1 is characterized by a rough surface full of dimples of varying sizes up to $\frac{1}{4}$ inch in diameter. The most remarkable feature is the presence of a band 8 inches to 18 inches wide which is 4 to 6 inches below the vent pipe reinforcement plate weld and about 30 inches in length. This bathtub ring contains the worst corrosion. Spots #1, 2, 3, 4, 5, 11, and 12 are located in this bathtub ring. Below the band the corrosion is much less. Above the band no corrosion was seen (spot #14 and #15) and the original red lead coating was still visible.

The inspection focused on the thinnest areas of the drywell, even if it was very local, i.e., the inspection did not attempt to define a shell thickness suitable for structural evaluation. The shell appears to be relatively uniform in thickness except for a band of corrosion which looks like a "bathtub" ring (see Fig. 10). Beyond the bathtub ring on both sides, the shell appears to be uniform in thickness at a conservative value of 0.800 inches. Measurements 14 and 15 confirm that the thickness above the bathtub ring is at 1.154 inches starting at elevation 11 feet, 00 inches. Below the bathtub ring the shell is uniform in thickness where no abrupt changes in thicknesses are present. Thickness measurements below the bathtub ring are all above 0.800 inches except location 7 which is very local area.

Therefore, a conservative mean thickness of 0.800 inches is estimated to represent the evaluation thickness for this bay. Given a uniform thickness of 0.800 inches, the buckling margin for the refueling load condition is recalculated based on the GE report 9-4 (Ref. 2.2). The theoretical buckling strength from report 9-4 (ANSYS Load Factor) is a square function of plate thicknesses. Therefore, a new buckling capacity for the controlling refueling load combination is calculated to be at 13% above the ASME factor of safety of 2.

The individual measured thicknesses must also be evaluated for structural compliance. Table 1 identifies 23 locations of UT measurements that were selected to represent the thinnest areas, except locations 14 and 15, based on visual examination. These locations are a deliberate attempt to produce a minimum measurement. Locations 14 and 15 were selected to confirm that no corrosion had taken place in the area above the bathtub ring.

Eight locations shown in Table 1 (1, 2, 3, 5, 7, 11, 12, and 21) have measurements below 0.736 inches. Observations indicate that these locations were very deep and not more than 1 to 2 inches in diameter. The depth of each of these areas relative to its immediate surroundings was measured at 8 locations around the spot and the average is shown in Table 1. Using the general wall thickness acceptance criteria described earlier, the evaluation thickness for all measurements below 0.736 inches were found to be above 0.736 inches except for two locations, 2 and 11, as shown in Table 2. Locations 2 and 11 are in the bathtub ring and are about 4 inches apart. This area is characterized as a local area 4 x 4 inches located at about 15 to 20 inches below the vent pipe reinforcement plate with an average thickness of 0.692 inches. This thickness of 0.692 inches is a full 0.108 inch reduction from the conservative estimate of a 0.800 inch evaluation thickness for the entire bay. In order to quantify the effect of this local region and to address structural compliance, the GE study on local effects is used (Ref. 2.21).

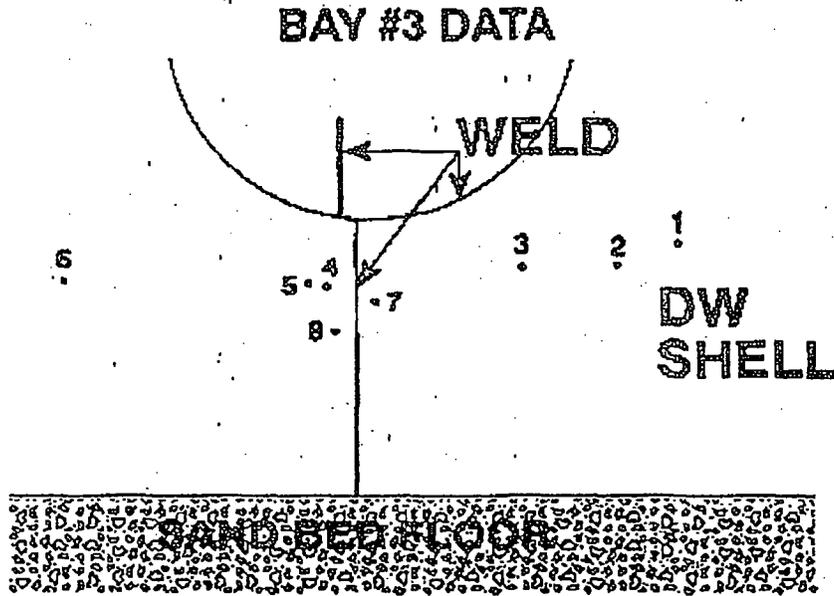
Figure 11

Except for a "band" approximately 6 inches below the vent header weld and 8 - 10 inches wide, the corrosion observed was uniform and characterized by a uniformly dimpled surface. The upper portion of the shell beyond the "bathtub ring" and the vent pipe was not corroded. The original "red lead" primer coating is still visible. The reinforcement bar sleeves, on the concrete side, were corroded uniformly. No perforation was seen in any of these sleeves. The concrete floor was in poor shape. It had a huge crater about half the length of the bay running along the drywell shell. It was about 18 inches deep at the worst location. No drainage channel was found on the floor. From the visual appearance, it was evident that the concrete floor was never constructed to the original design.

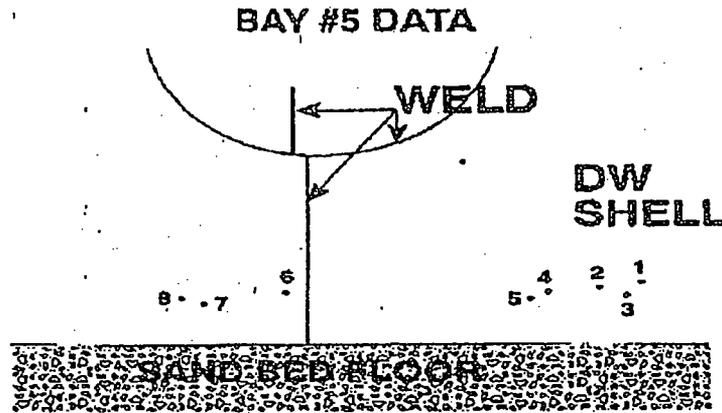
Figure 12

This bay was very similar to bay 3 in physical condition except that, (1) the floor crater was 12 inches deep at the worst location and (2) the localized low spots from corrosion were clustered at the junction of bays 3 and 5, 30 - 32 inches above the floor.

Given the UT measurements, a conservative mean evaluation thickness of 0.950 inches is estimated for this bay and therefore, it is concluded that the bay is acceptable.

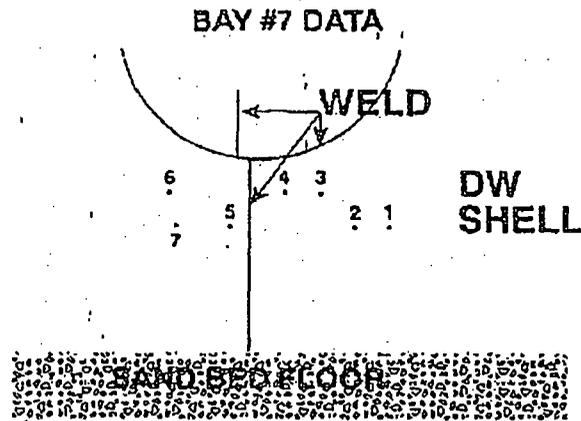
Figure 13

The drywell surface showed uniform dimples in the corroded area, but it was shallow in depth. The bathtub ring, seen below the vent header in other bays, was not very prominent in this bay. The sleeves for the reinforcement bars showed no perforations and were uniformly corroded. The concrete floor had no drainage channel, was unfinished and had a few small craters.

Given the UT measurements, a conservative mean evaluation thickness of 1 inch is estimated for this bay and therefore, it is concluded that the bay is acceptable.

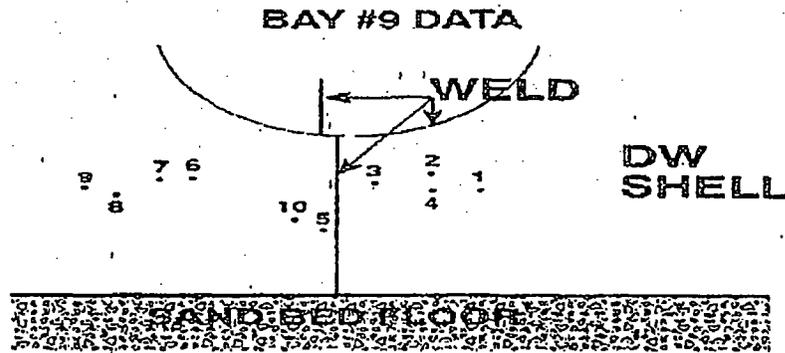
Figure 14

This bay was similar to bay 7 in physical condition except that the bathtub ring that is 6 to 9 inches wide and 6 to 8 inches below the vent pipe reinforcement plate contained some localized corrosion. Above this band no corrosion had occurred.

Given the UT measurements, a conservative mean evaluation thickness of 0.900 inches is estimated for this bay and therefore, it is concluded that the bay is acceptable.

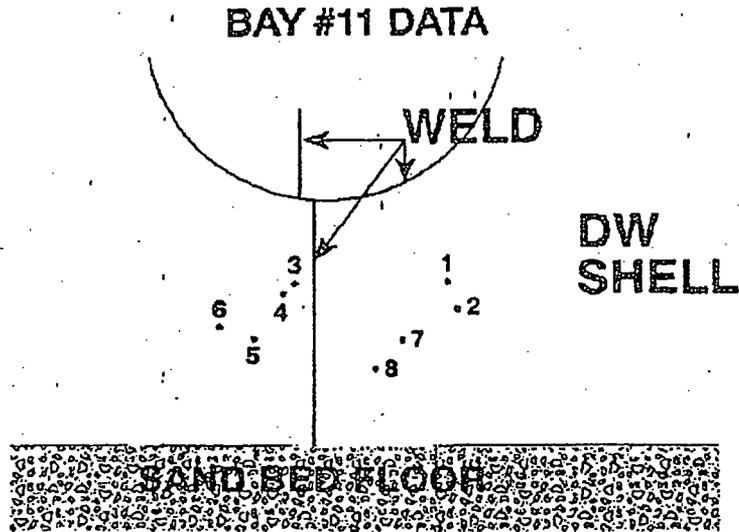
Figure 15

This bay was wet, during the initial inspection, from the water leaking out of the reactor cavity. The water was seen trickling/dripping down the concrete wall on the inside of the sand bed. No water stream/trickle was seen on the drywell shell. Most of the localized corroded spots were on the upper right hand side (i.e. toward bay 9) 10 to 12 inches below the vent pipe reinforcement plate. The shell on the left hand side (i.e. toward bay 13) showed an uniformly corroded (dimpled) surface. The concrete reinforcement bar sleeves were corroded but not perforated. The concrete floor was unfinished and no drainage channel was seen.

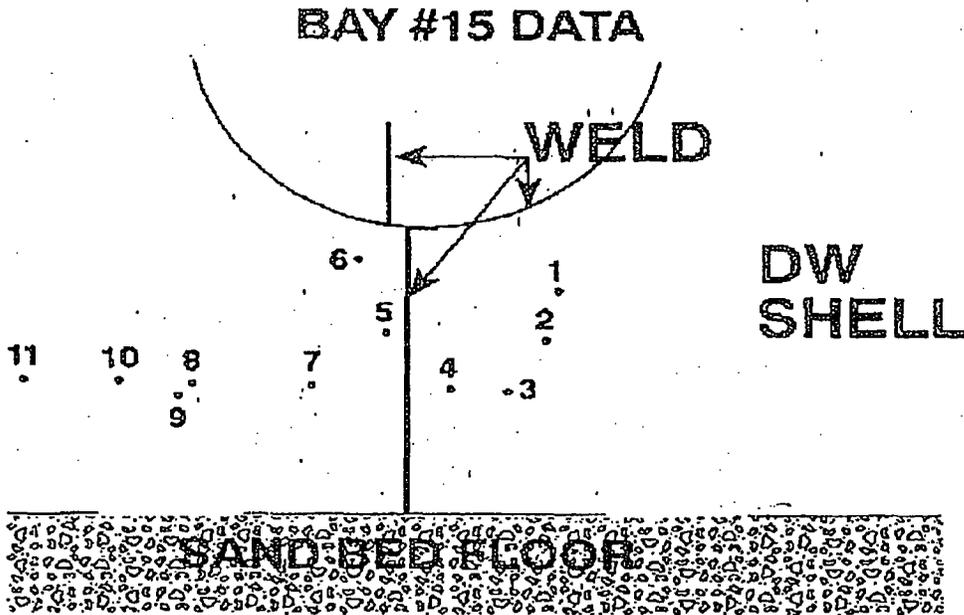
Figure 17

The drywell shell in this bay was uniformly dimpled and the upper part of the shell (i.e. near the vent pipe/reinforcement blade and up) was not corroded. The original "red lead" primer was still visible in this region. The bathtub ring was less prominent than other bays. The reinforcement bar sleeves were corroded, but not perforated. The concrete floor had no drainage channel and there were craters in the floor.

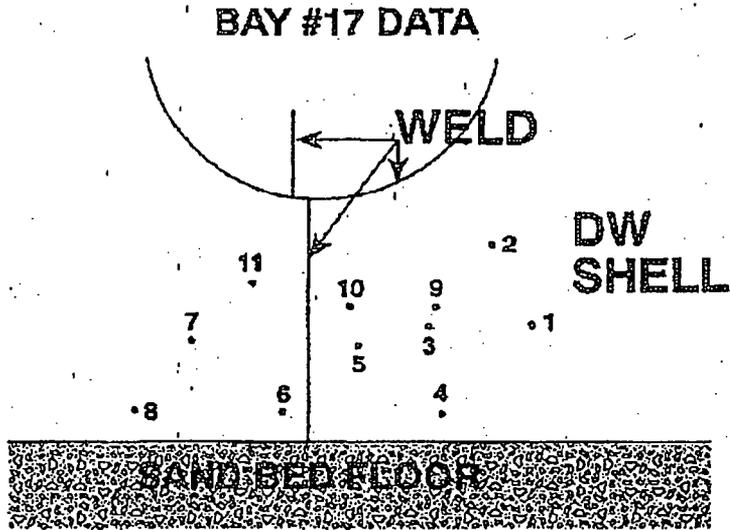
Figure 18

This bay (along with bay 19) provided the first glimpse of the conditions of the drywell shell. The most remarkable feature of this bay was the presence of the bathtub ring 8 to 10 inches wide that was located 8 to 10 inches below the vent tube reinforcement plate. UT spots # 1,3,5 and 7 are located in this band which is the most corroded area in this bay. Spots # 1 through 8 were ground carefully to minimize loss of good metal. Spots # 9,10 and 11 were ground flat and most likely removed good metal. The reinforcement bar sleeves were corroded, but not perforated. The concrete floor was unfinished with no sign of a drainage channel.

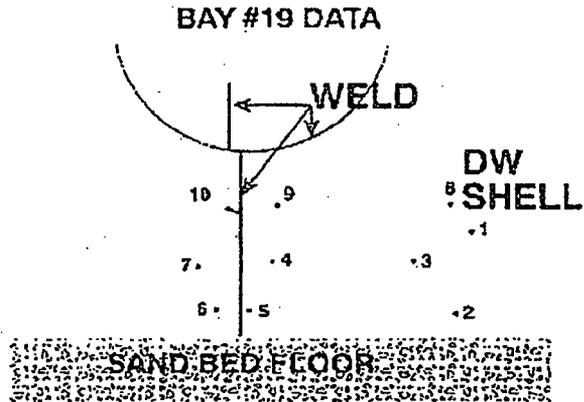
Figure 19

The physical condition of this bay was similar to bay 17 except that UT spots 1 through 7 were ground carefully to minimize loss of good metal, whereas spots 8, 9 and 10 were ground flat.
