March 19, 2008

Subject: Non Destructive Examination Summary of Pressurizer Safety Nozzles Removed from Service at Port St Lucie Unit 1

INITIAL EXAMINATION OF PORT ST LUCIE UNIT 1 PRESSURIZER SAFETY NOZZLES

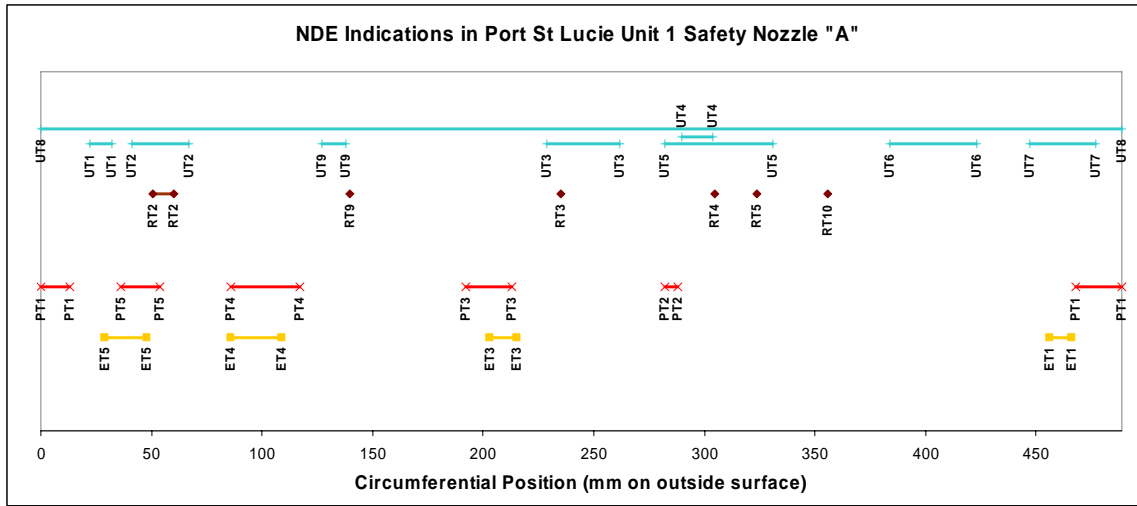
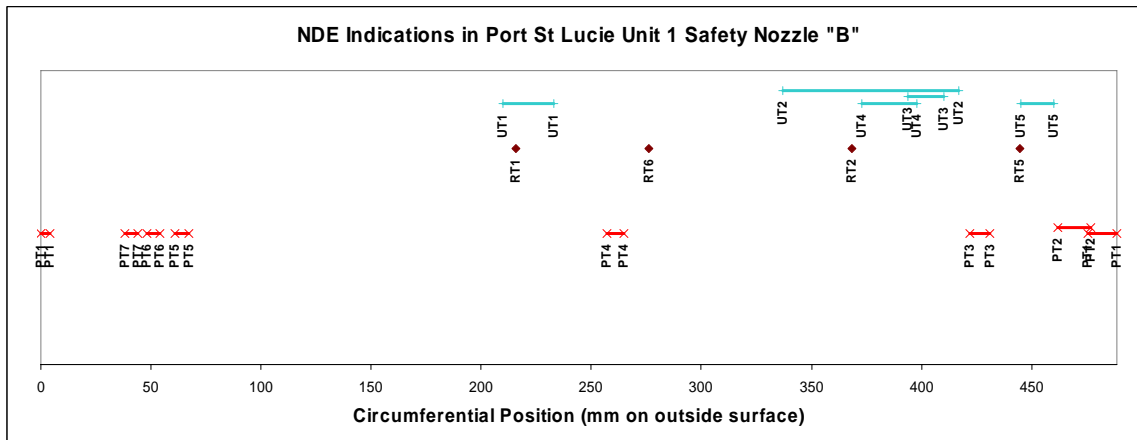
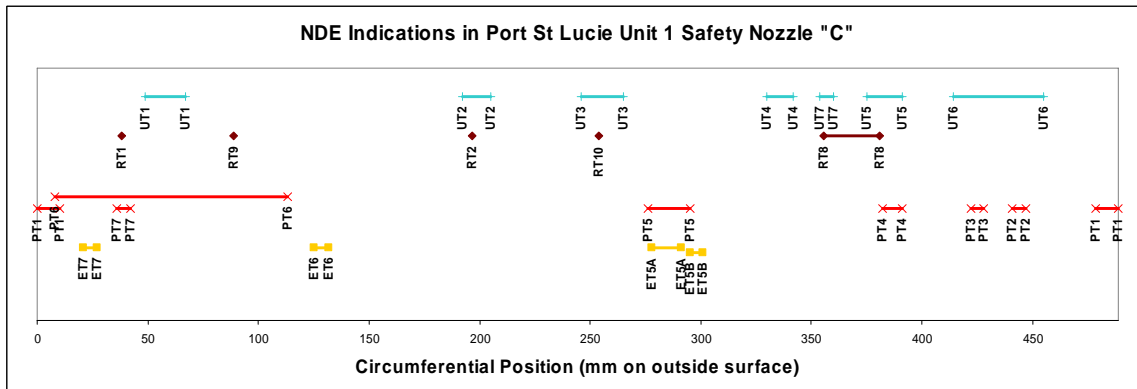
Figure 1. Comparison of all NDE results for PSL safety nozzles A, B, and C.

Nine indications were reported in nozzle A, five in nozzle B, and seven in nozzle C. All indications were attributed to subsurface flaws resulting from the fabrication process. All were characterized as embedded flaws that are adequately separated from both the inside and outside surfaces of the nozzle. Many additional responses from embedded reflectors were observed but were below the amplitude threshold for reporting indications, as defined in the examination procedure.

The vendor concluded that the double-wall examination of all three nozzles revealed no inside surface connected indications indicative of stress corrosion cracking. Embedded flaws indicative of fabrication defects were detected in all three welds.

Four circumferential linear indications were identified in nozzle A. They range in length from 0.25 to 0.46 inch (6.3mm – 12mm). No indications were recorded in nozzle B. Four indications were identified in nozzle C; they lacked definitive characteristics of either circumferential or axial orientation, and were identified as surface blemishes.

A graphical summary of the comparison is presented in Figure 1. The results of the two volumetric methods, UT and RT, should be compared to each other for assessment of indications obtained throughout the material. The results of ET and PT should be compared to each other for assessment of inside surface conditions. The vertical positions of the indications in Figure 1 are not indicative of the axial position of the indications; a few of the overlapping indications have been staggered vertically for clarity.

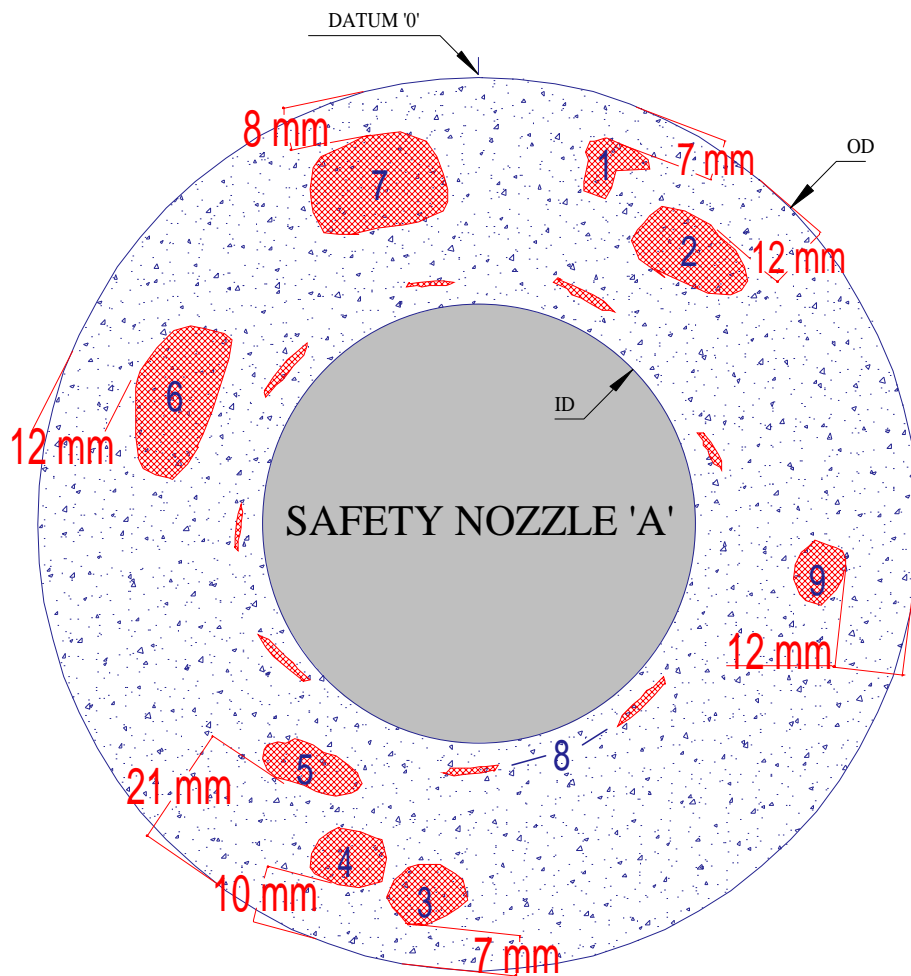
Figure 2. Profile of indications from encoded ultrasonic examination.

The profile of the indications reported from the manual data is shown in Figure 2 (the same profile that had been reported in Reference [4]). The indications that were reported by the encoded UT vendor were overlaid on the manual UT profile as shown in Figure 3. The two profiles are mutually consistent. Some discrepancies may be due to the difficulty of precisely maintaining a constant circumferential position while scanning manually. There are gaps in the encoded UT profile because the vendor reported only those reflectors whose amplitudes exceeded the procedure’s reporting threshold. Many additional reflectors are present in the encoded data and corresponded well with the manual UT measurements, as shown in the side-by-side comparisons in Attachment 8.

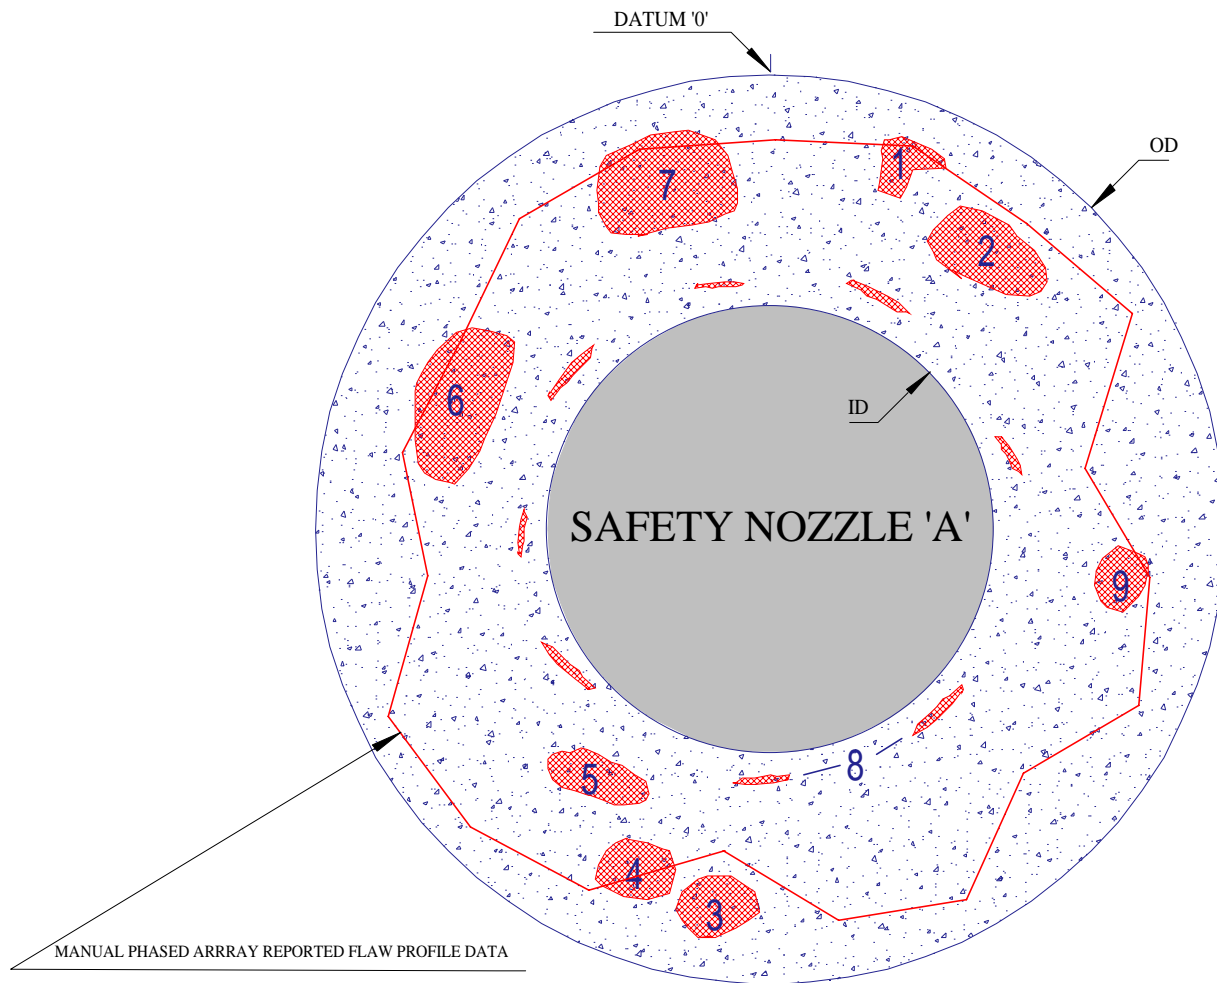
Figure 3. Encoded UT data profile, with manual UT data profile (from MRP 2008-014) overlaid.

The manual UT examiner was provided an opportunity to review the encoded UT data to help develop an understanding of the relative behavior of manual vs encoded examination. After reviewing the encoded data he concurred that the indications represent fabrication defects.
