Issue date: April 28, 2003  
Revision 1

SIL No. 642

## CR105X auxiliary contact failure

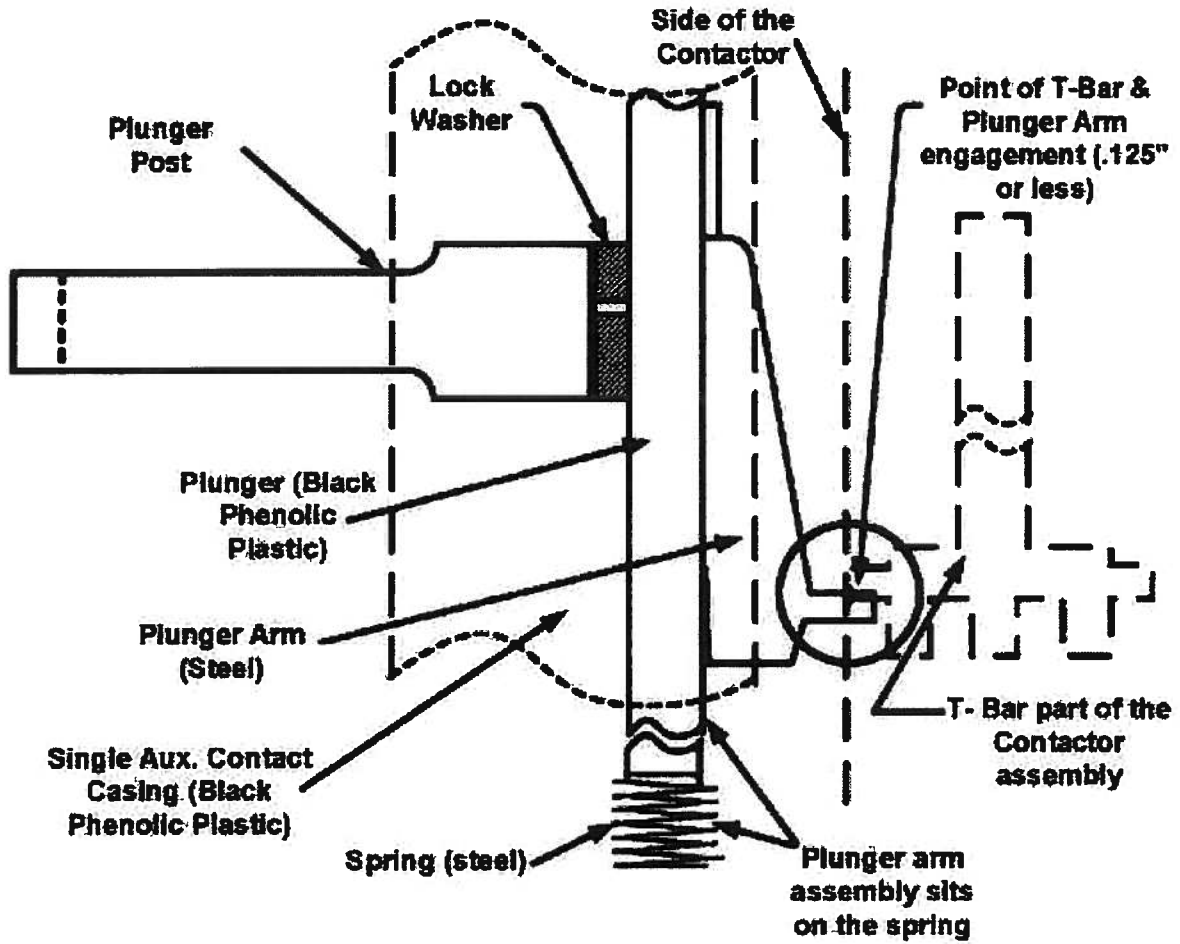
**Figure 1**

Recently at a BWR in the United States, a GE CR105X auxiliary contact failed to change state from the open to closed position. Plant troubleshooting revealed that the CR105X auxiliary contact was stuck in the open position. During repair, the auxiliary contact plunger arm was found disengaged from the T-Bar (see [Figure 1](#)), which caused the failure of the contact to change state. The cause of the disengaged plunger arm and loose plunger post was determined to be a missing #6 lock washer.

CR105X auxiliary contactors have been sold as either kits ([Figures 2 and 3](#)), or as part of an assembly. The CR105X auxiliary contacts sold as kits contain the #6 lock washer; however, the provided installation instructions did not contain guidance on where to install the #6 lock washer or the required torque to the plunger post. Assemblies shipped from the factory containing an auxiliary contact may not have the #6 lock washer installed. The plunger arm may disengage from the T-Bar causing the failure of the contact to change state if the plunger post is not properly torqued or if the #6 lock washer is not installed. There should be no gap between the steel plunger post and phenolic plunger (see [Figure 1](#)).

1. Visually verify that the #6 lock washer is installed between the plunger post and the plunger. There should be no gap between them.
2. If the #6 lock washer is missing, either install a new #6 lock washer or replace the auxiliary contact with a new one containing a #6 lock washer.
3. If the plunger arm is determined to be loose, tighten the plunger post to 4-7 in-lbs.
