***Pre-Decisional  
Enforcement  
Conference***

***May 19, 2008***

***Global Nuclear Fuel - Americas***

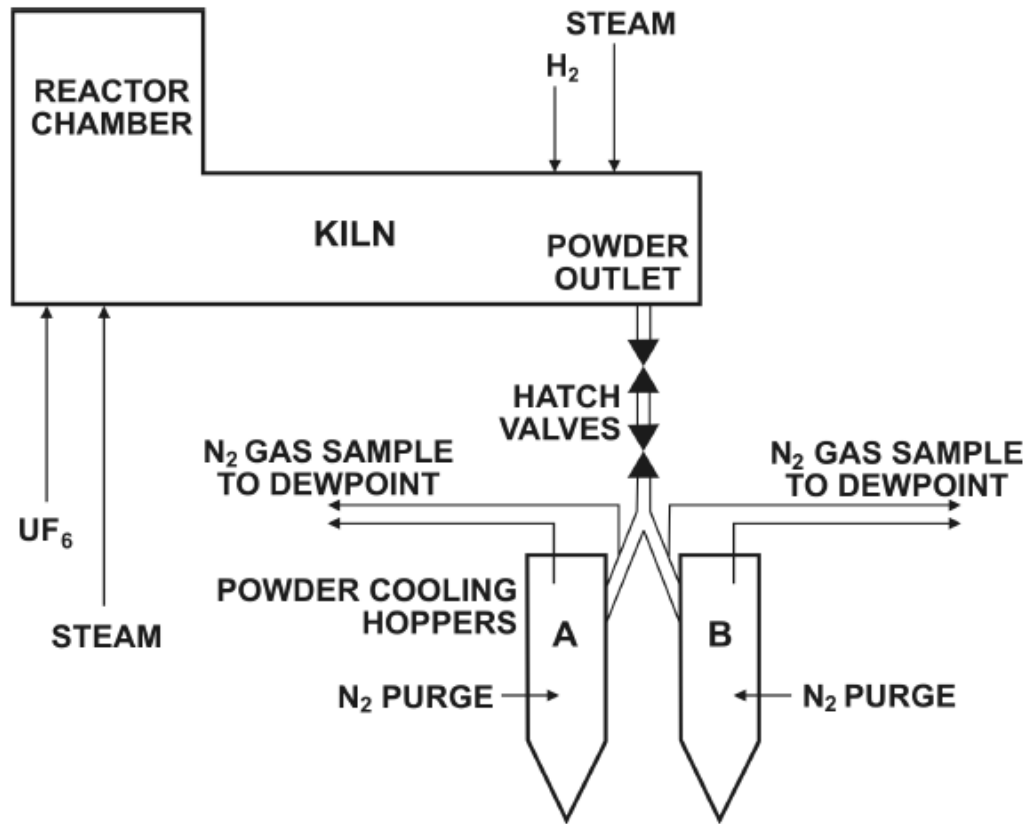
Figure 1

Conversion Reactor/Kiln and Cooling-Hopper Equipment Arrangement

During post-maintenance verification on the hatch valves, the operator identified that cycling the hatch valves resulted in elevated moisture levels. This discrepancy was reported to the Controls Engineer who confirmed the problem by observing two additional cycles. The Area Engineer directed that the system be secured in preparation for troubleshooting. Misalignment was discovered upon removing actuator.

Steam was only applied to the system during cycling of the hatch valves.
