**TENNESSEE VALLEY AUTHORITY  
BROWNS FERRY NUCLEAR PLANT (BFN)  
UNIT 2**

**EVALUATION OF DISSIMILAR METAL WELD INDICATION AT WELD RCRD-2-52**

WCAP-16845-NP  
Revision 0

# **Metallurgical Investigation of Recorded Indications at the Check Valve to Pipe Dissimilar Metal Weld at Browns Ferry Unit 2 Nuclear Generating Station**

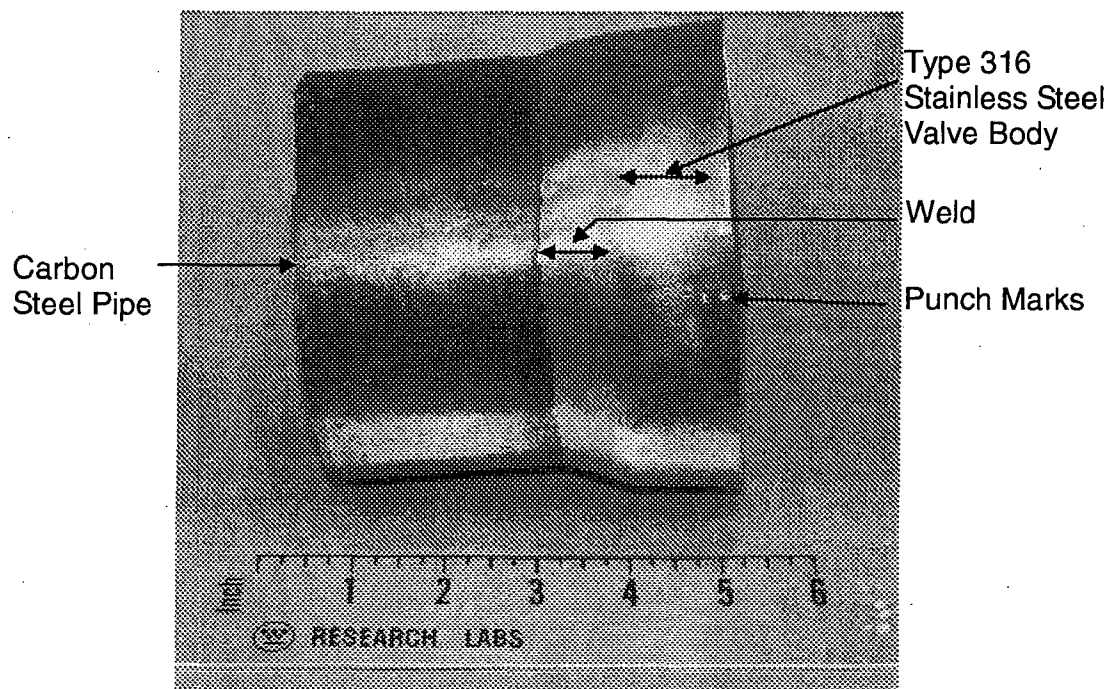
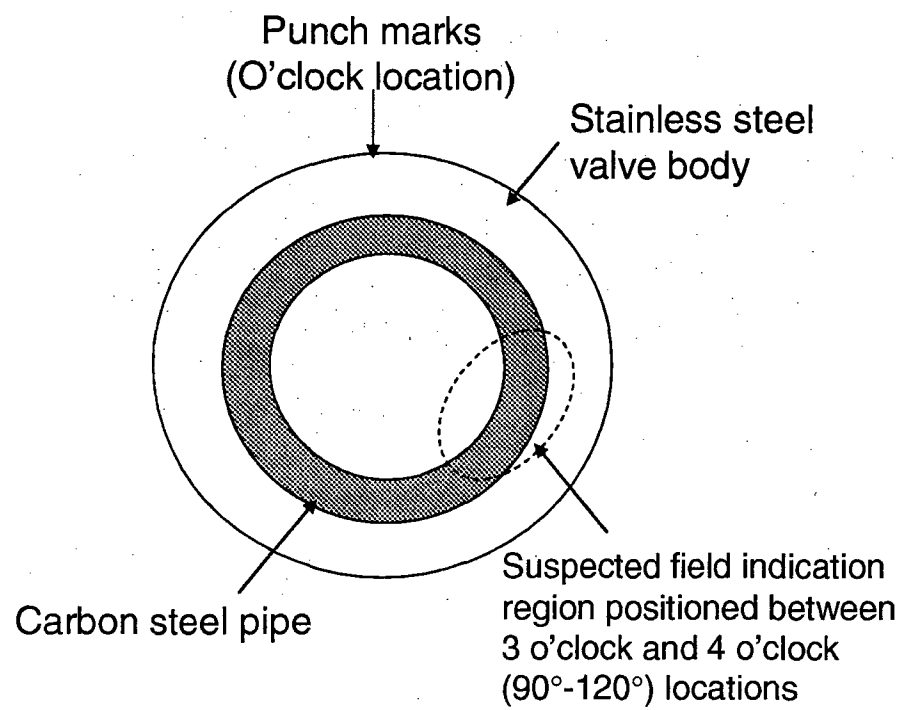
**Figure 1 Schematic Representation of the Geometry of As-received Sample Showing the Location of Suspected Field Indication**

The results of the surface examination of the pipe weld sample in the as-received condition are illustrated in Figures 1 through 6. Figure 1(a) shows the appearance of the as-received sample with punch marks made in the field for referencing the field indication. Figure 1(b) is a schematic representation of the sample showing the location of the field indication, looking from the pipe into the valve body.

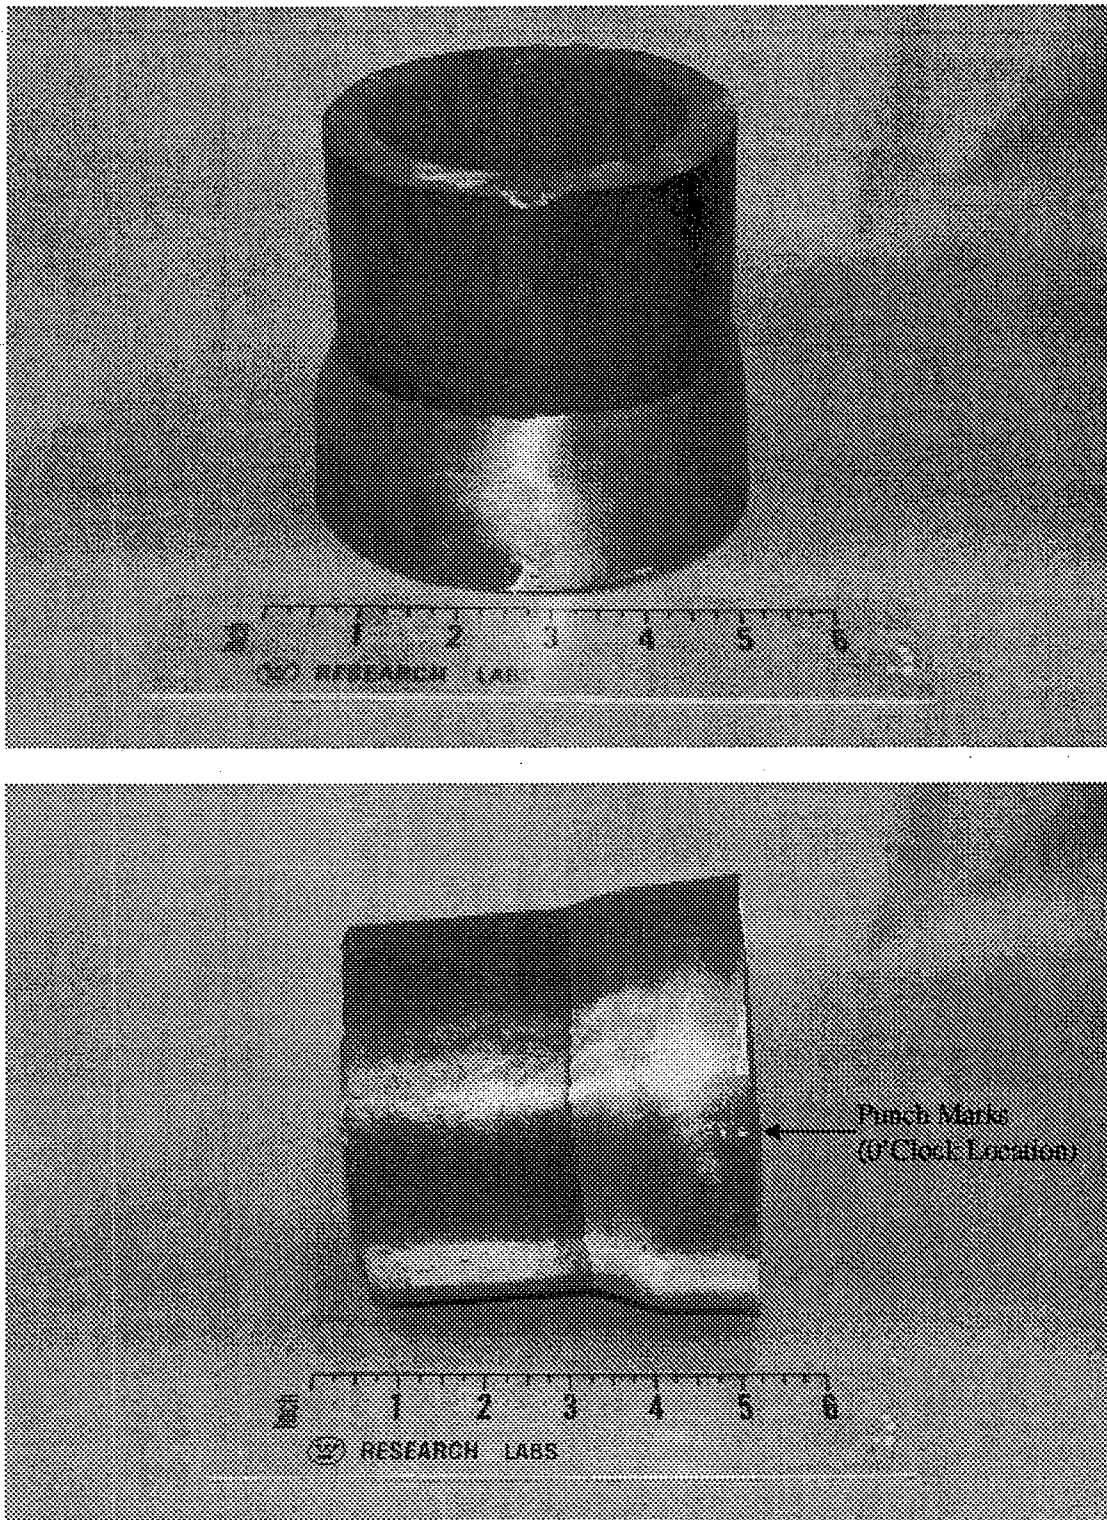
The outside diameter (OD) surface appearance of the pipe weld sample in the as-received condition is illustrated in Figures 2 and 3. The surface appeared smooth with no evidence of cracking, corrosion or any mechanical distress. The punch marks seen on the OD surface on the valve side corresponds to the 12 o'clock location or top dead center. (The valve and pipe were oriented horizontally.) Figures 4 through 6 illustrate the inside diameter surface appearance of the pipe to valve weld. The caliper pointers show the position of the suspected UT indication recorded at the site. Several important observations can be made from the ID surface examination results: the weld root pass appeared irregular and of non uniform thickness; the circumferential machining marks in the counter bore region of the carbon steel pipe appeared to be deep and significant; and the carbon steel counter bore region adjacent to the weld showed evidence of significant pitting (Figure 6). Another important observation from Figure 6 is the presence of a circumferential crack in the carbon steel adjacent to the weld interface. These observations suggested potential deviations from the normally expected conditions associated with the welding process.

**Figure 2 Side Views Showing the OD Surface Condition of the As-received Sample**

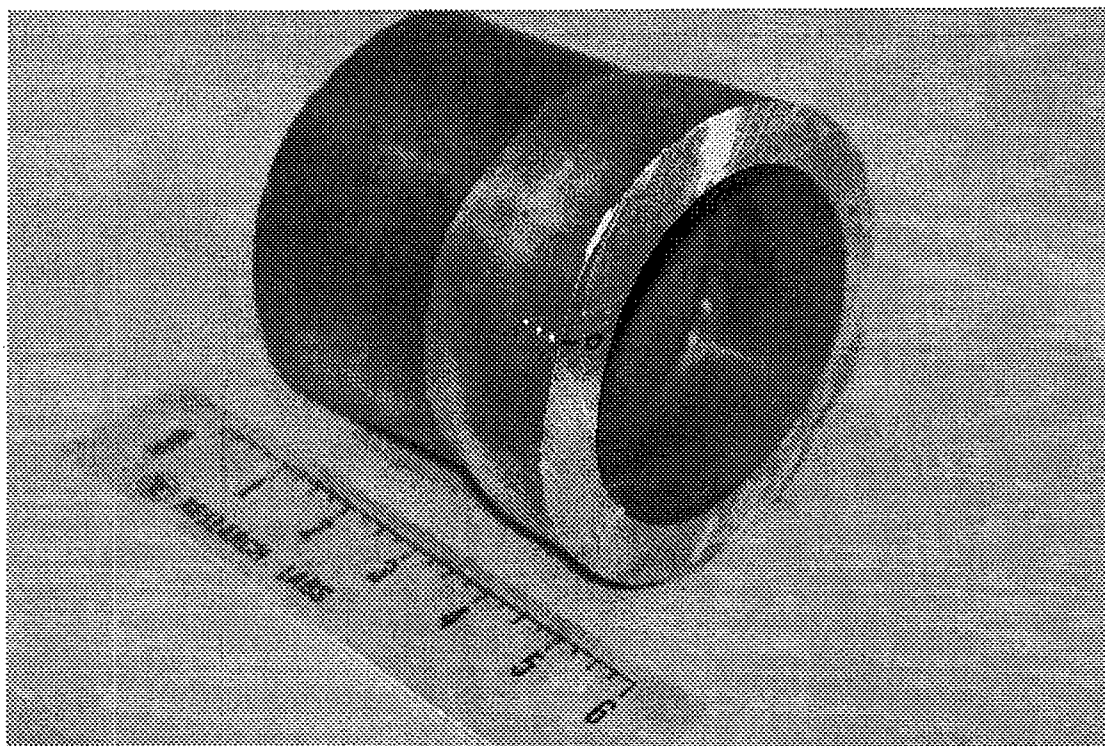
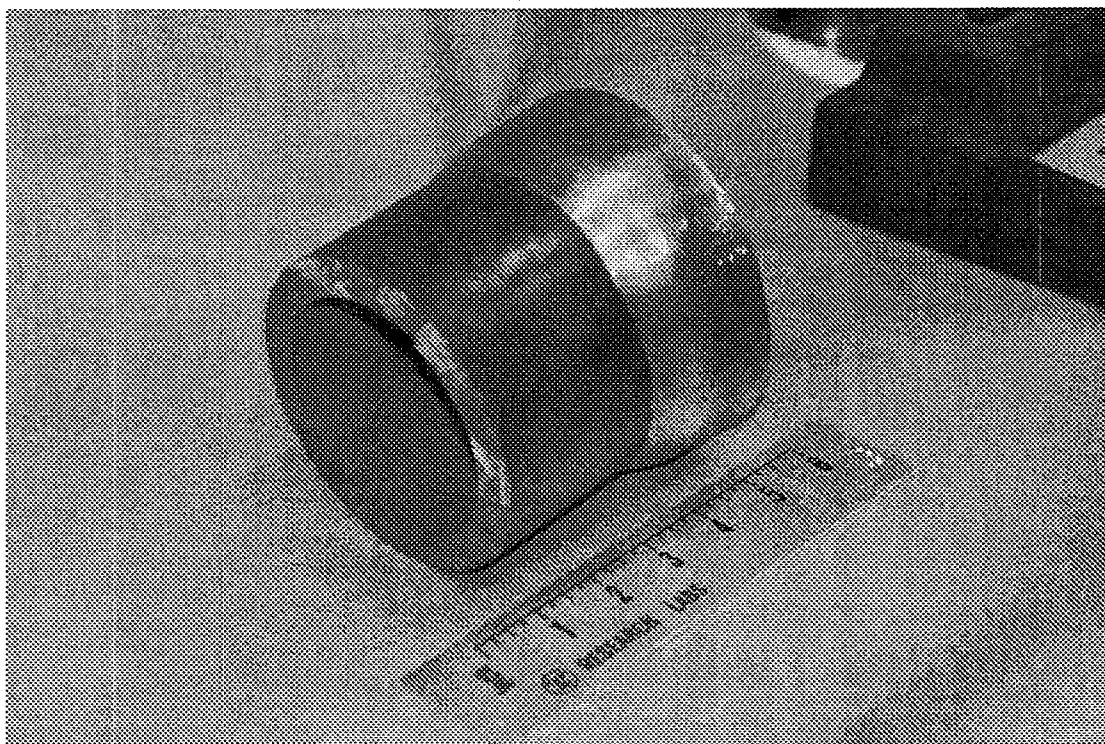
**Figure 3** Side Views Showing the OD Surface Condition of the As-received Sample – Punch Marks at 0’Clock Location of Valve Body can be Seen

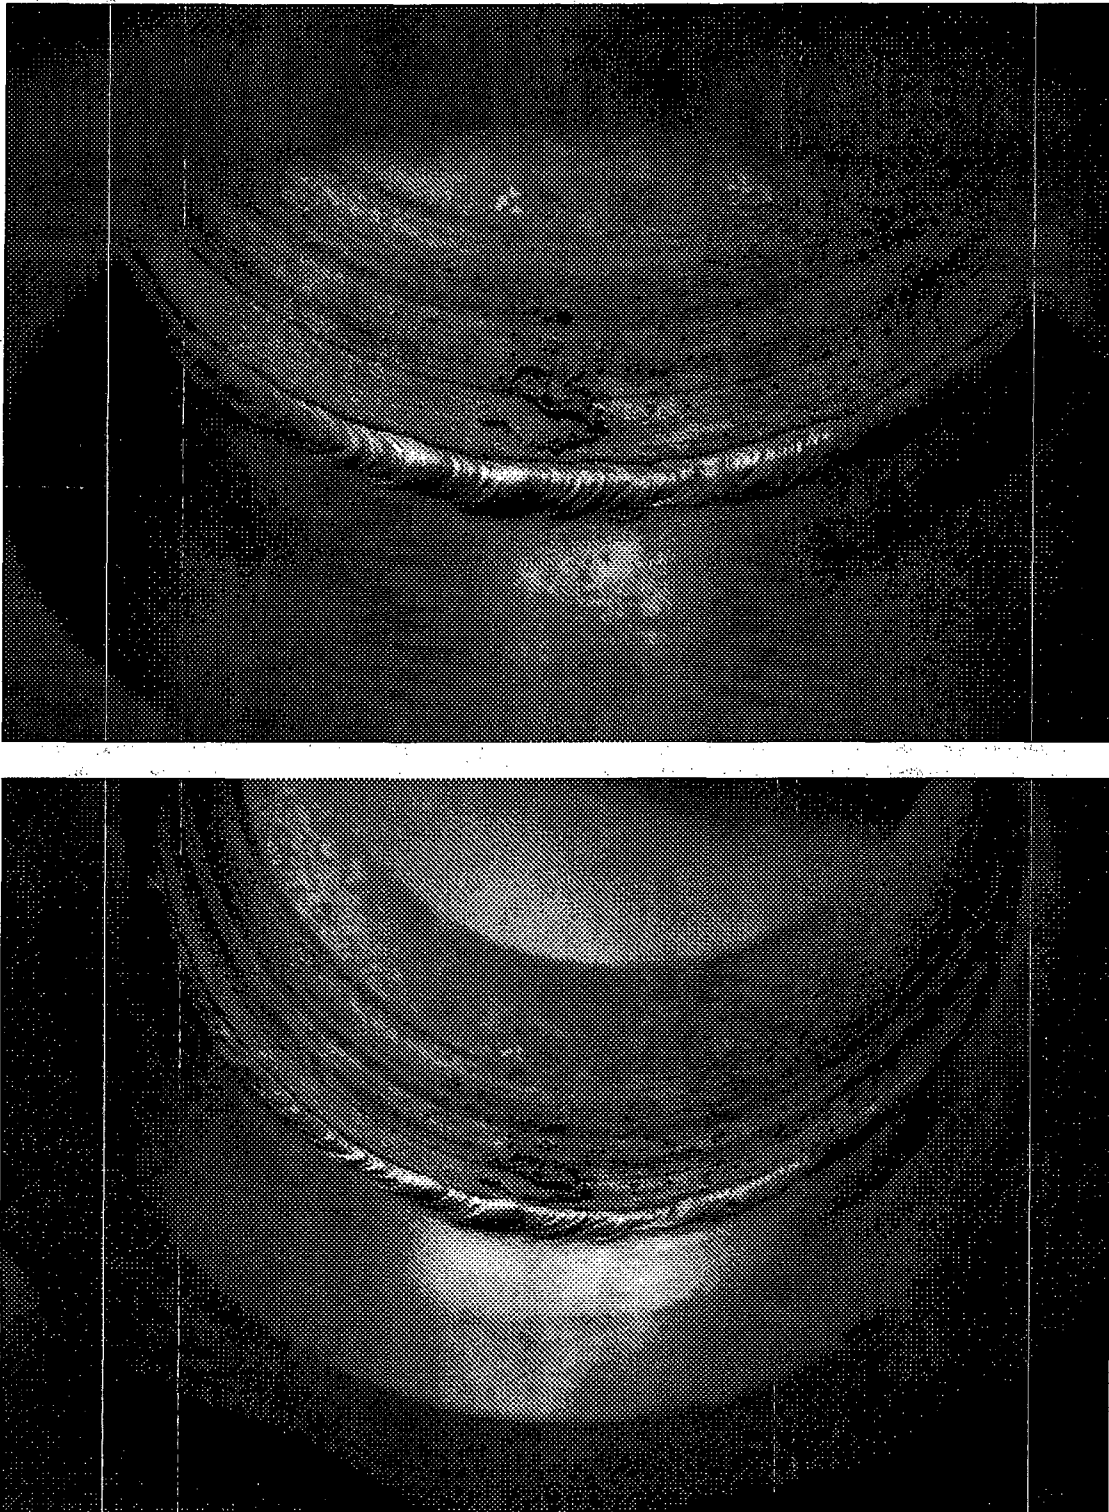
TVA's in-service inspection reported that an indication was recorded between 90° and 120° (3 o'clock and 4 o'clock) orientations in the weld at the ID, looking from the pipe side in to the valve. Detailed surface examinations by light optical microscopy and dye penetrant tests failed to confirm the reported ID surface indication at the 90 to 120 degree location. The Westinghouse NDE examination procedures were then extended on to the entire weld sample by employing fluorescent dye penetrant (PT), Radiographic (RT) and Ultrasonic (UT) examination techniques. A brief summary of the NDE procedures and the results is summarized in the Attachment 'A' of the report. The RT examination results of the 90 to 120 degree segment are illustrated in Figures 7 through 10. Although PT examination failed to reveal any indications, volumetric examinations by UT and RT confirmed the presence of at least two indications at the suspected field indication location. The fluorescent dye penetrant examination results of the remaining ID surface are illustrated in Figure 10. PT indications were recorded at several isolated regions around the circumference.

**Figure 4 Appearance of the ID Surface Condition of the Weld in the As-received Sample**

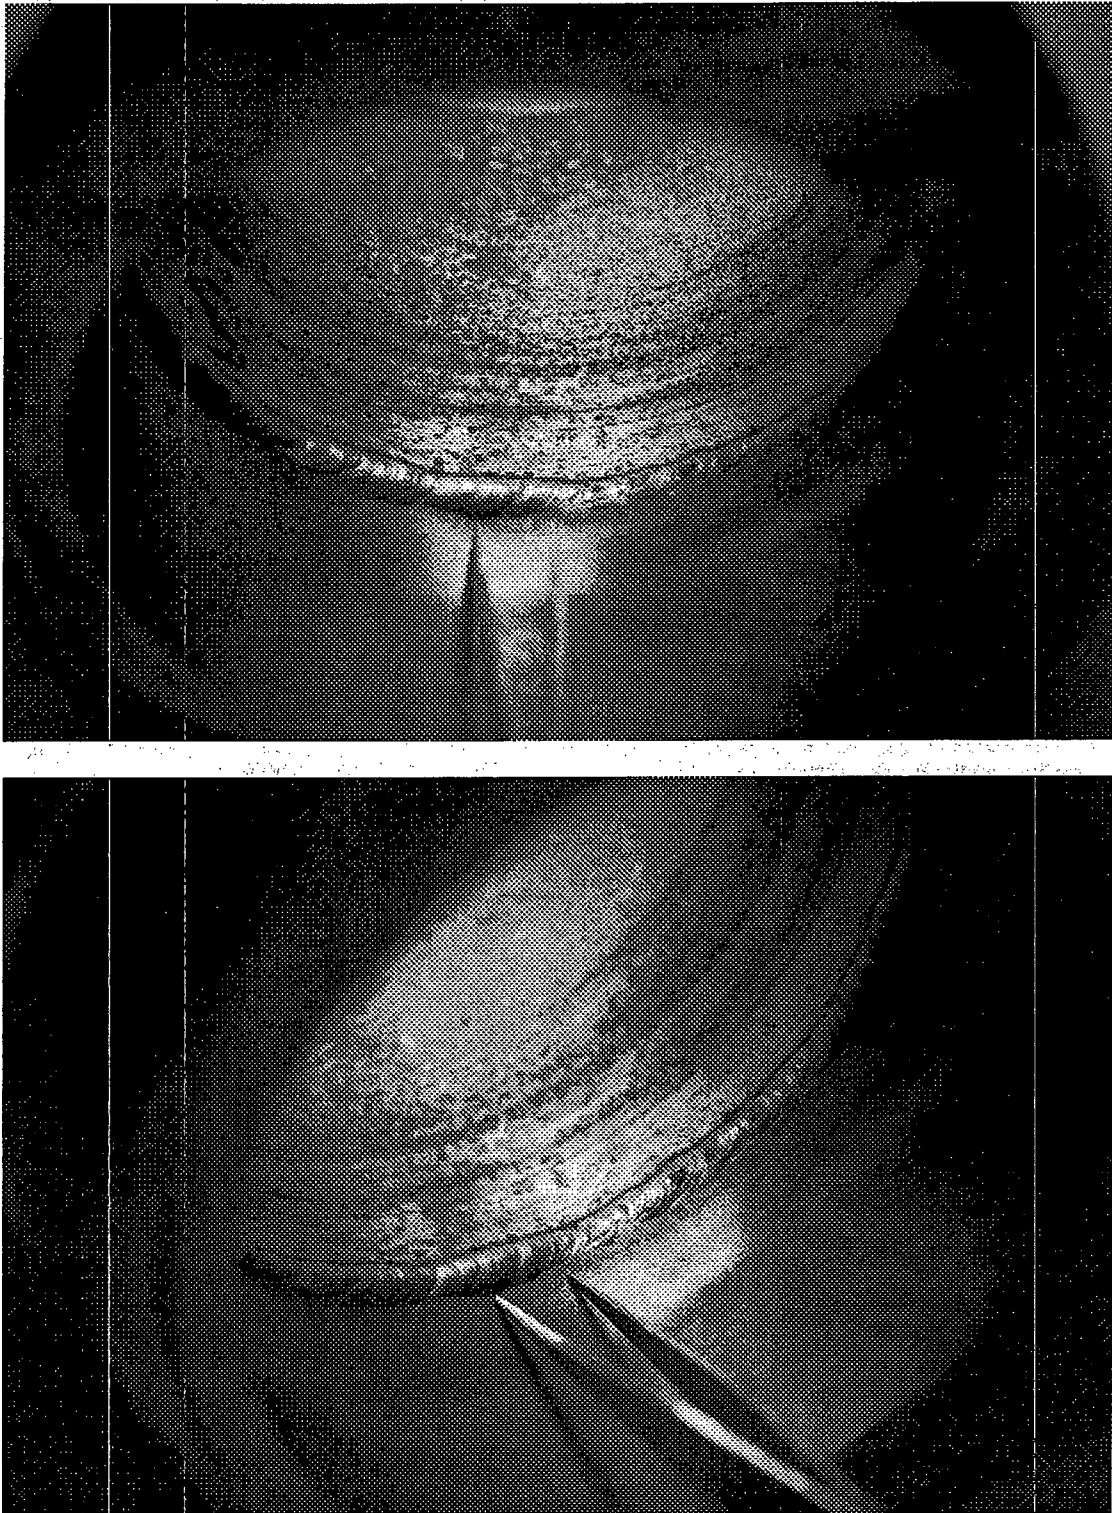
**Figure 5** ID Surface Condition of the Weld in the As-received Sample – The Caliper Points to the Region Corresponding to 4 to 6 o'clock Location where Suspected UT Indication was Reported by Site Personnel

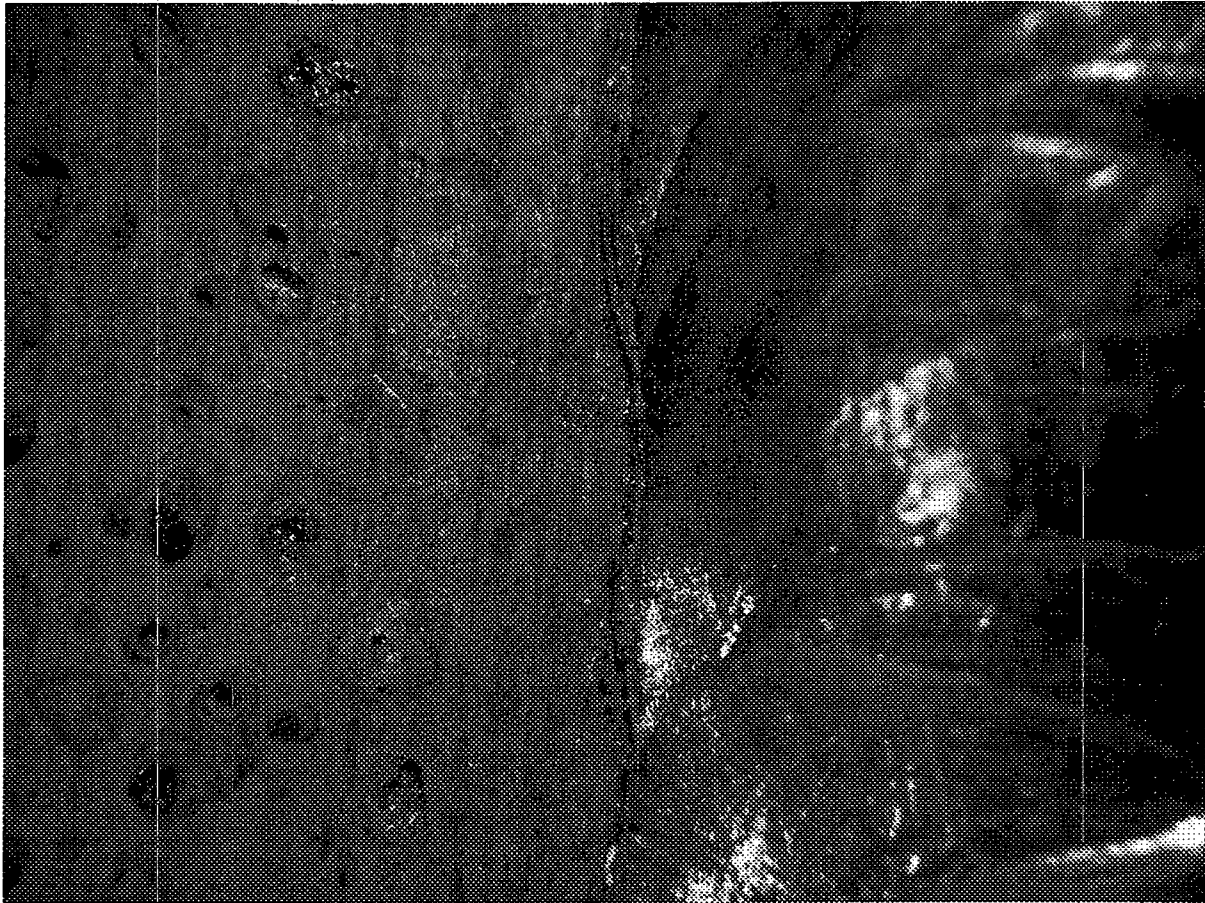
The metallographic examinations suggested that cracking was initiated on the ID surface at the weld interface where an unusually sharp geometric discontinuity due to excessive root bead penetration was present. The initiation of isolated cracks at multiple locations around the circumference suggested that residual stress conditions associated with the weld may have played a role in the cracking. The metallographic examinations revealed that the crack progression occurred both in the carbon steel as well as in the Type 309 stainless steel weld metal dilution zone immediately adjacent to the interface where resistance to oxidation is minimized due to the chromium depletion and/or other dilution affects in the mixing zone. The presence of heavy oxide deposits at the crack mouth as well as within the cracks, all

**Figure 6** ID Surface Appearance of the Weld at the Carbon Steel Interface – Note the Presence of Pitting in the Carbon Steel at the Weld Heat Affected Zone and Cracking at the Weld Interface

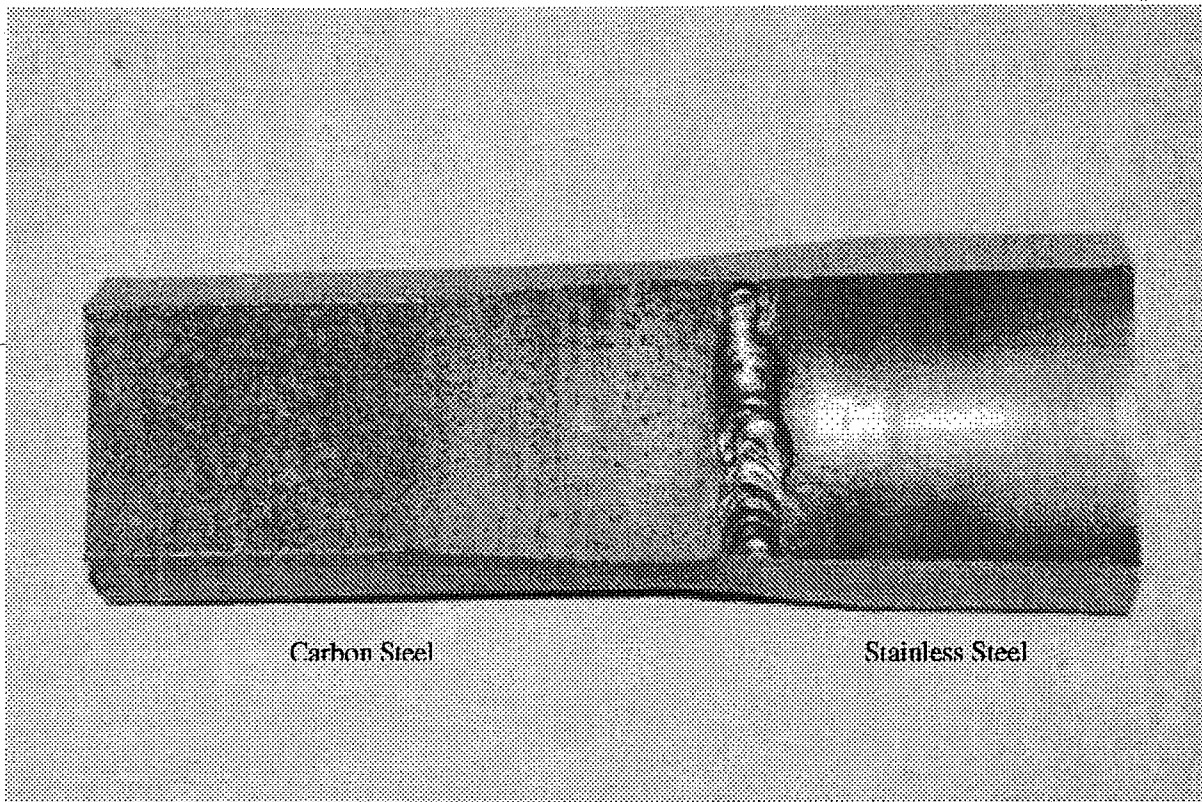
**Figure 7 Image of the Inside Surface of the 90°-120° Segment**

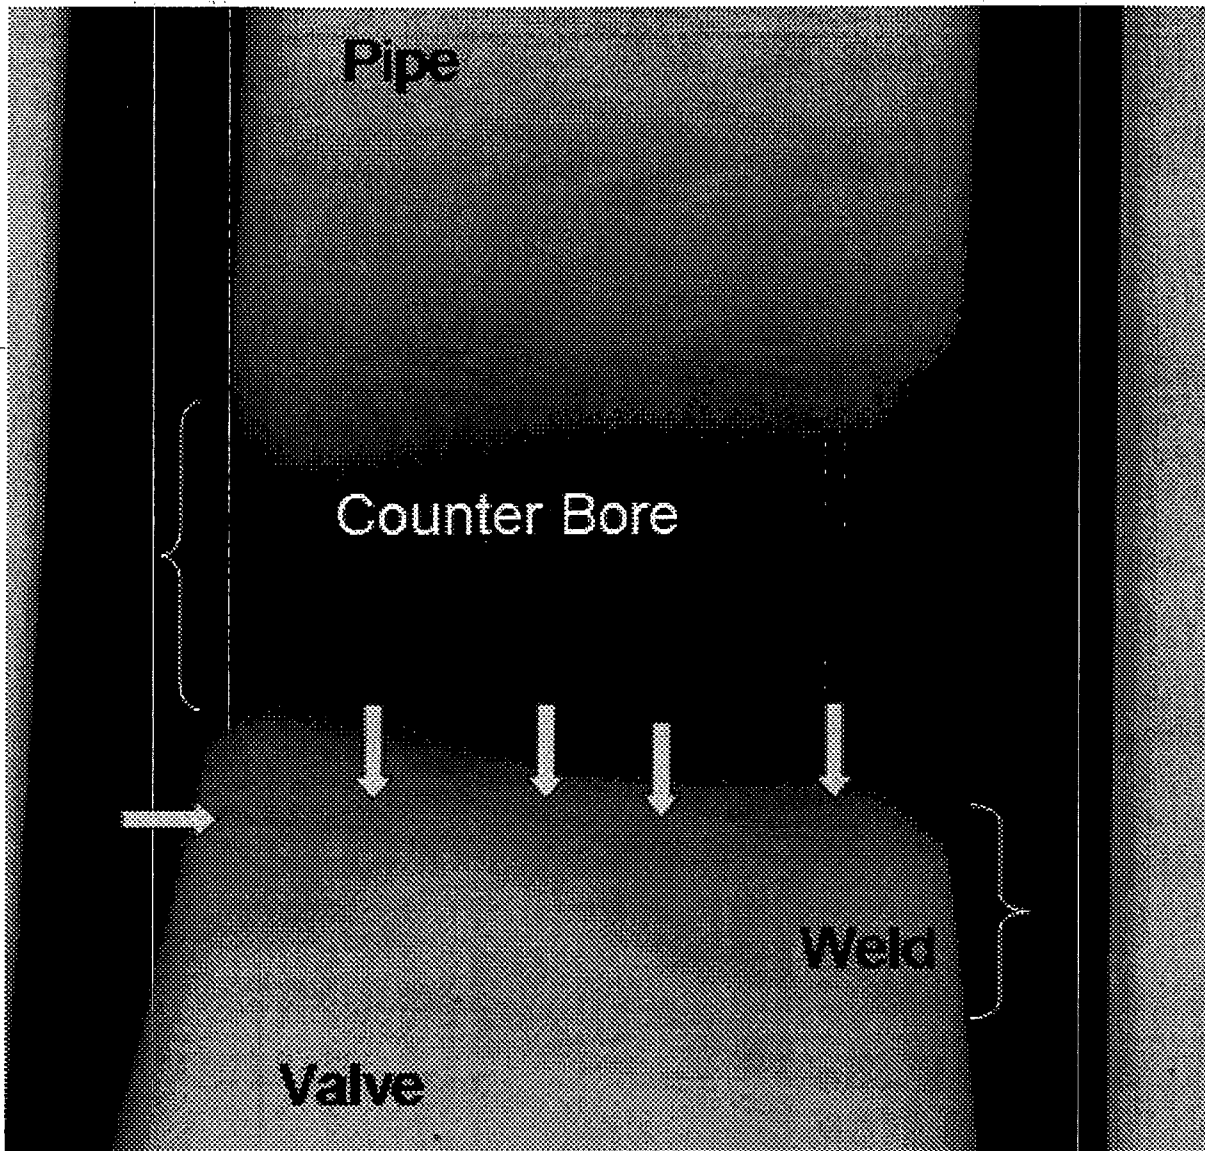
**Figure 8** Digitized Radiograph of the Section of Pipe-Valve Weld Assembly Corresponding to the Indications Found in the Field Ultrasonic Examination – Note the radiograph was taken with the id of the assembly against the film. The arrows show the locations of the radiographic indications.

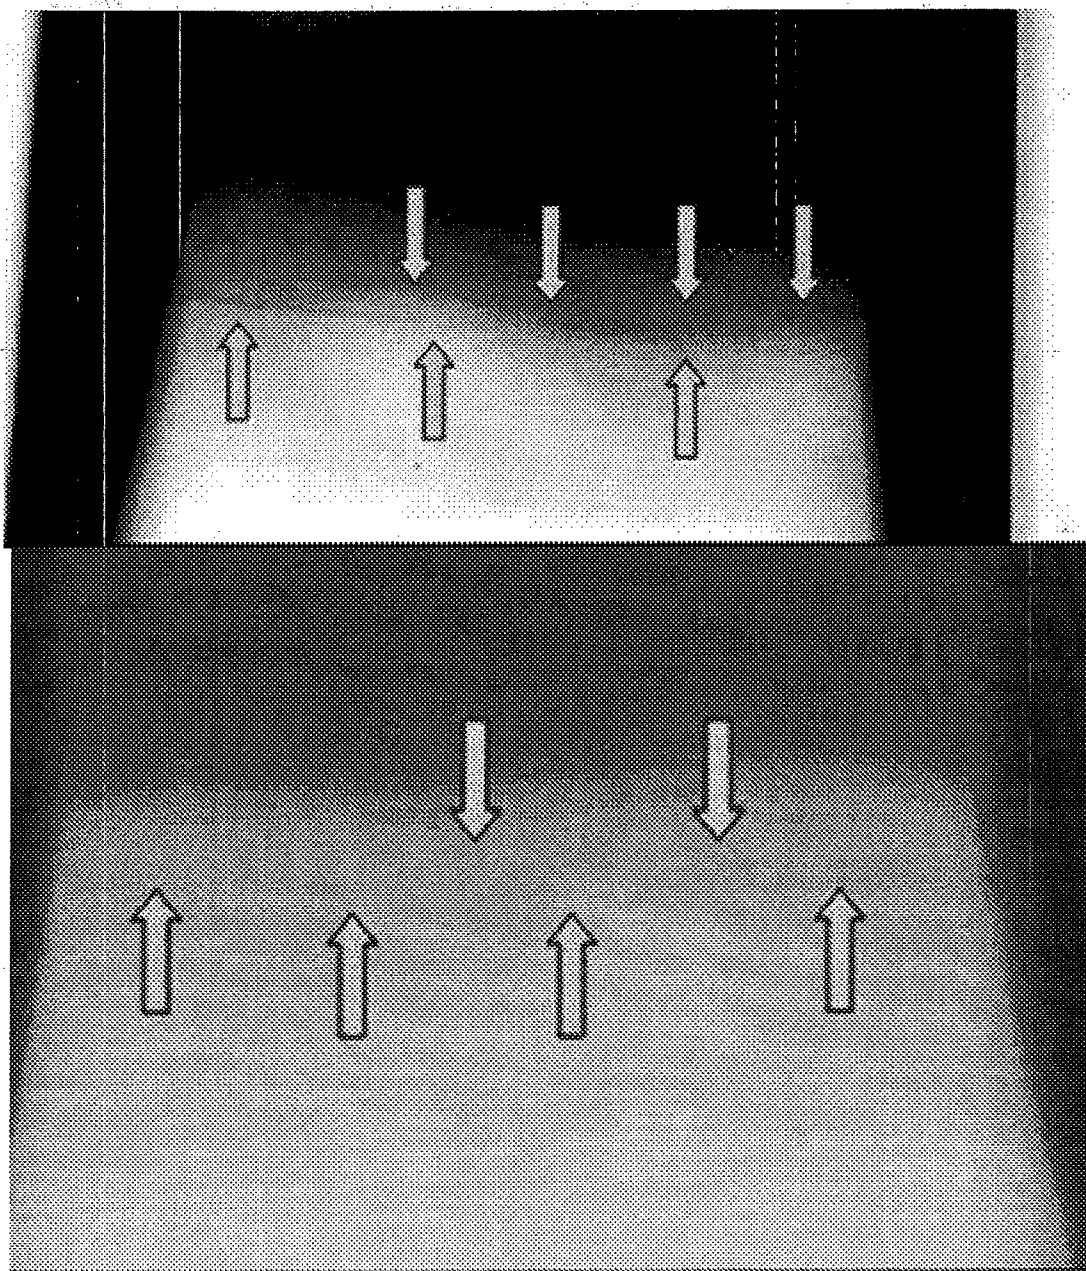
**Figure 9** Enhancement of the X-ray Radiographs in the Vicinity of the weld – Upper image is from the image in Figure 8 while the lower is for a radiograph taken with the II of the component away from the film. The arrows show the location of the radiographic indications.

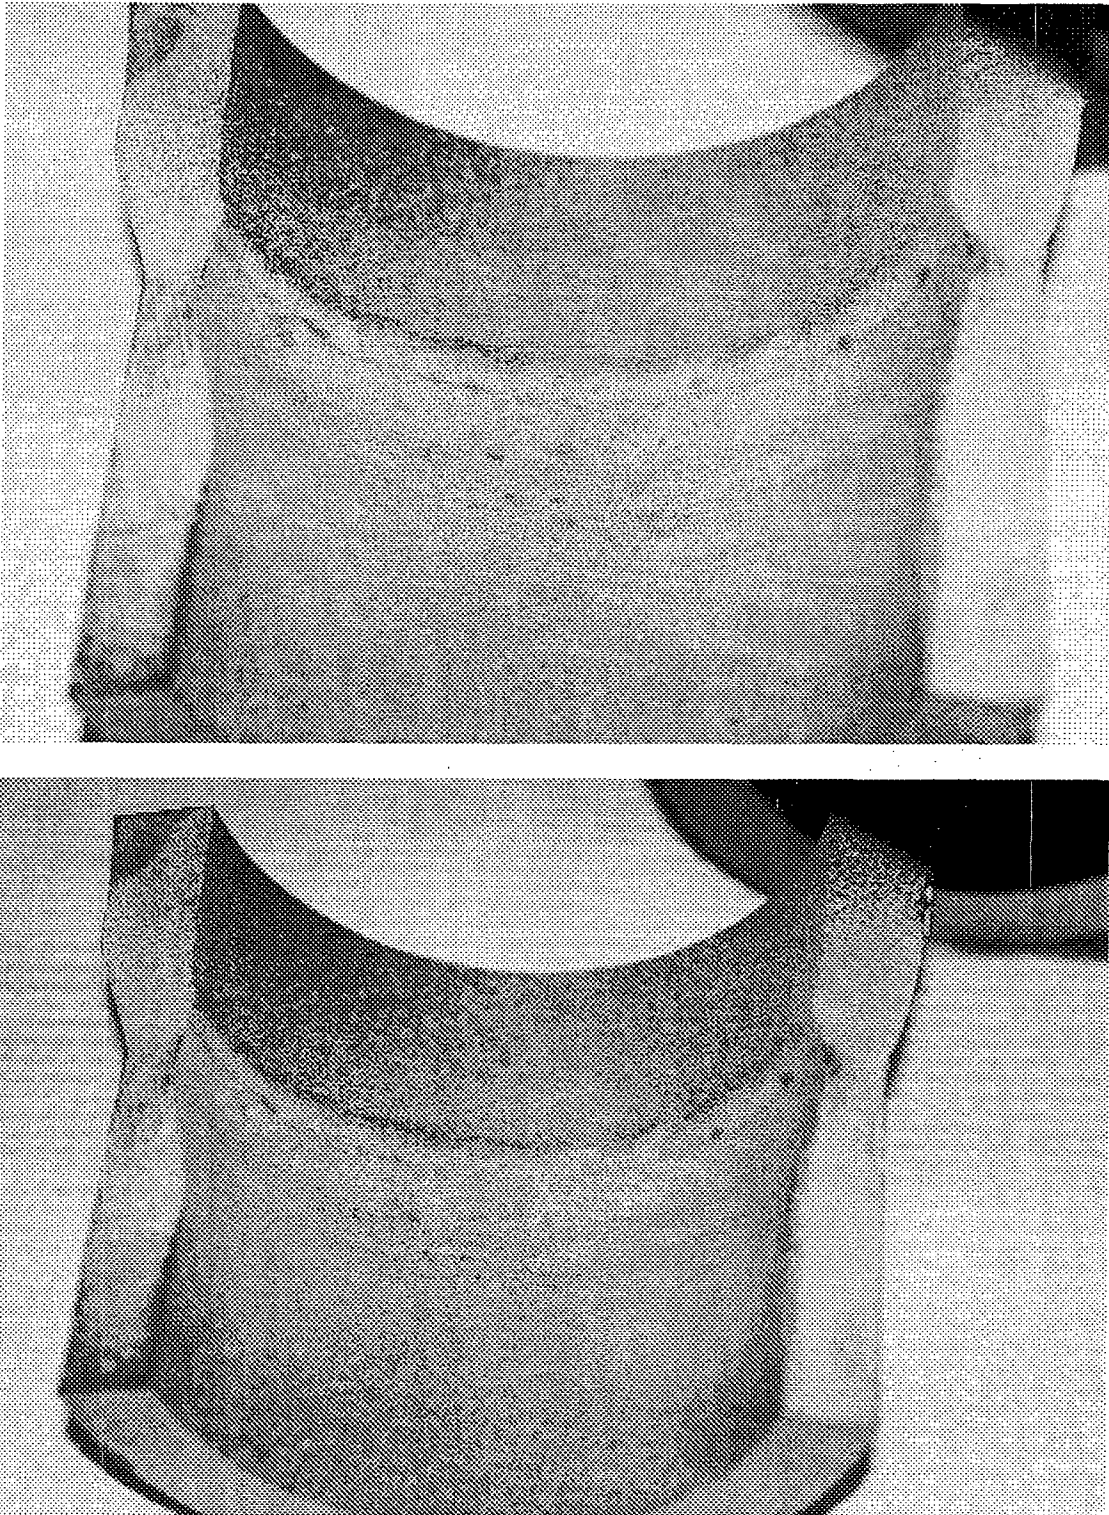
**Figure 10** Fluorescent Dye Penetrant Examination Results of the ID Surface of the Pipe to Valve Weld Sample

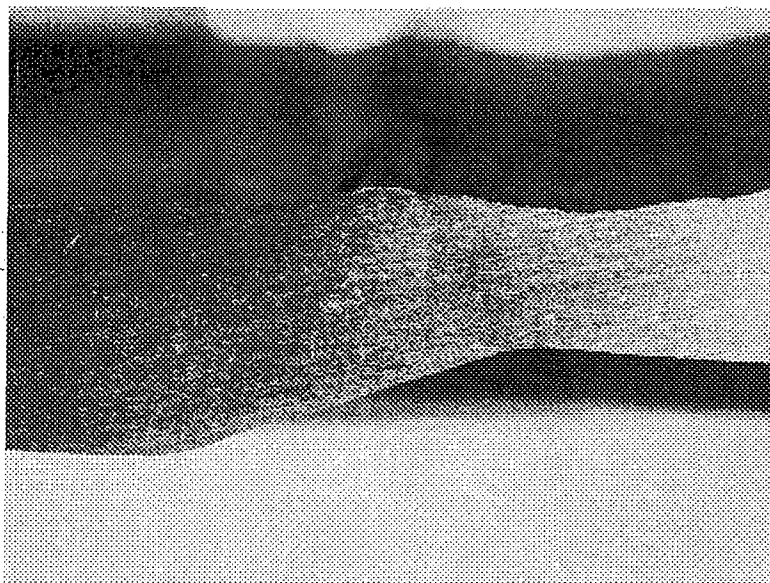
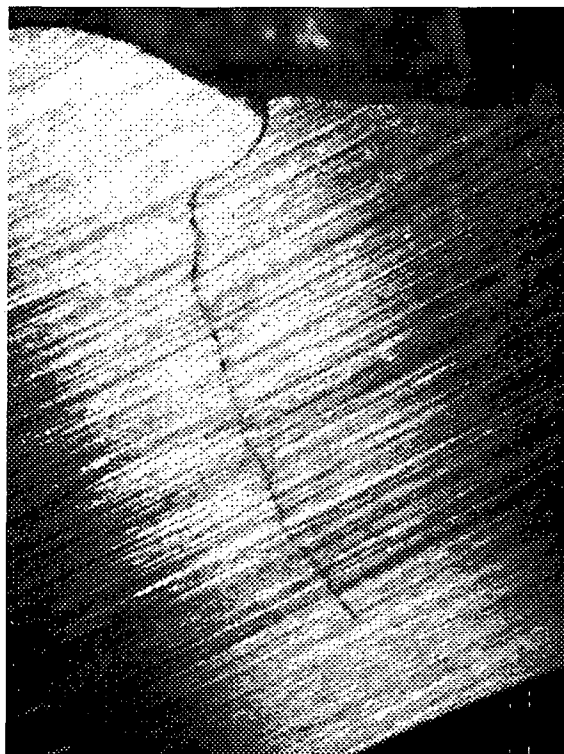
**Figure 13** Appearance of 270° Axial Cut Face Revealing the Presence of 80% Through Wall Crack (B2A Segment)

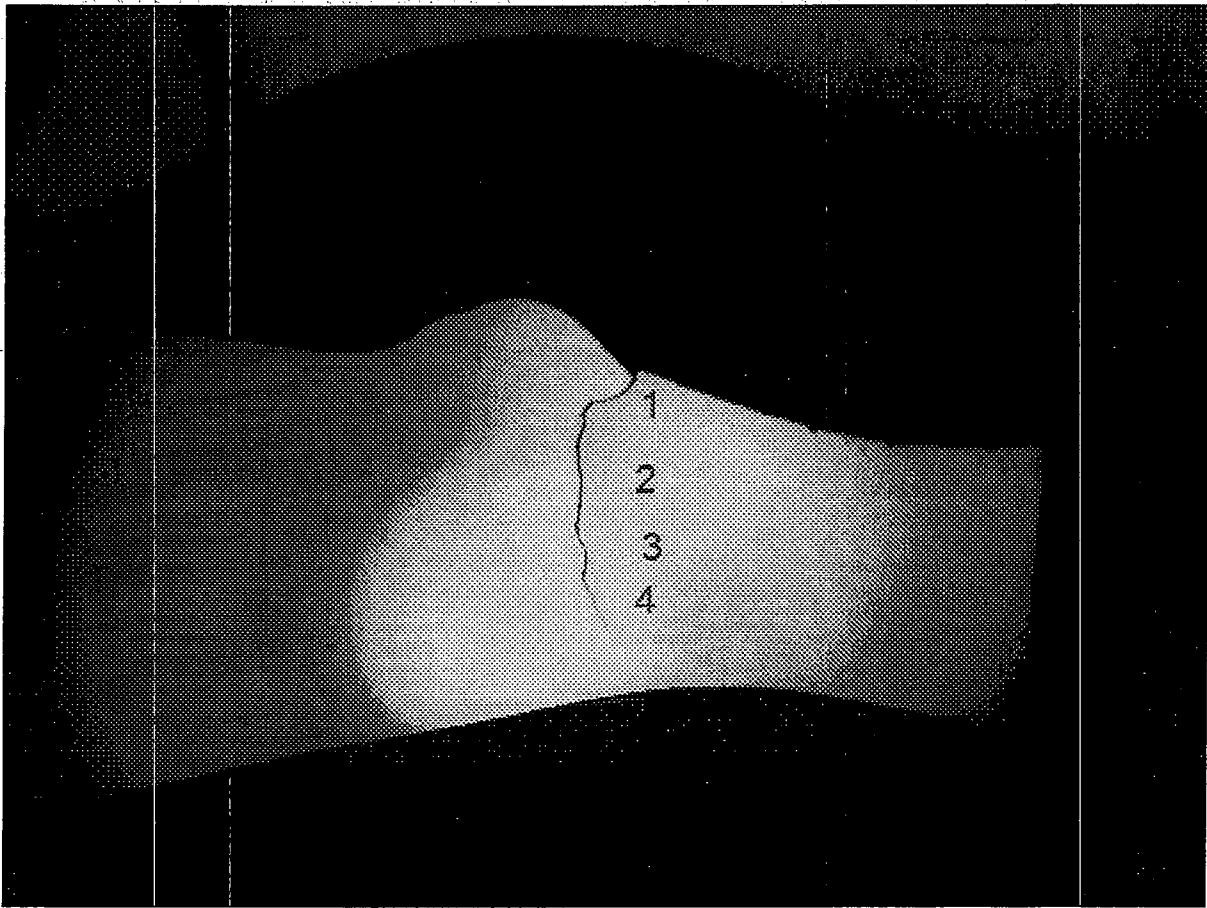
**Figure 14** Metallography Results in the As-polished Condition of Axial Section at 270° Orientation Showing the Deepest Crack at the Carbon Steel Interface

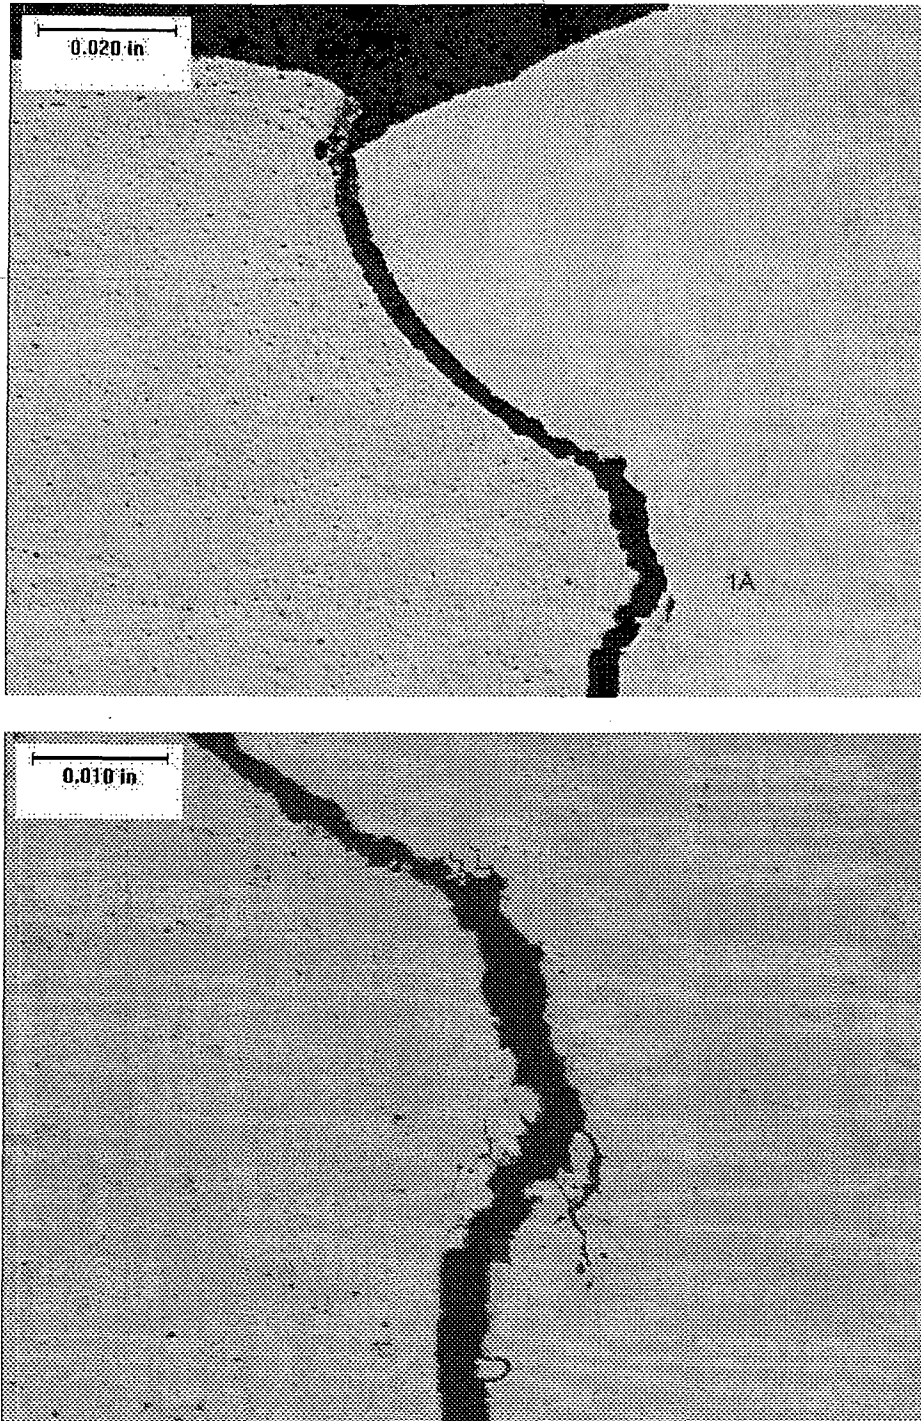
**Figure 15** Metallography Results in the As-polished Condition of 270° Section Illustrating the Morphology of Crack in the Weld Metal (Specimen B2A)

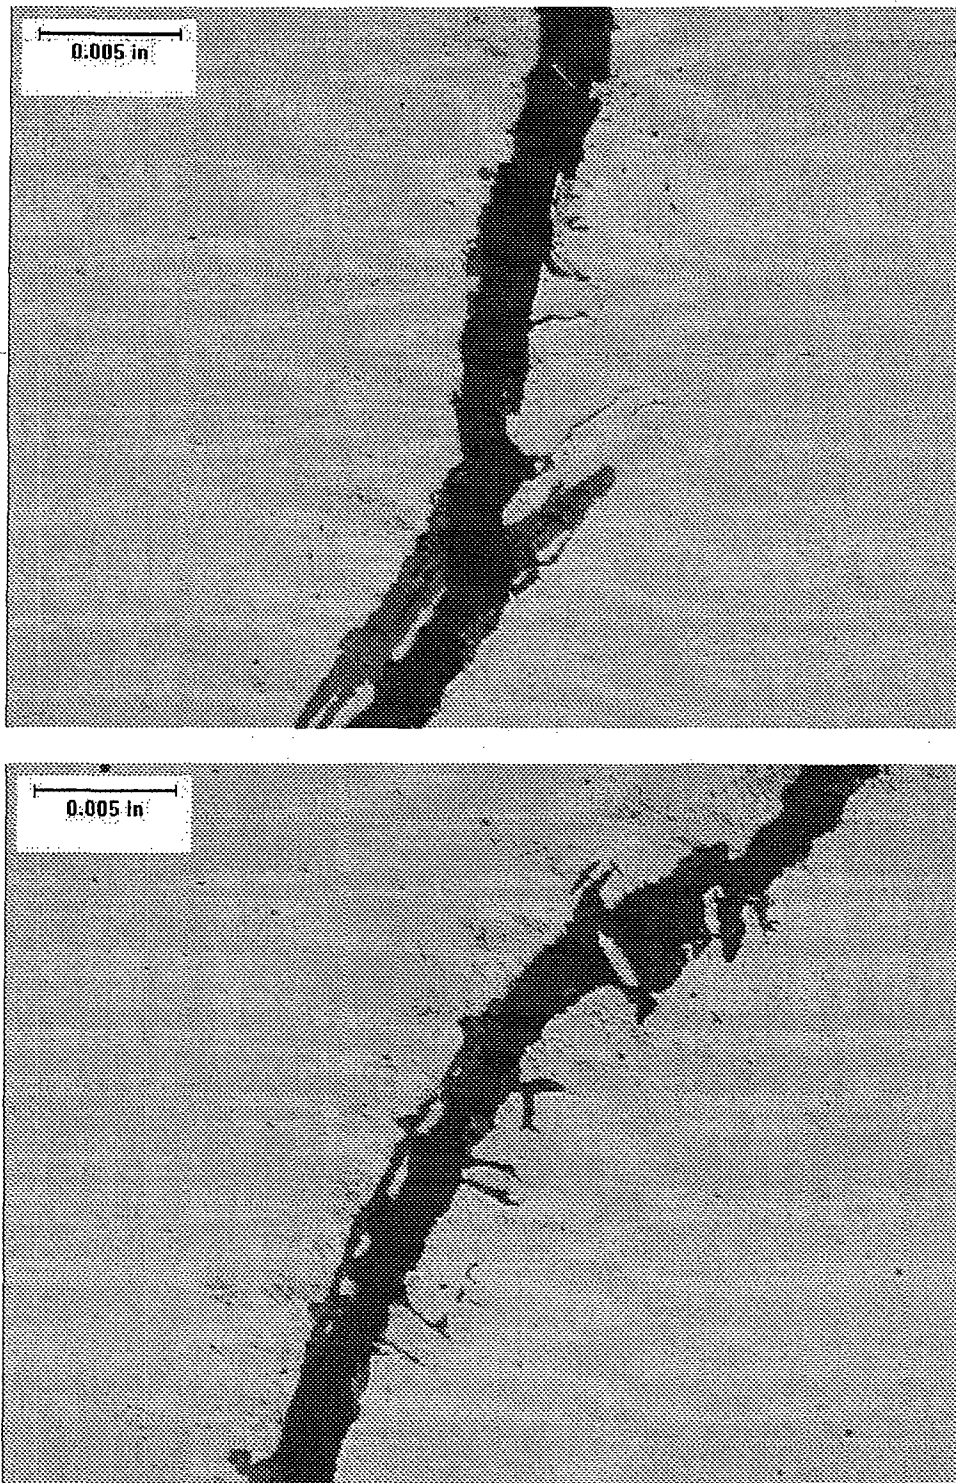
**Figure 16** Metallography Results in the As-polished Condition of Axial Section at 270° Illustrating the Cracking Morphology in the Weld Metal (Specimen B1A)

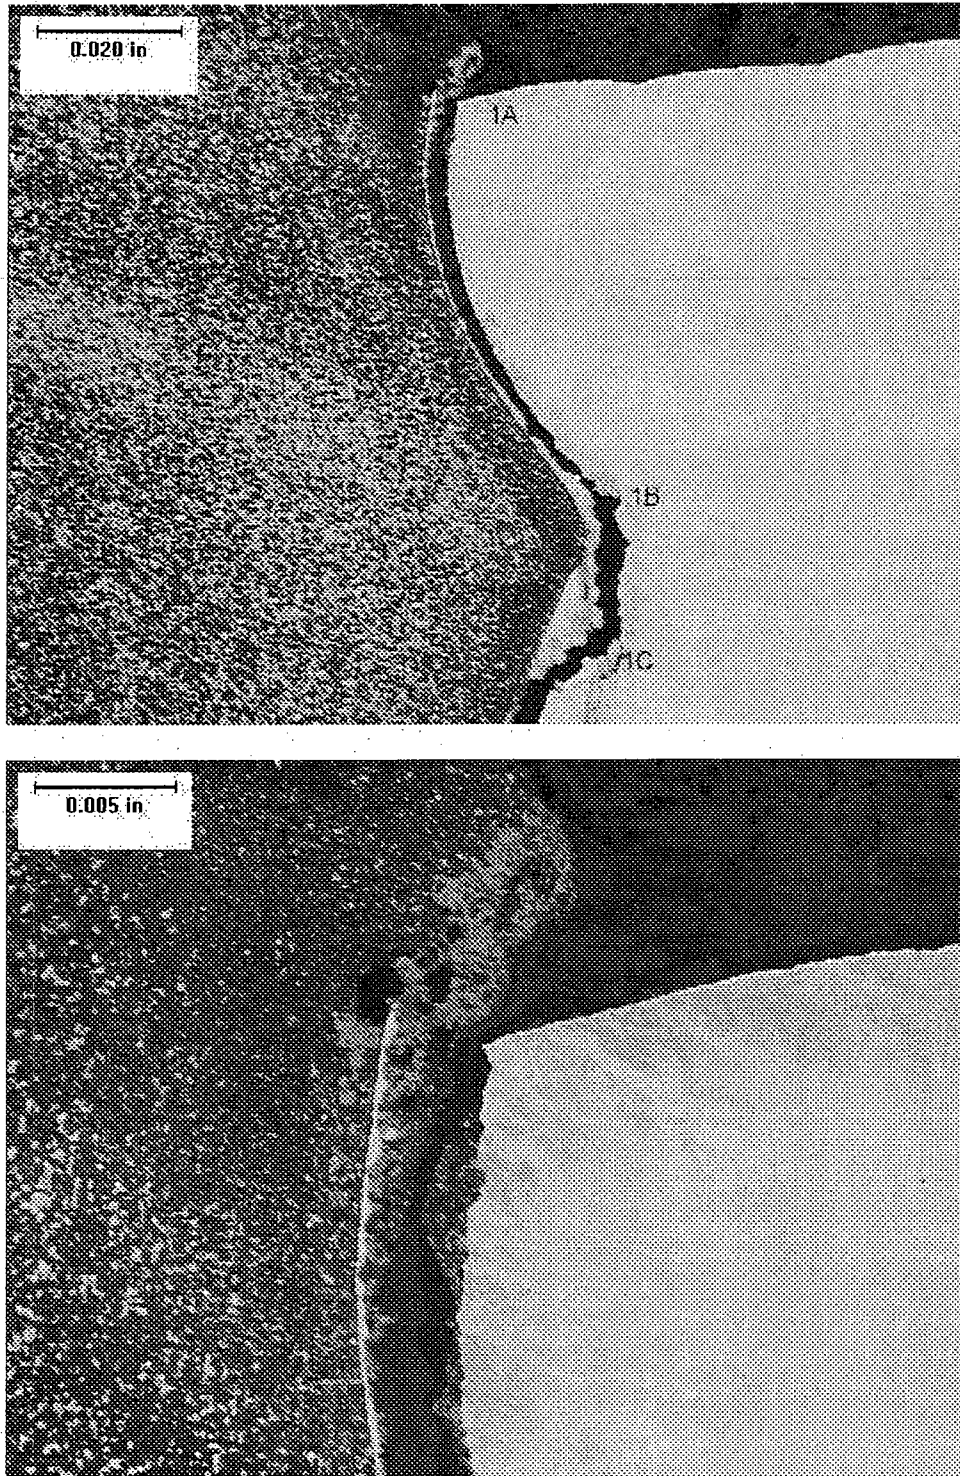
Figure 17 Morphology of Crack at 270° Orientation (Specimen B2A Polished and Etched Condition)
