**TENNESSEE VALLEY AUTHORITY  
BROWNS FERRY NUCLEAR PLANT (BFN)  
UNIT 2**

**EVALUATION OF DISSIMILAR METAL WELD INDICATION AT WELD RCRD-2-52**

WCAP-16845-NP  
Revision 0

# **Metallurgical Investigation of Recorded Indications at the Check Valve to Pipe Dissimilar Metal Weld at Browns Ferry Unit 2 Nuclear Generating Station**

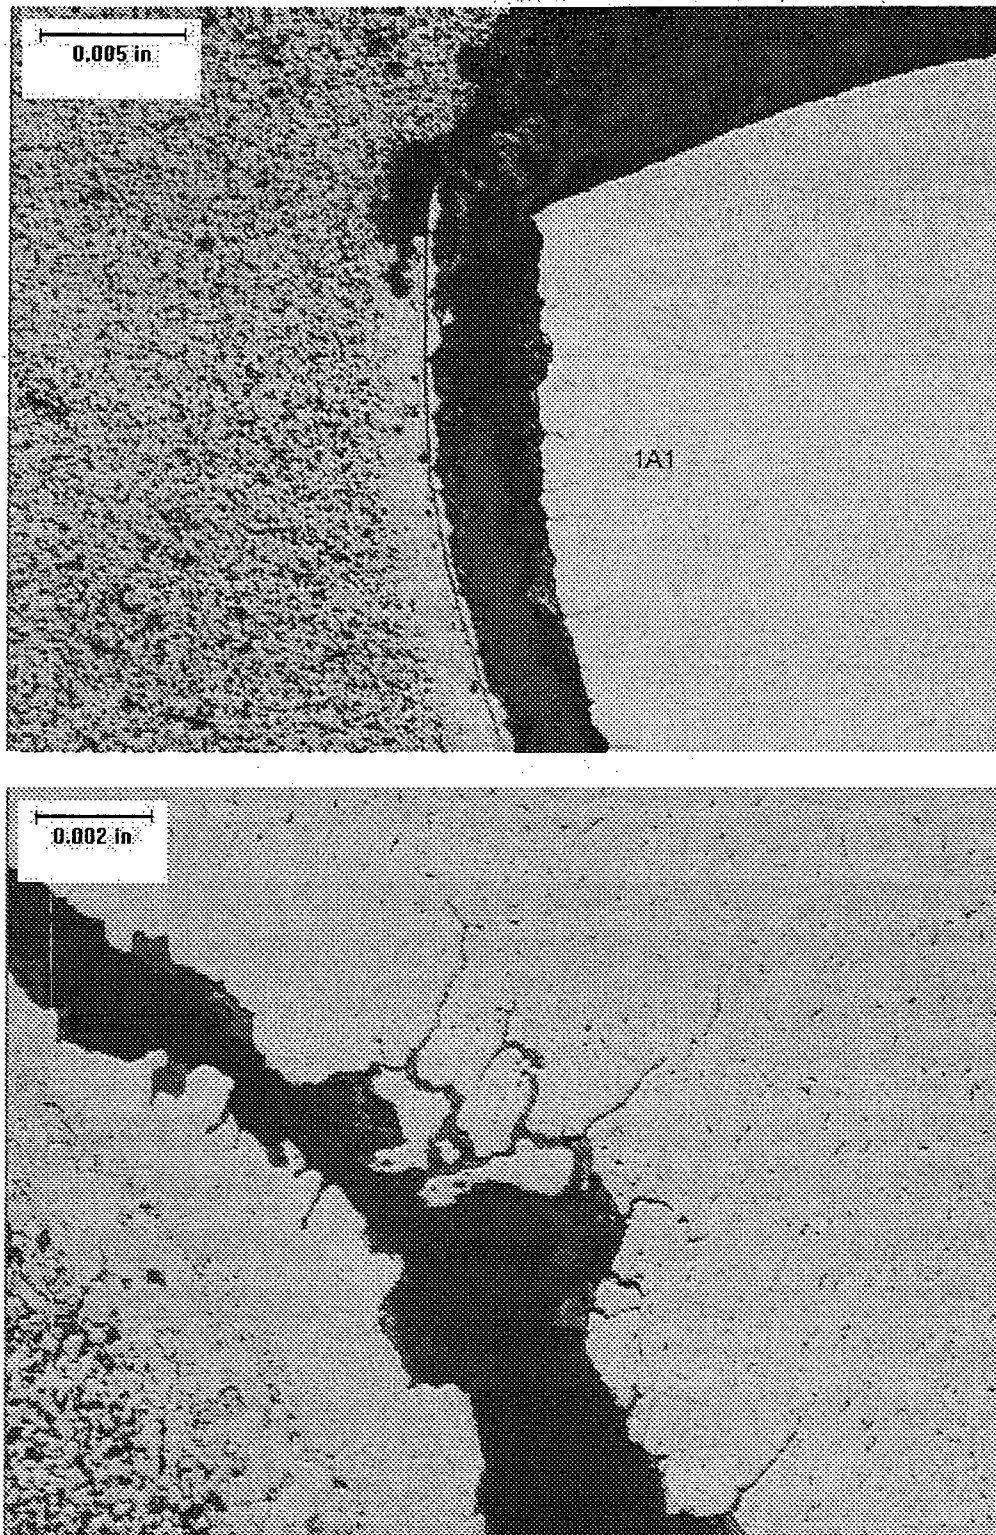
**Figure 18** Morphology of Crack at 270° Orientation (Specimen B2A Polished and Etched Condition)

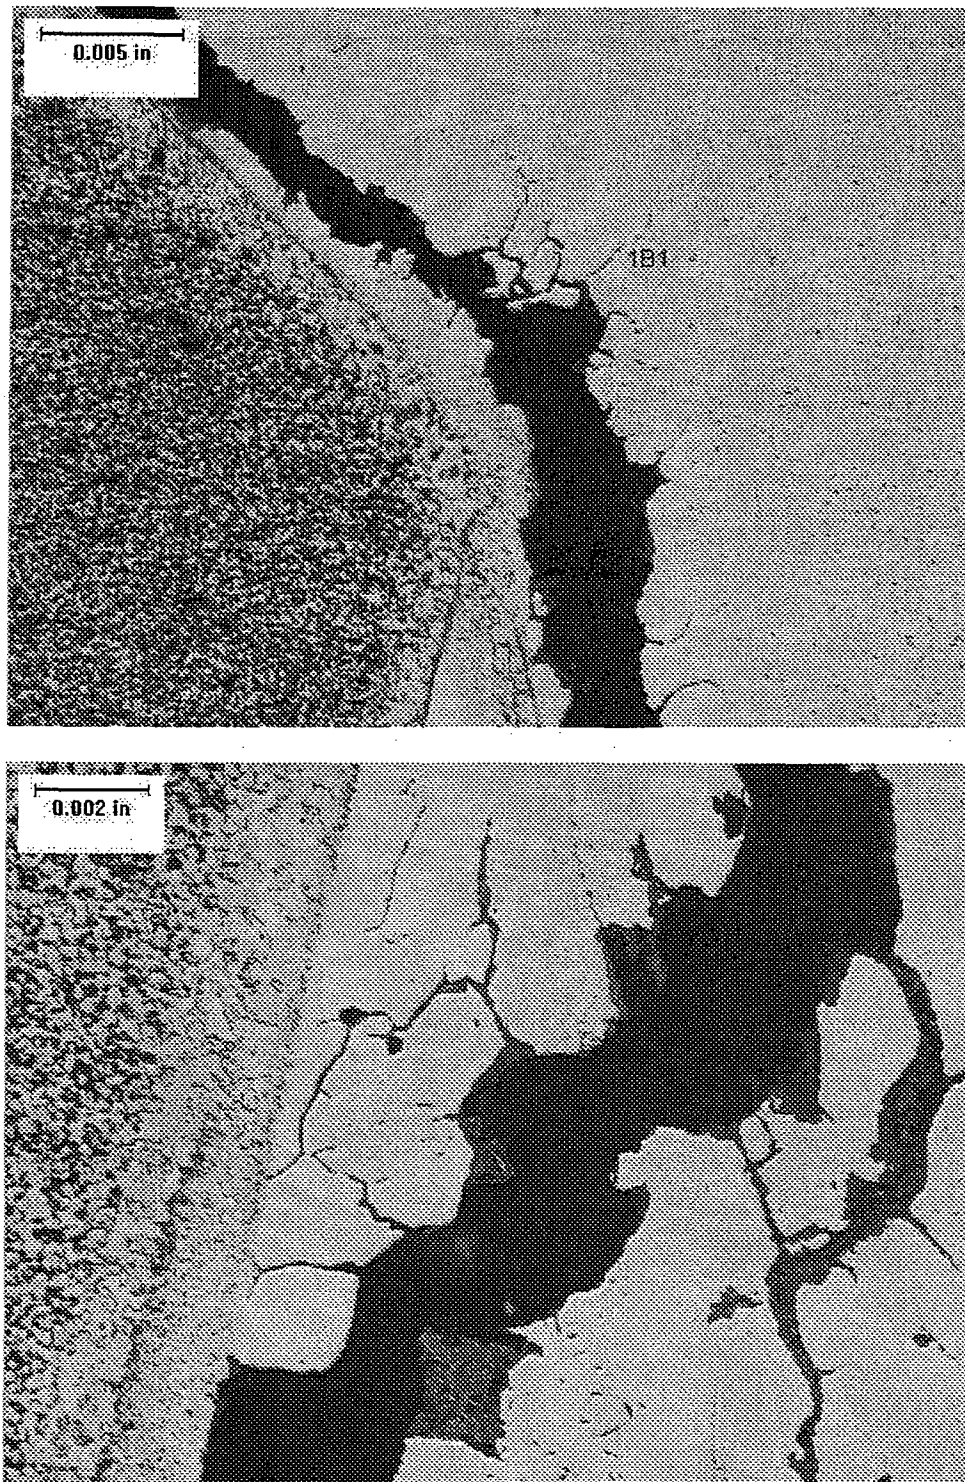
**Figure 19** Morphology of Crack at 270° Orientation (Specimen B2A Polished and Etched Condition)

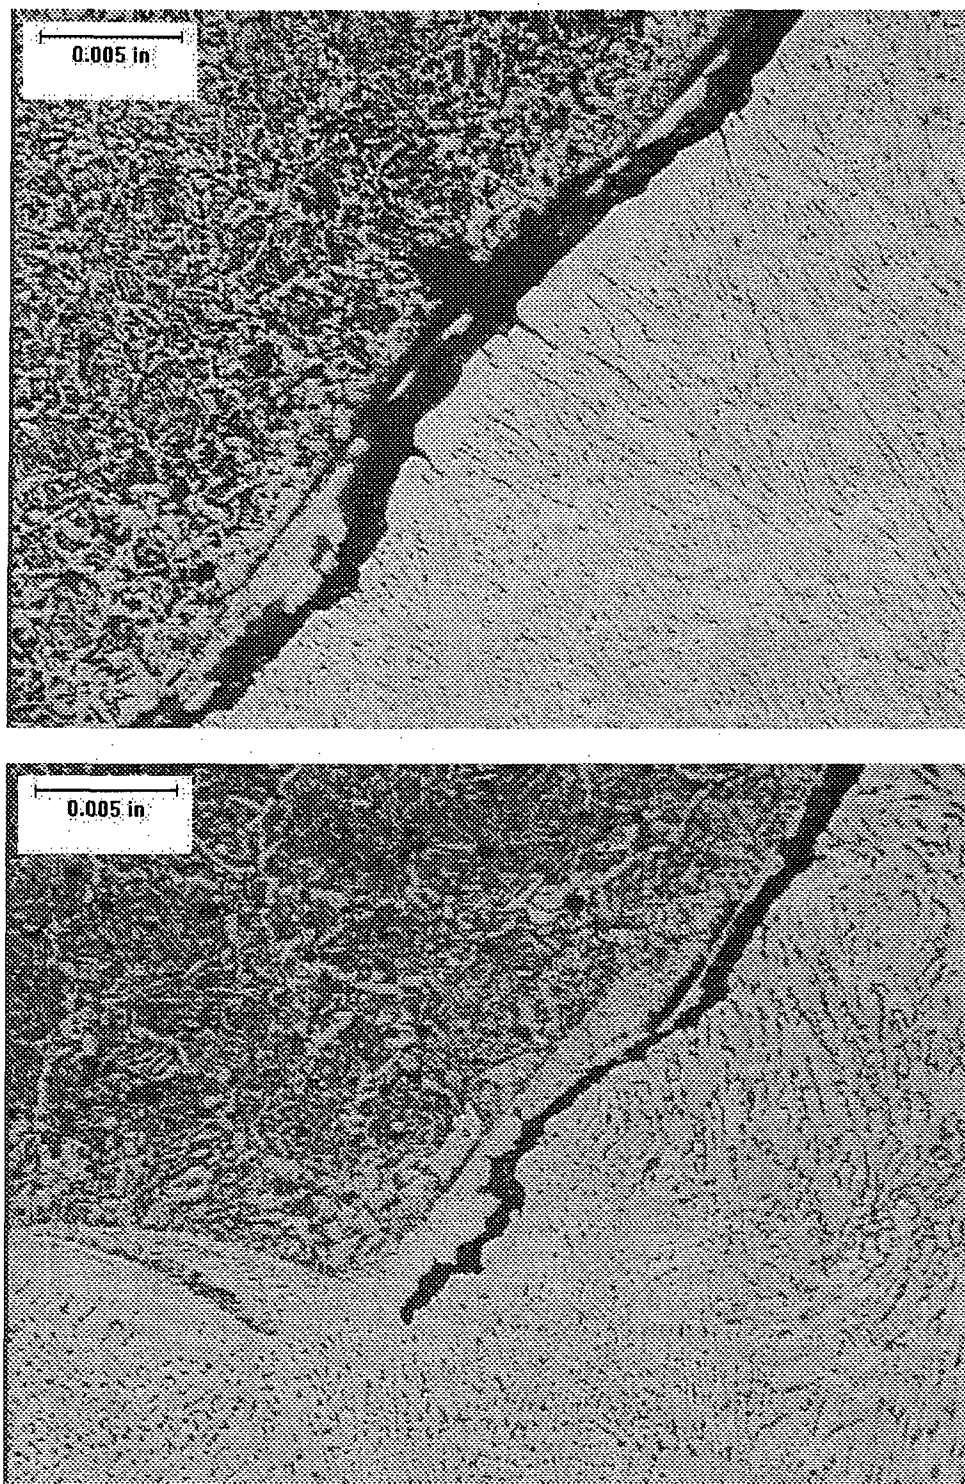
the way up to the crack tip regions, revealed by the metallographic examinations suggested that corrosion played a significant role in the cracking process. The observations also point out that the oxygenated conditions of the piping system played a role in the cracking process. Microhardness measurements supported the existence of hardened zone in the diluted weld metal region which is likely to support higher residual stresses.

**Figure 20** Morphology of the Crack-tip of the Deepest Crack seen at  $270^\circ$  (Specimen B2A Polished and Etched Condition)

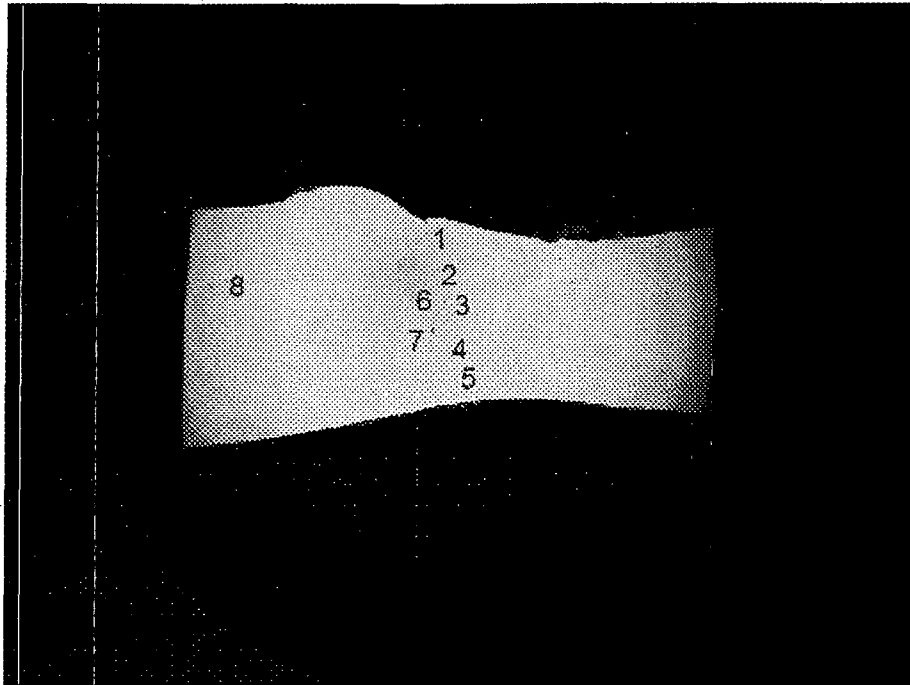
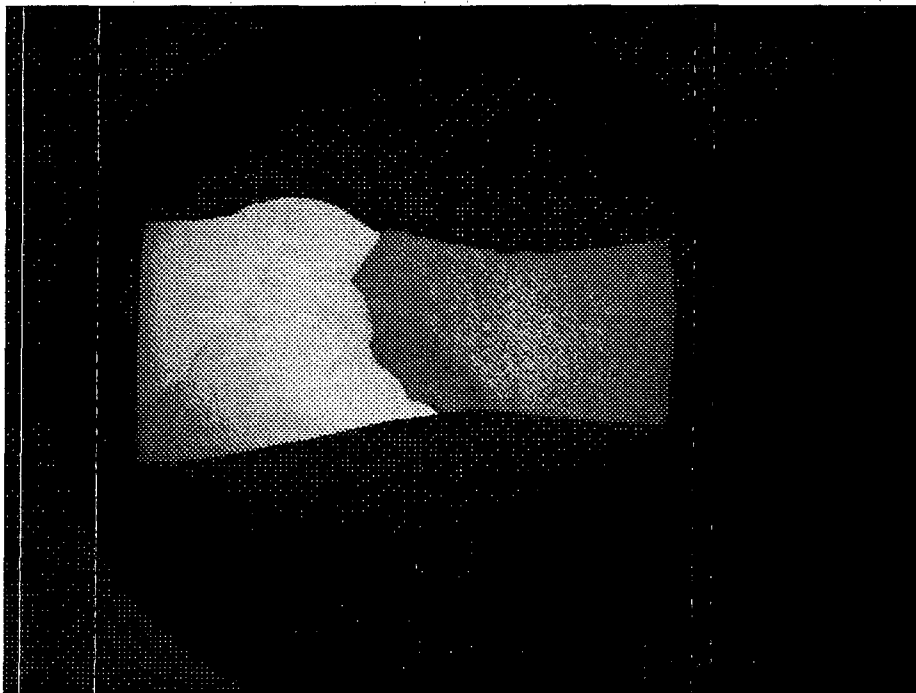
**Figure 21** A3B Mount Showing the Section at 180° Orientation – Showing in the a) As-polished and b) Polished and Etched Conditions

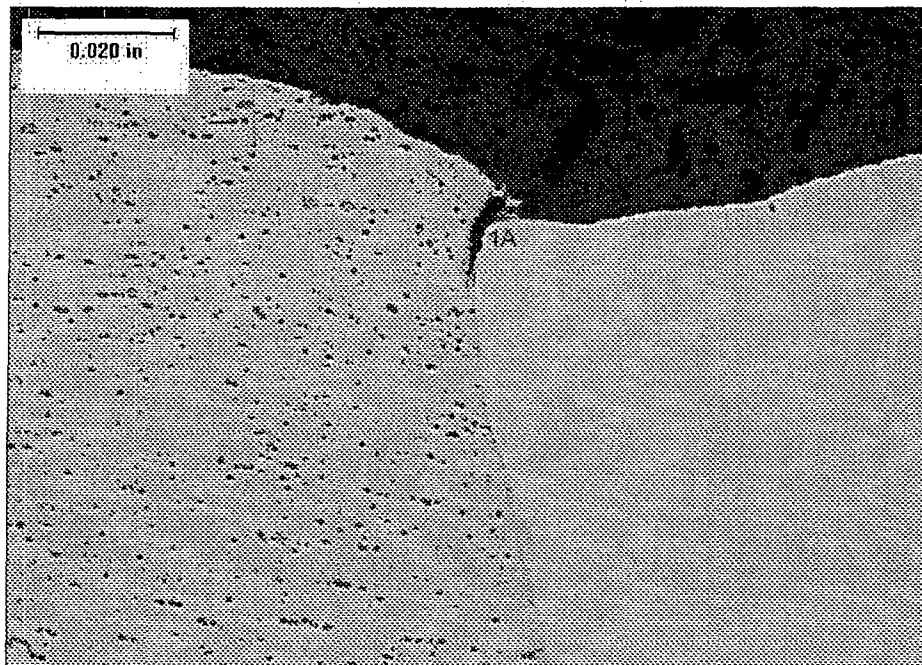
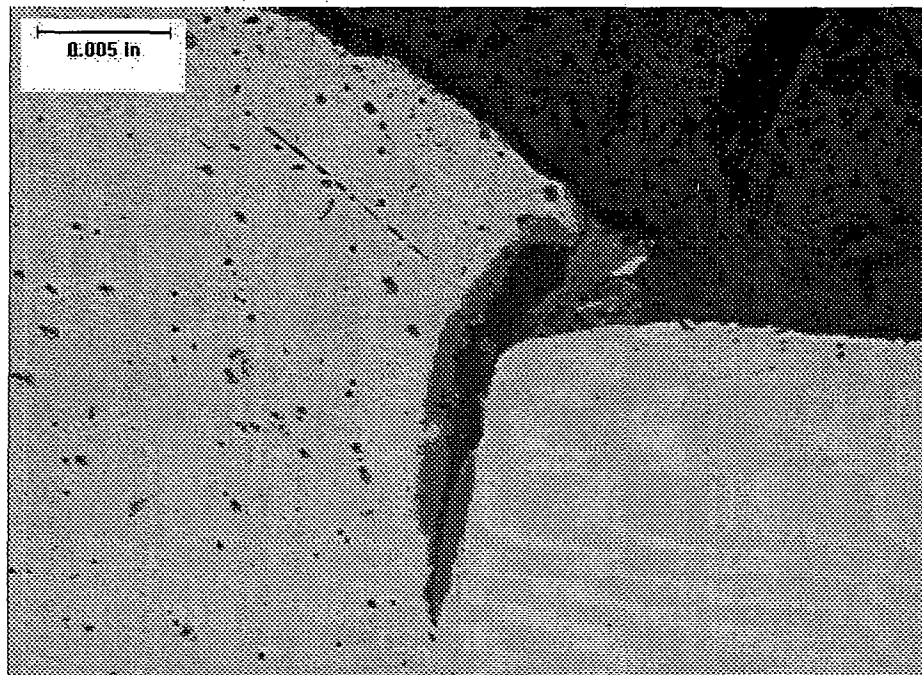
**Figure 22** Metallography Results of an Axial Section through the Indication at the 180° Orientation Shown in the “As-Polished” Condition (Piece A3B)

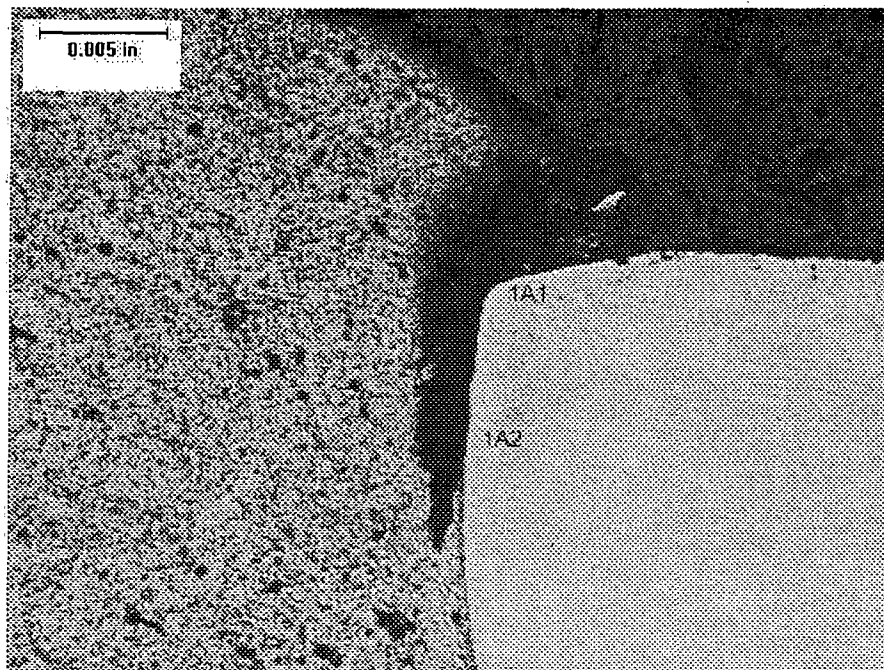
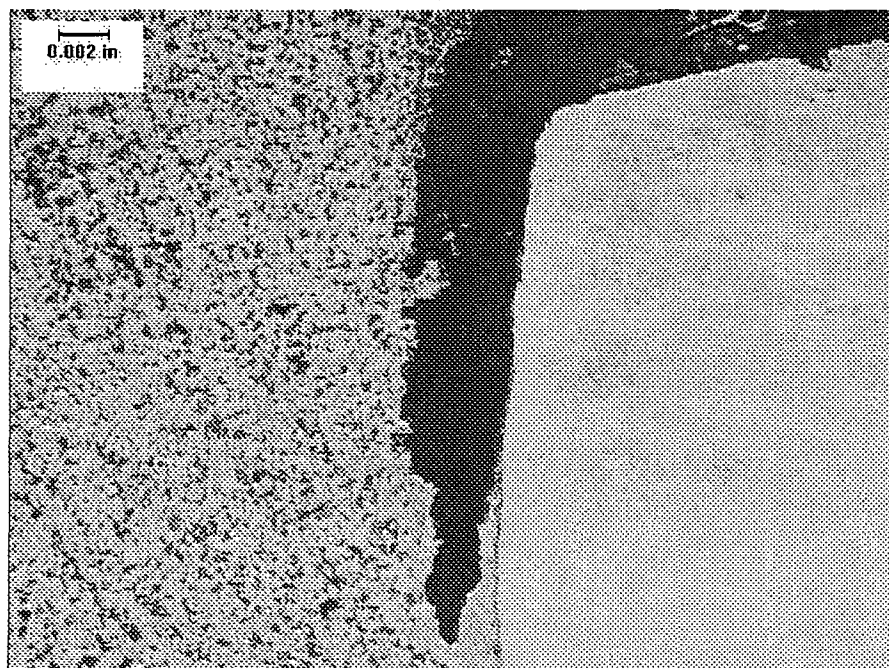
**Figure 23** Metallography Results Shown in the 'Polished and Etched' Condition of the Crack at 180° Orientation

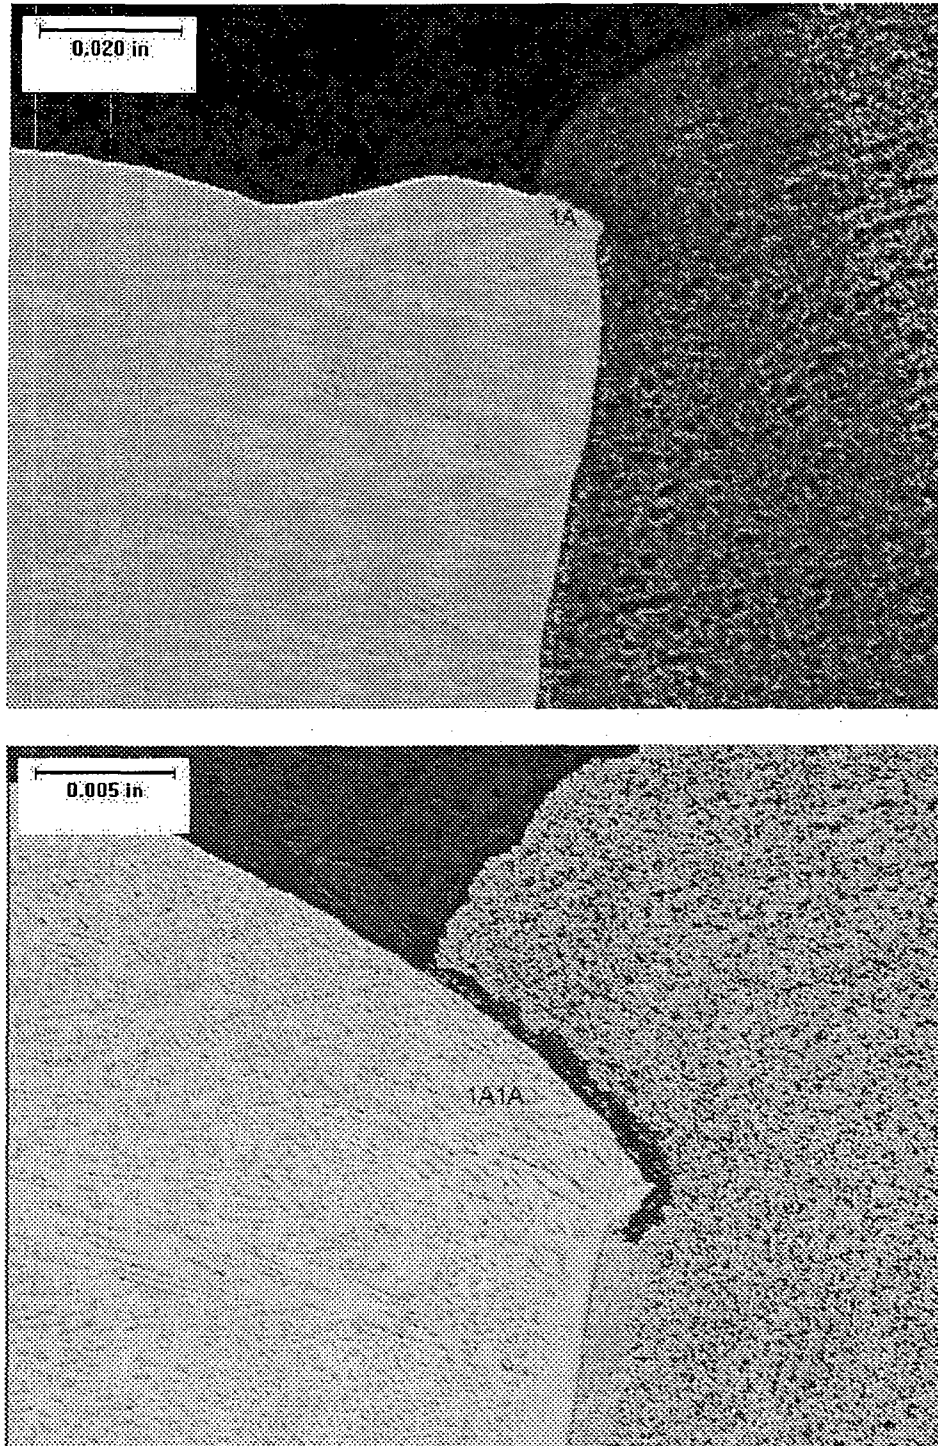
**Figure 24** Morphology of Crack in the Carbon Steel Side, on 90° Section (Specimen A2A Polished and Etched Condition)

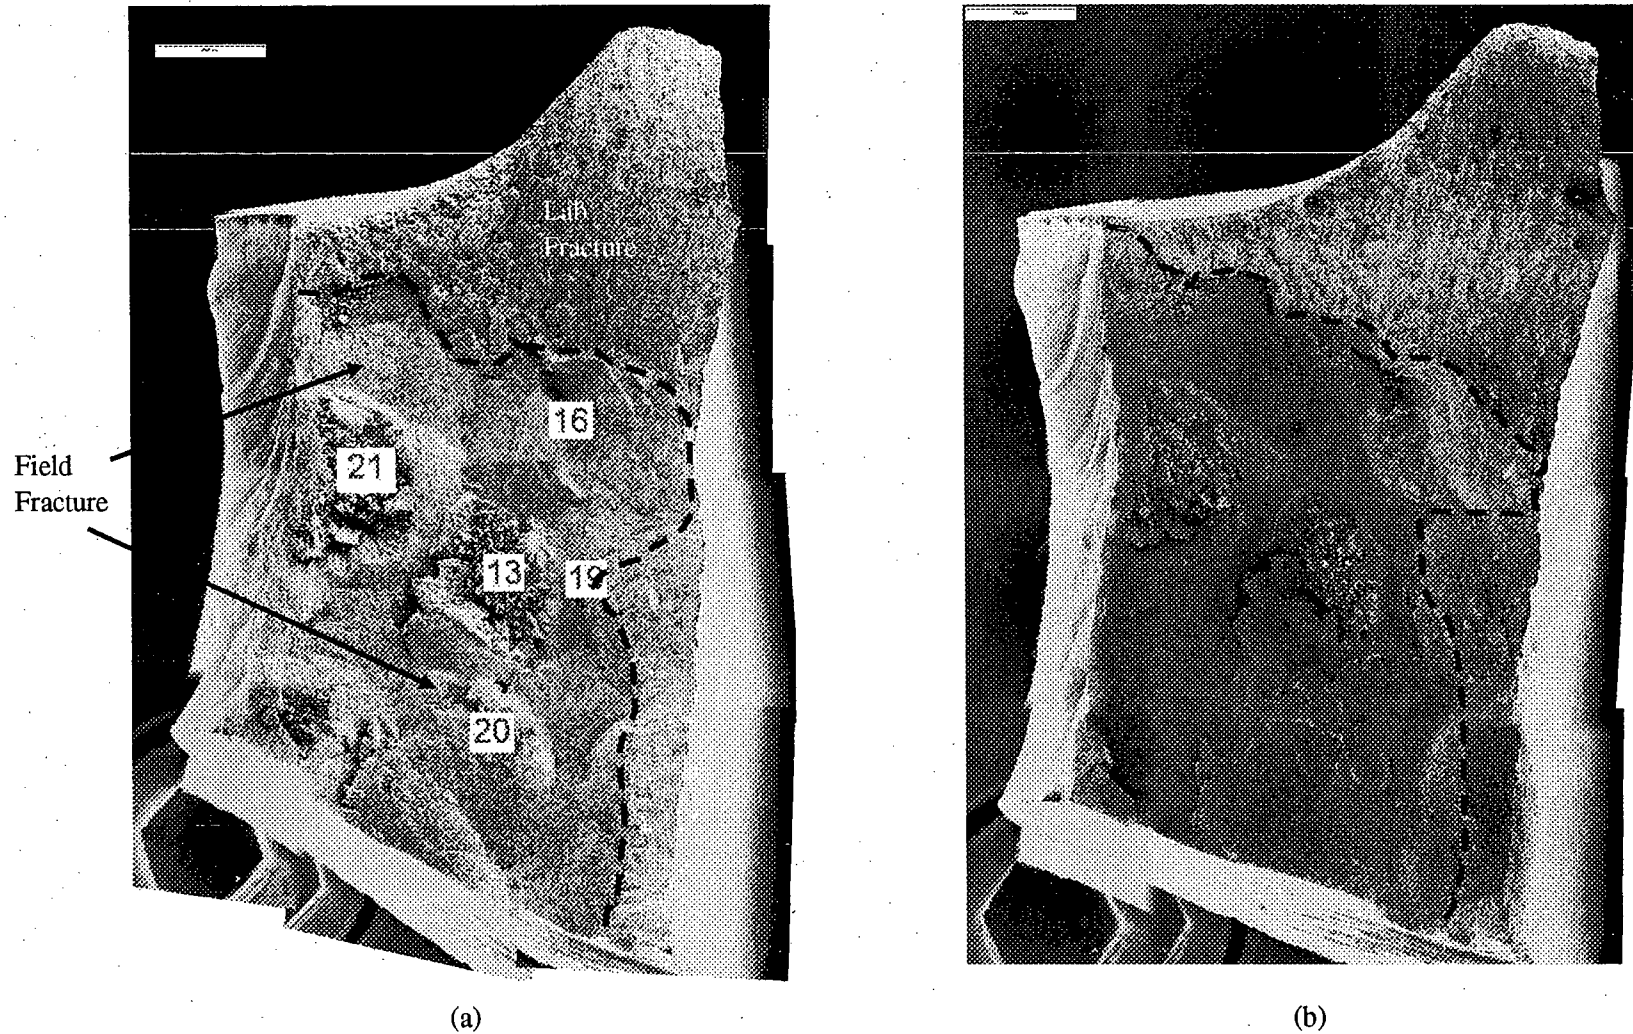
The results of the scanning electron fractography of the cracks freshly opened in the laboratory are illustrated in Figures 26 through 30. Figure 26 illustrates the crack opening procedure employed in the laboratory in opening the deepest crack at 270°. A low magnification fractograph of the freshly opened crack showing the laboratory fractured and field fractured regions is shown in Figure 27. The fracture surface shows the weld interface with islands of weld metal. Higher magnification SEM fractographs in

Figure 27 Lower Magnification SEM Fractograph of Freshly Opened Crack at 270° Orientation – Showing the Carbon Steel Face with Islands of Weld Metal

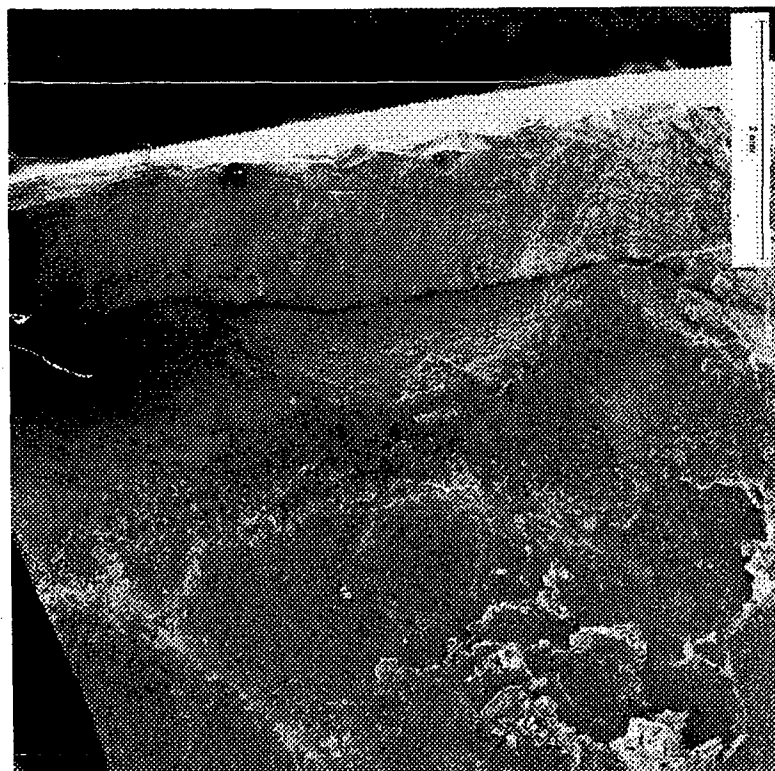
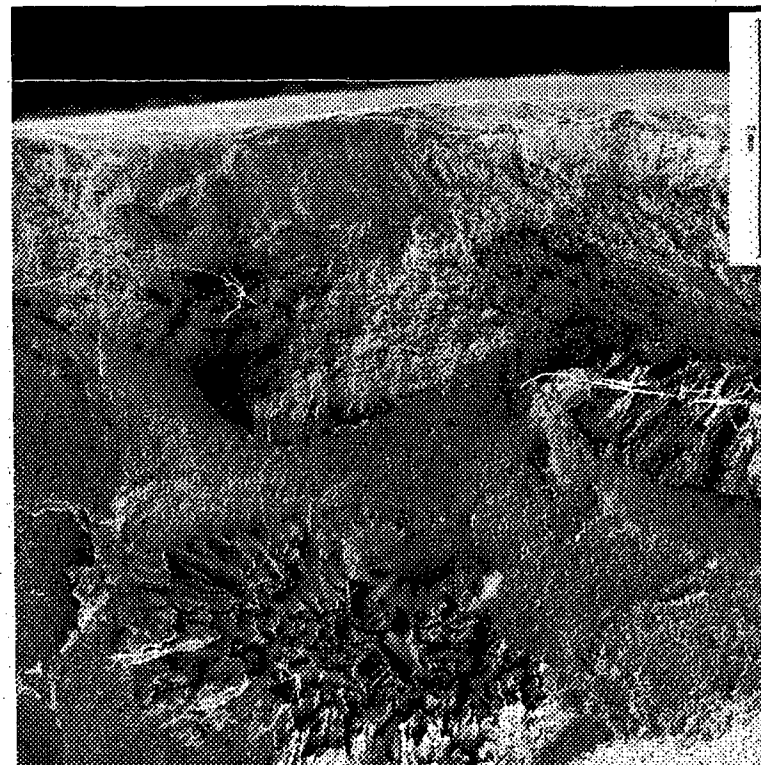
Figures in Figures 28 and 29 illustrate the morphology of interdendritic attack in the weld metal islands. Figure 30 illustrates the formation of iron oxide crystal deposits in the crack.

**Figure 28 Scanning Electron Fractograph of the Freshly Opened Crack at 270° Location – Delaminated Carbon Steel Interface and Islands of Weld Metal can be Seen**

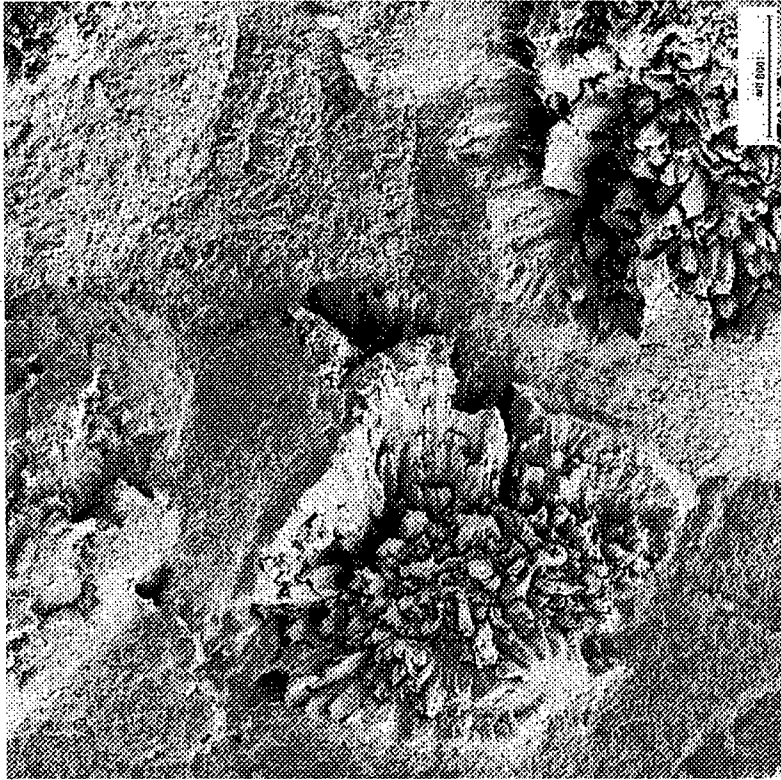
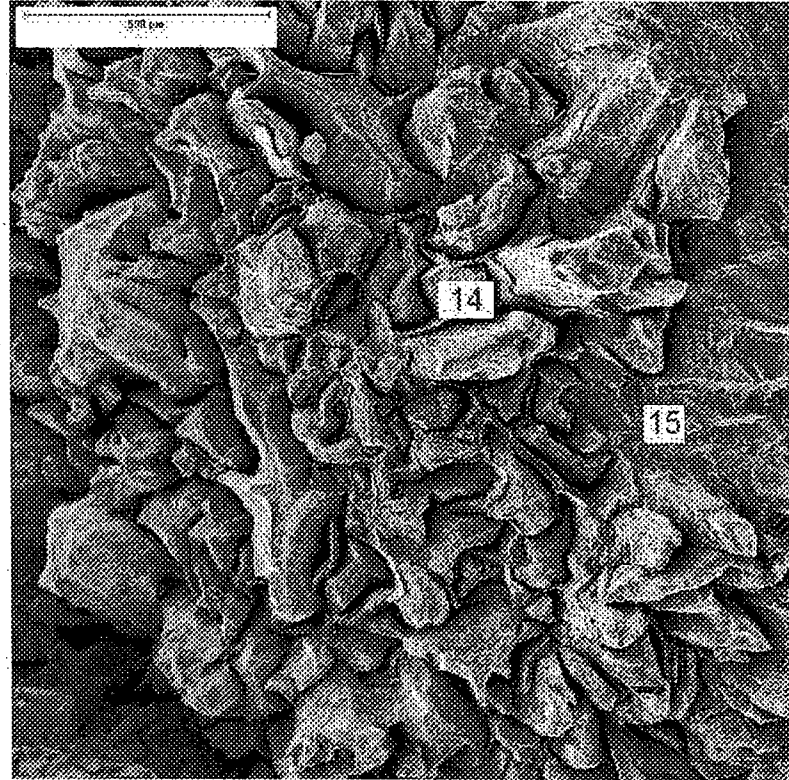
**Figure 29 SEM Fractograph of 270° Crack Illustrating the Appearance of Carbon Steel Surface and Weld Metal Islands at the Interface**

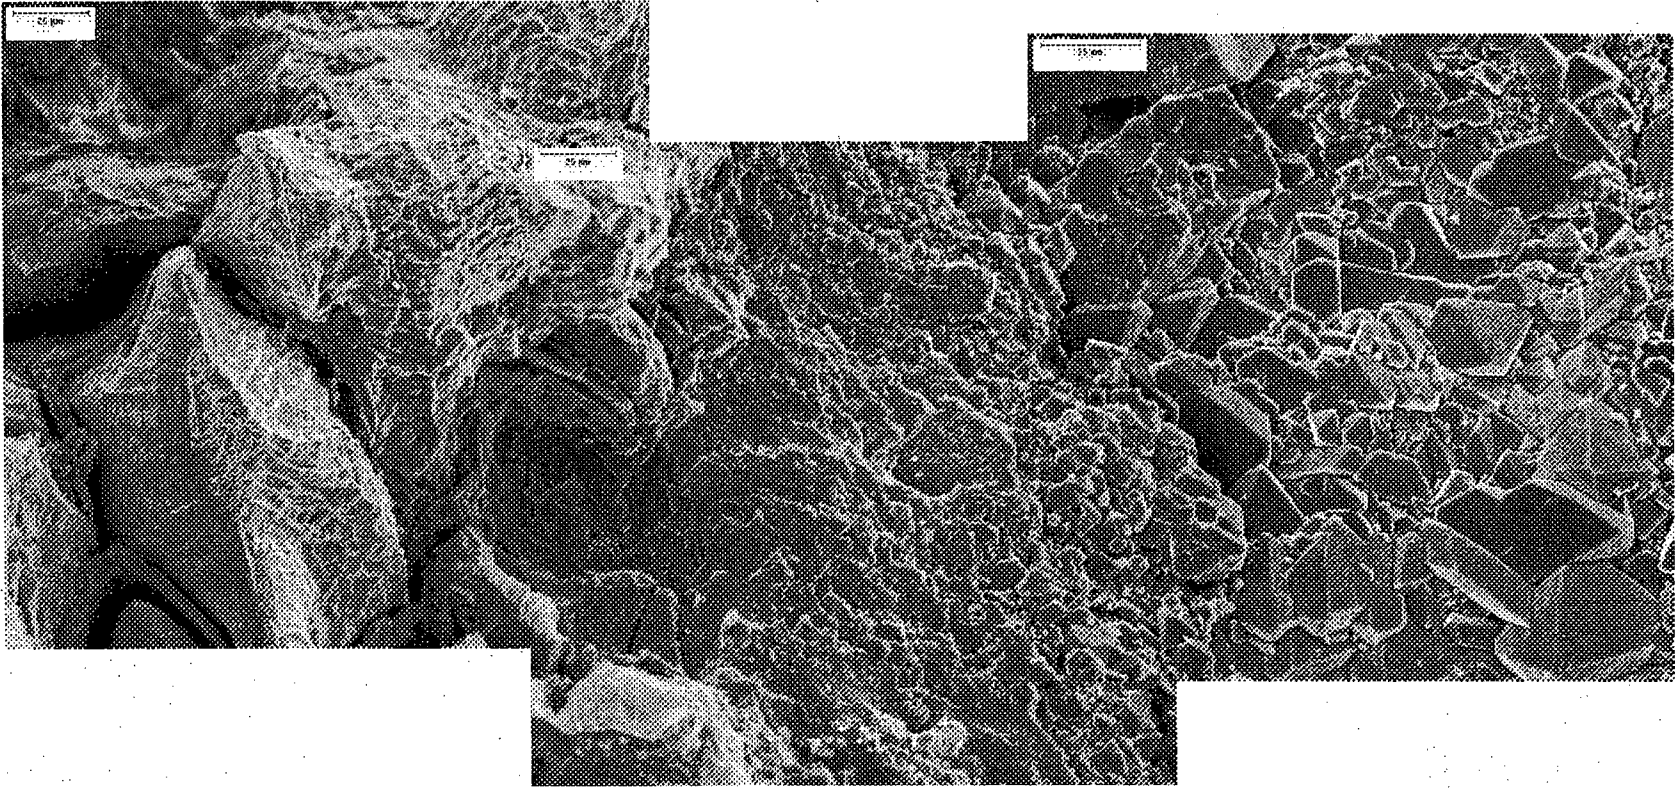
**Figure 30 SEM Fractograph of 270° Crack Showing Weld Metal and Iron Oxide Regions on the Fracture Face**

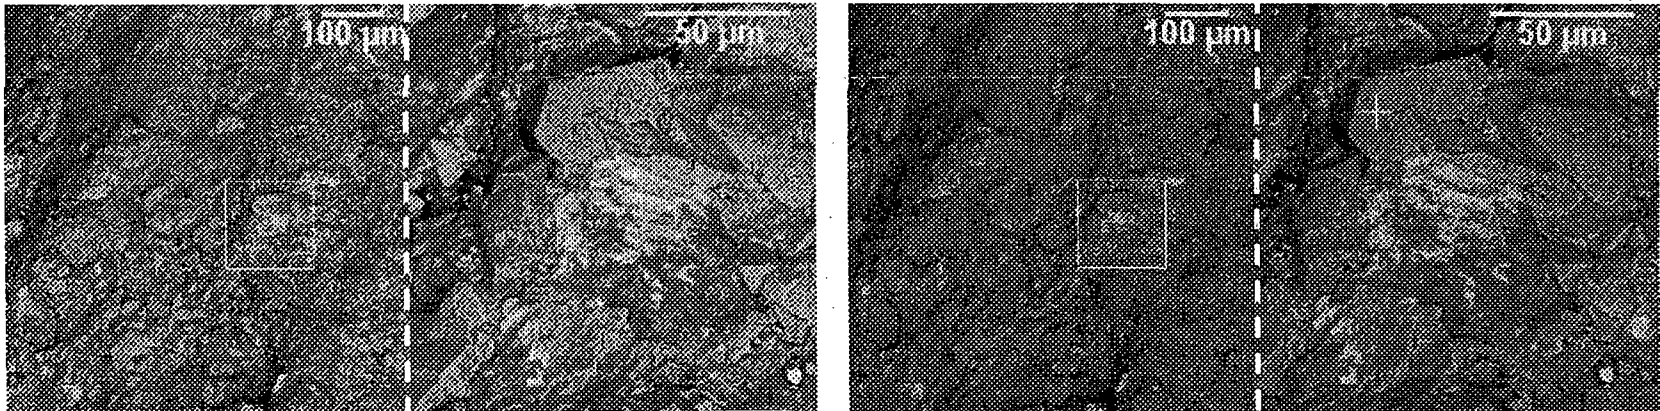
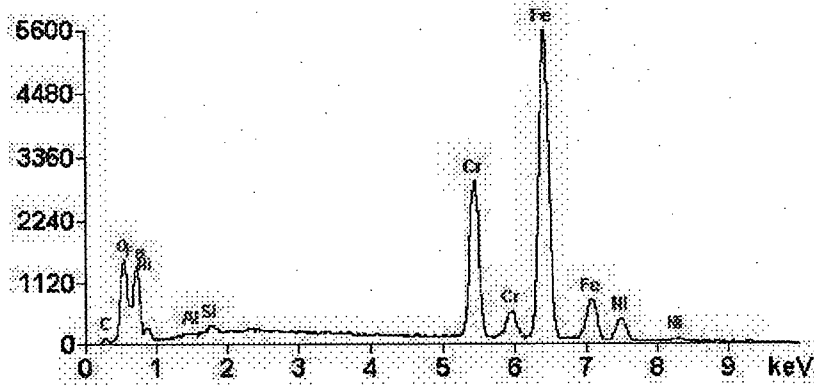
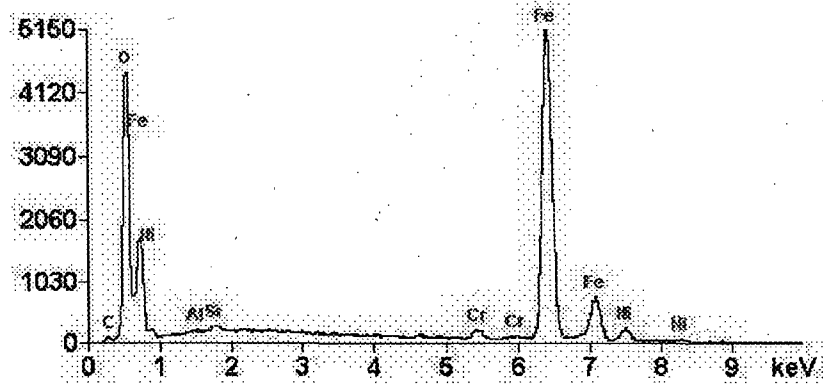
The fracture constituents and oxide deposits were identified by semi quantitative EDS spectroscopy. Figures 31 and 32 illustrate the typical results of EDS spectroscopy results of the fracture constituents. A comparison of oxygen and chromium peaks differentiates the iron oxide deposits from weld metal islands. Wet chemistry analysis of samples from the carbon steel pipe, the stainless steel valve body and the 309 weld deposit materials was conducted to examine their conformance to the specification requirements. The results are summarized in Table 1. The chemistry analysis results suggested that the materials generally met the specifications with the exception of the Nitrogen content in the weld metal.

Figure 31 EDS Spectrums Illustrating the Weld Metal and Iron Oxide Regions on the Fracture Face

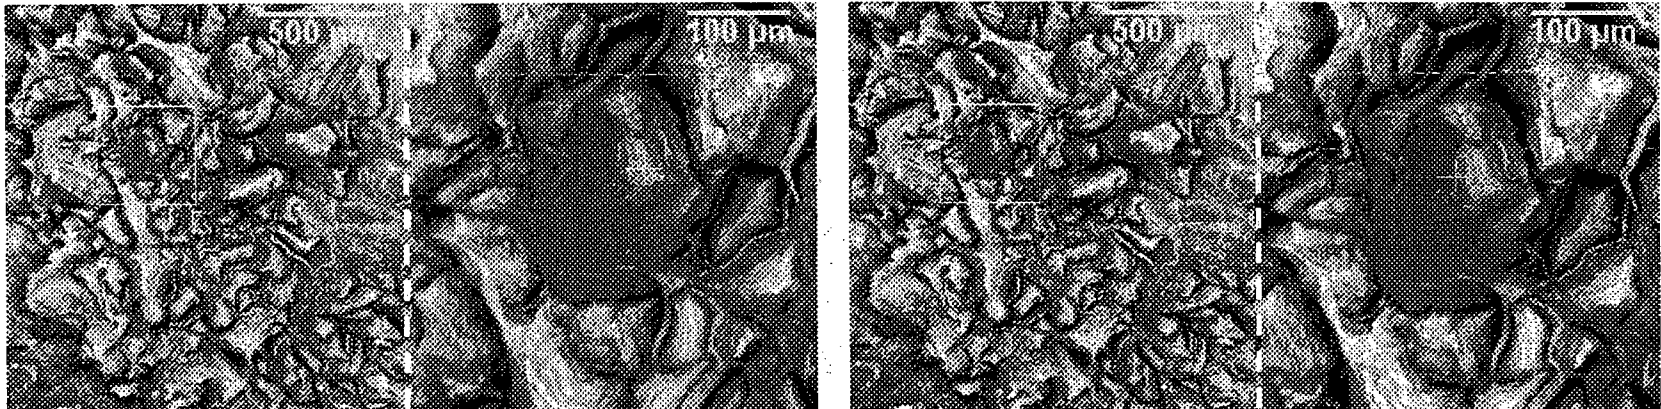
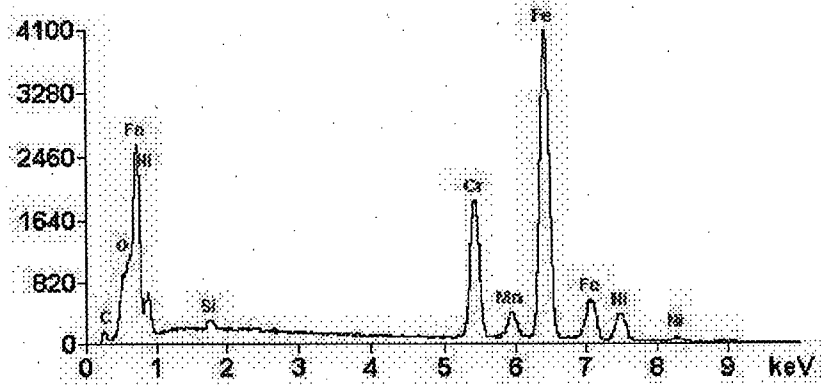
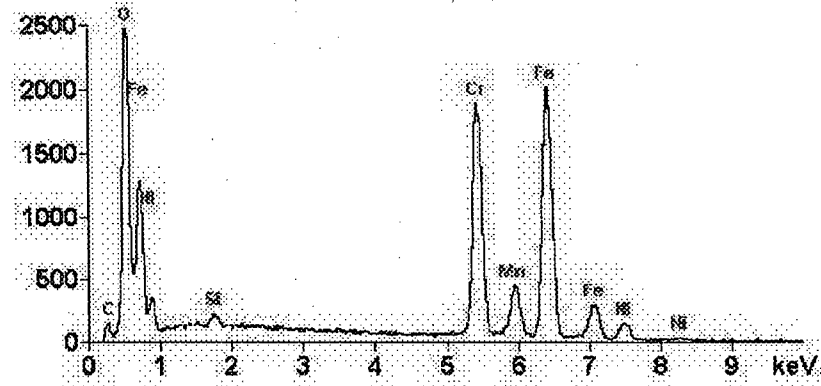
Figure 32 EDS Spectrums Illustrating the a) Weld Metal and b) Iron Oxide Regions on the Fracture Face

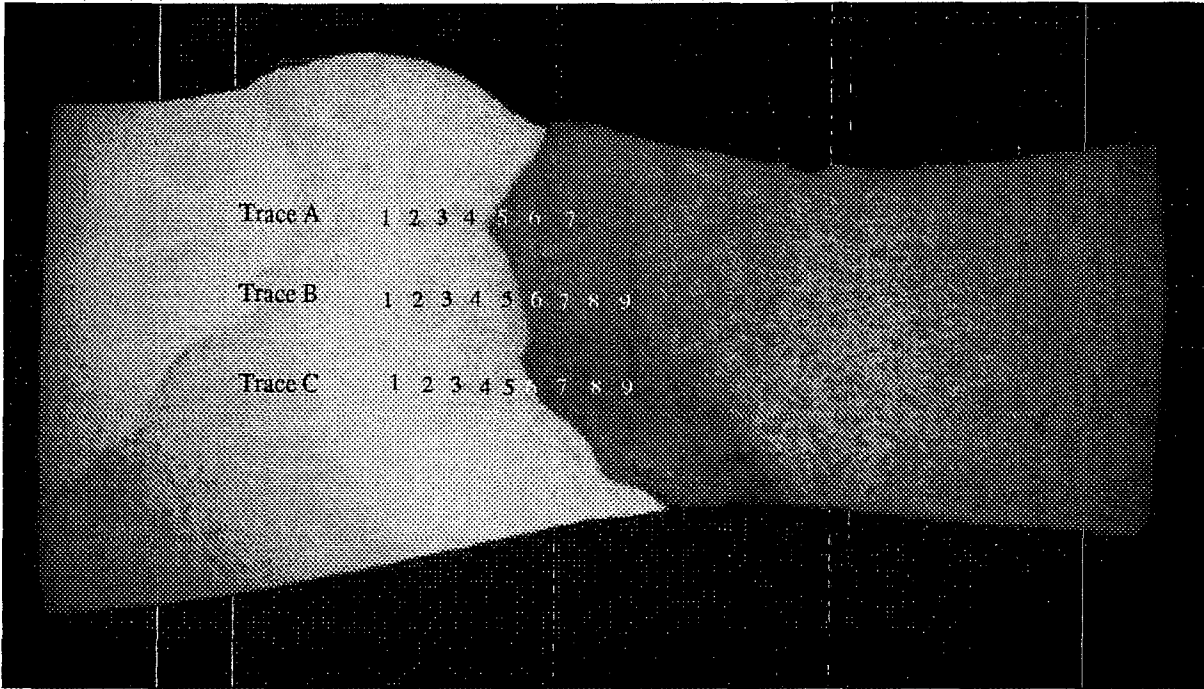
Micro hardness traverse measurements were made across the weld interface on the polished samples to assess in strength levels of base and weld materials, and to gain more understanding of the transition or mixing zone where the major crack was detected at 270° orientation. The results are summarized in Figures 33 and in Table 2. These results suggested the occurrence of a thin hardened zone at the interface in the weld metal potentially due to dilution, inadequate pre heat and cleaning effects associated with the welding. These conditions are likely to contribute to the observed cracking.

**Figure 33 Piece A3B, Weld Mount Prepared for Microhardness Measurements**

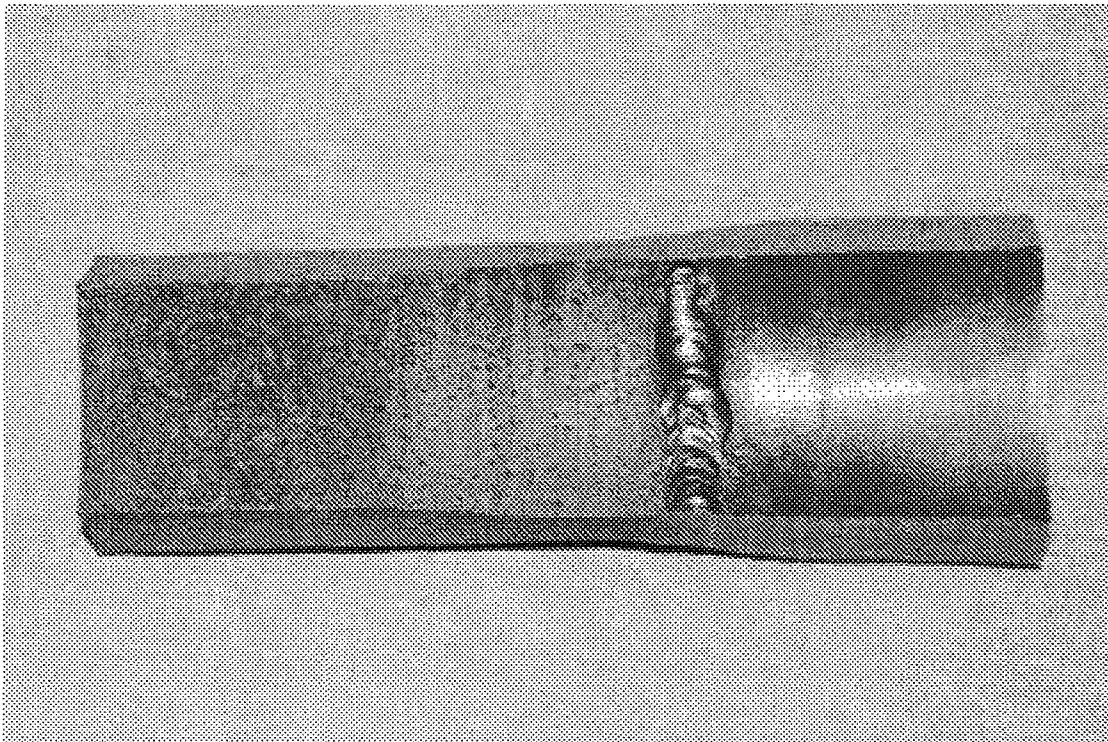
After the radiographic examination a visual inspection of the ID surface of the section identified the presence of a crack like feature on the surface where the x-ray indications were located. Why these had not been found by the dye penetrant examination is possibly due to the presence of a small ligament present on the inside surface that was breached when the section was cut from the component or crud present in the crack. The resolution of this dilemma awaits final destructive characterization.

Figure A1 Image of the Inside Surface of the Removed Section – The Pipe Portion of the Assembly is Toward the Left

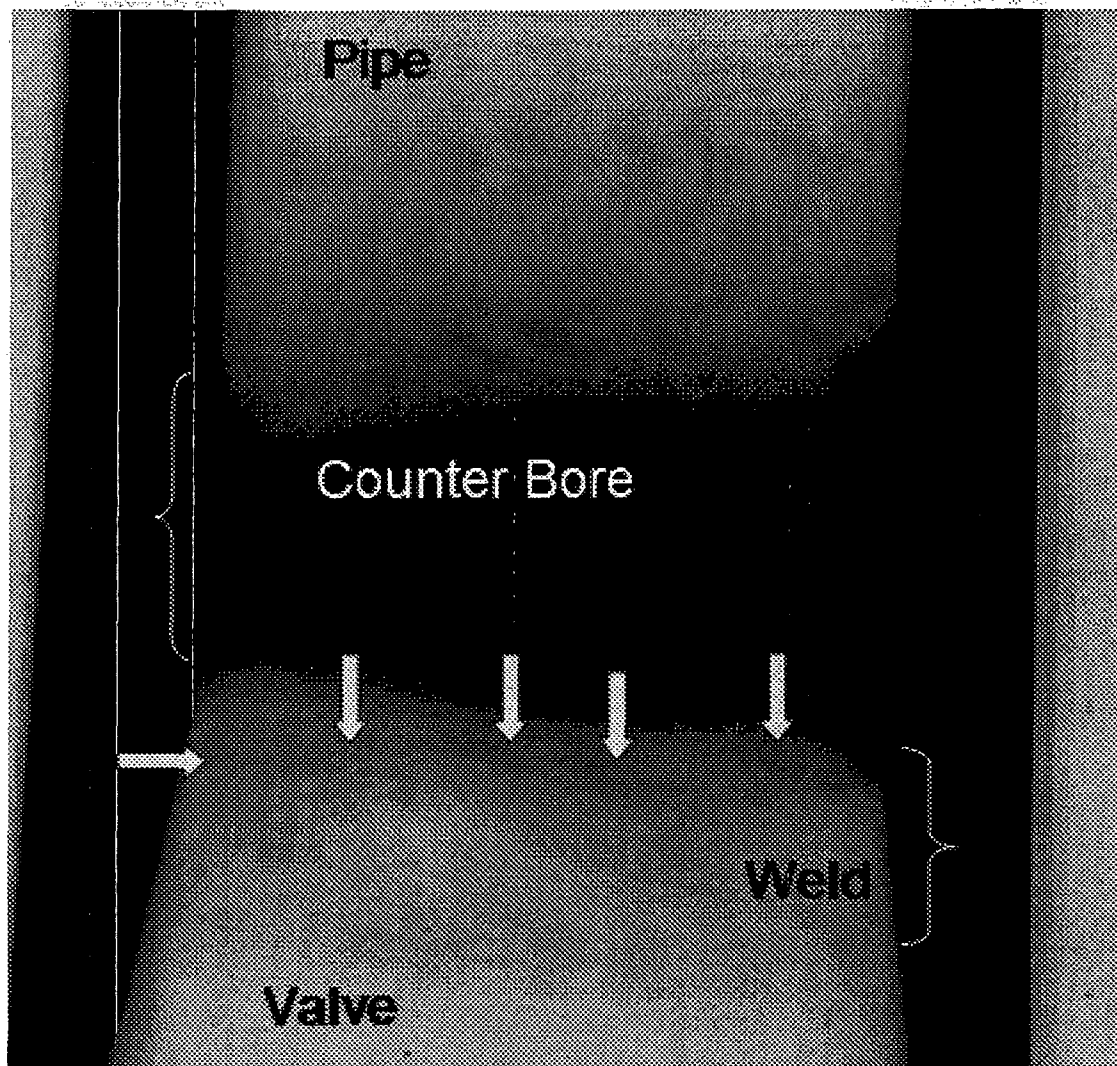
Figure A2 Digitized Radiograph of the Section of Pipe-Valve Weld Assembly Corresponding to the Indications Found in the Field Ultrasonic Examination – Note the radiograph was taken with the ID of the assembly against the film. The arrows show the locations of the radiographic indications.

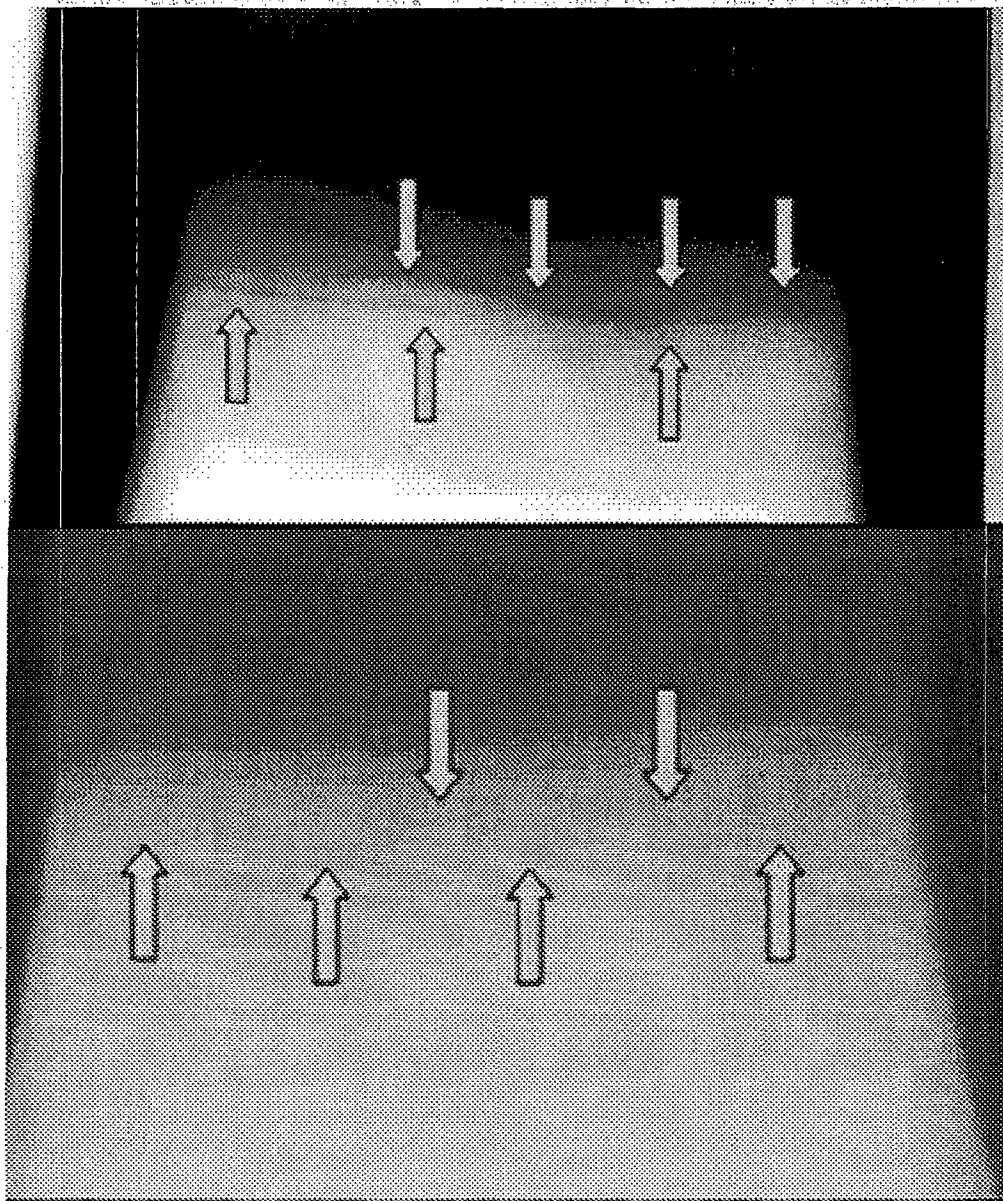
Figure A3 Enhancement of the X-ray Radiographs in the Vicinity of the Weld – Upper image is from the image in Figure 1 while the lower is for a radiograph taken with the II of the component away from the film. The arrows show the location of the radiographic indications.
