**TENNESSEE VALLEY AUTHORITY  
BROWNS FERRY NUCLEAR PLANT (BFN)  
UNIT 2**

**EVALUATION OF DISSIMILAR METAL WELD INDICATION AT WELD RCRD-2-52**

WCAP-16845-NP  
Revision 0

# **Metallurgical Investigation of Recorded Indications at the Check Valve to Pipe Dissimilar Metal Weld at Browns Ferry Unit 2 Nuclear Generating Station**

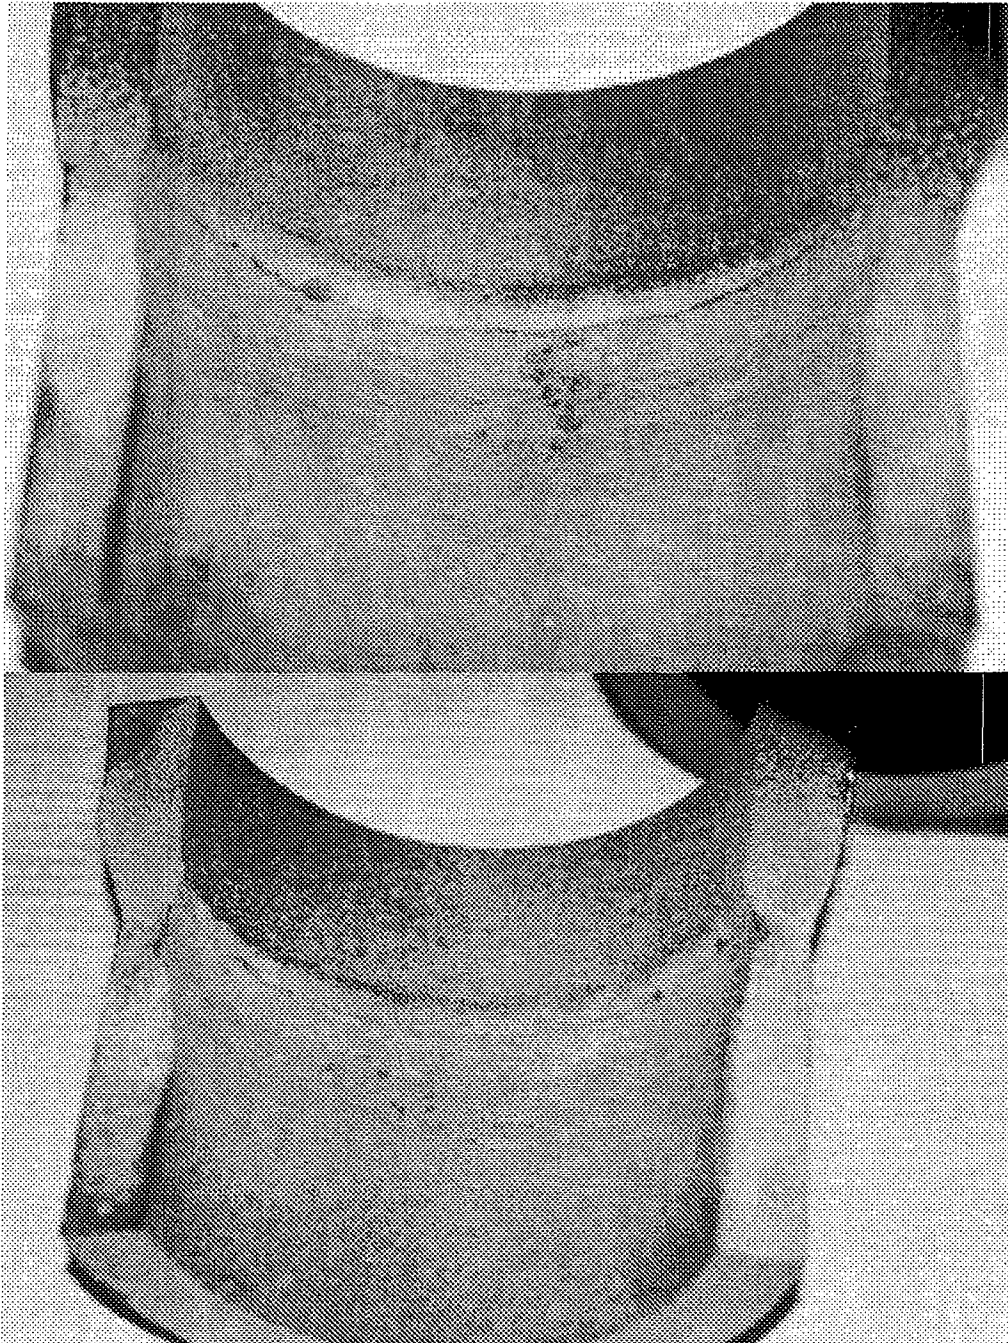
Figure A4 Florescent Dye Penetrant Results for the Remaining Portion of the Assembly – Both images are taken from the pipe end of the assembly. The indications in the counter bore region are believed associated with the original welding. The obvious indication in the counter bore in the upper image is at approximately the 180 degree orientation. The left surface in the upper image corresponds to approximately 4.3 inches from the 0 degree reference while the right surface of the lower image corresponds to approximately 2.7 inches from the 0 degree reference so that the right side of the upper image corresponds to the left side of the lower image.
