Presentation to the NRC On the Causes and Corrective Actions of the AREVA NP Mount Athos Road Shipment of Fuel Cleaning Equipment to the Watts Bar Plant Exceeding Transportation Radiation Limits

Presentation Agenda

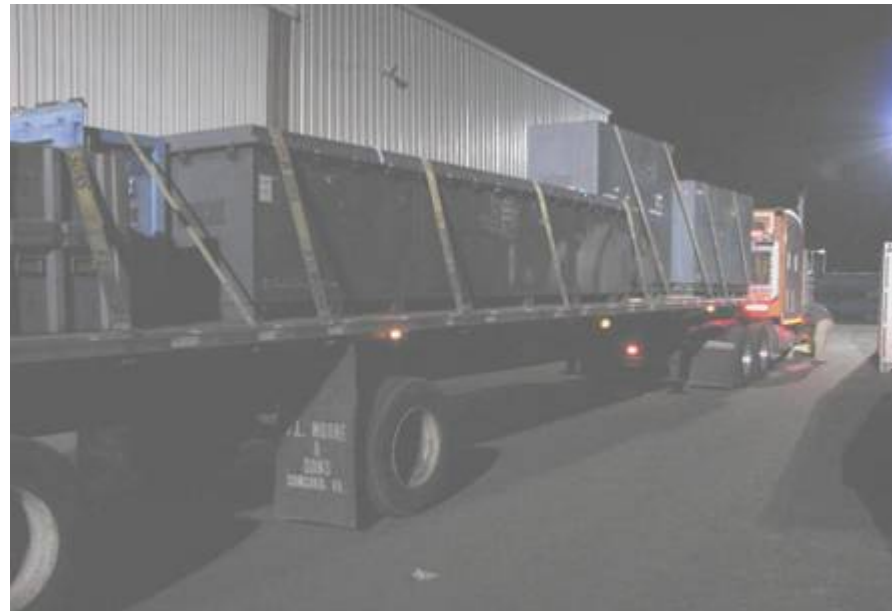
On February 4, 2008, WB received a shipment of fuel cleaning equipment sent from the AREVA NP Inc, Mount Athos Road (MAR) facility. The receipt radiation survey indicated that Box 455 had a localized “hot spot” which exceeded the transportation requirements of 10 CFR 71.47.

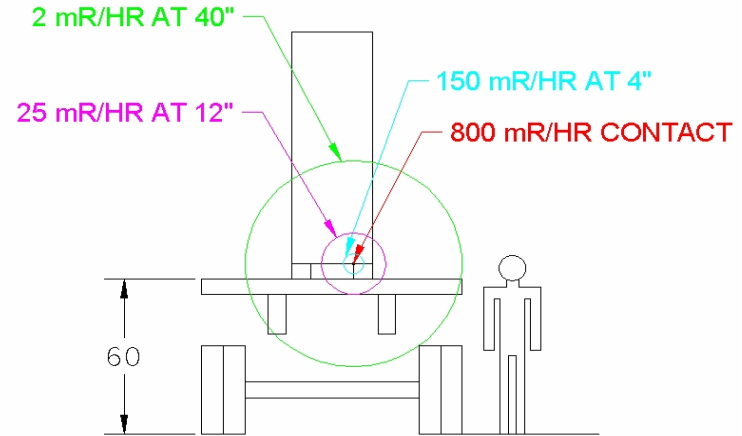
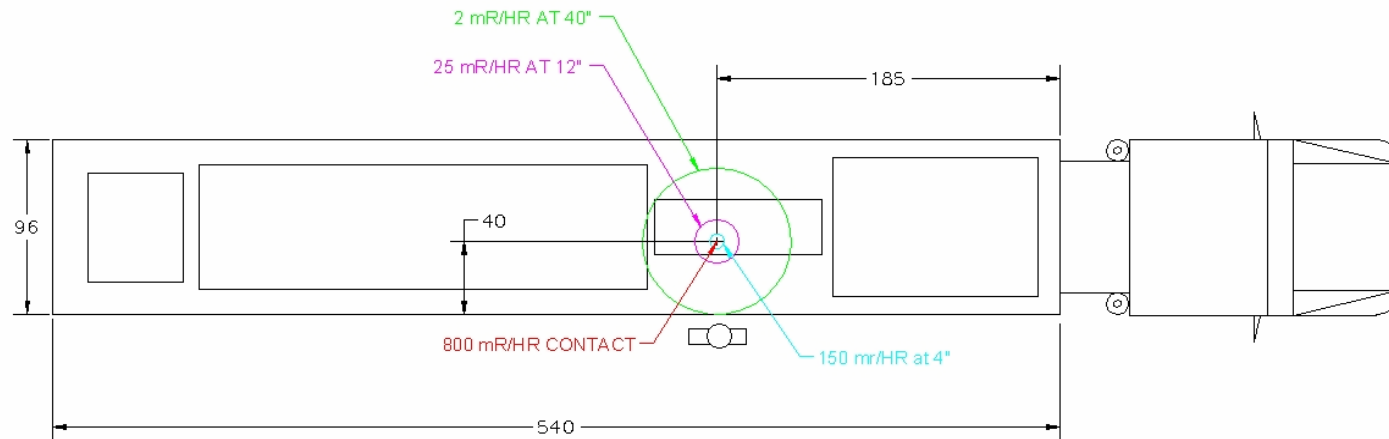
**Survey data
illustrated
graphically**

MAR Survey Data	WB Survey Data
OUTSIDE of box 455 Performed at WB	Detector : TELEPOLE (gamma readings) 800 mr/hr on contact 25 mr/hr at 12 inches No smearable contamination	Detector : TELETENSOR 2000 mr/hr gamma and beta on contact 150 mr/hr at 4 inches No smearable contamination
INSIDE of box 455 Performed at WB	Detector : TELEPOLE 800 mr/hr on contact 70 mr/hr at 12 inches	Detector : RSO-5 1500 mr/hr on contact (open window) 800 mr/hr on contact (closed window)
INSIDE of BOX 455 after removal of "Hot Spot" Performed at WB	Detector : TELEPOLE 1 to 2 mr/hr on contact	
On hot spot removed from BOX 455 Performed at MAR	Detector : TELEPOLE 1100 mr/hr on contact	
On hot spot removed from BOX 455 with 3/16" plate Performed at MAR	Detector : TELEPOLE 800 mr/hr on contact 14 mr/hr at 12 inches

Good Gamma Survey Data Consistency With No External Beta Contamination Found

**Conclusion of Risk Assessment :
No Undue Risk to the Public or Truck Driver**
