INSPECTION REPORT

**Spent Fuel Project Office
Office of Nuclear Material Safety and Safeguards**

Docket No.: 72-1007

Inspection Report: 72-1007/97-212

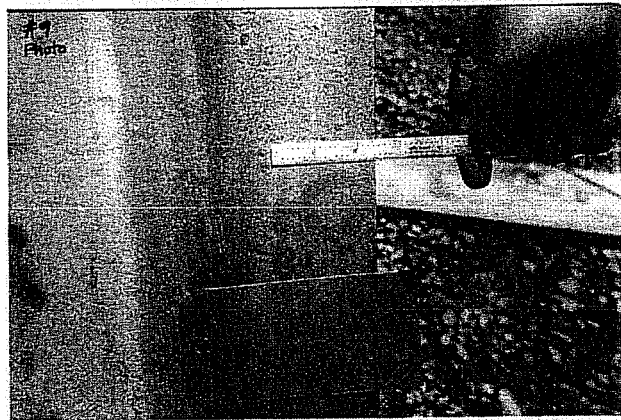
Photo #9

The circular indications on photographs #9, #14, and #14A were found by nitric acid etching of the surface and are weld fusion areas. These are typical of indications found on other empty MSB's currently on site. The largest circular indications are typically 61-63 inches from the zero circumference mark, are approximately an inch from the edge, and are approximately 1.6 inches in diameter. The shape of the other weld fusion regions vary from circular to more elongated and irregular, with a "C" shape on several.

Note that none of these imperfections were found to be deep enough to intrude upon the minimum wall thickness
