SUBJECT: NRC INSPECTION REPORT 050-00312/08-001

Docket No.: 050-00312  
License No.: DPR-54  
Report No.: 050-00312/08-001  
Licensee: Sacramento Municipal Utility District  
Facility: Rancho Seco Nuclear Generating Station  
Location: 14440 Twin Cities Road  
Herald, California  
Dates: April 14 through May 16, 2008  
Inspectors: Emilio M. Garcia, Health Physicist  
James L. Montgomery, Health Physicist  
Accompanied by: Thomas H. Youngblood, Jr., Health Physicist Reactor  
Decommissioning Branch, Office of Federal and State  
Materials and Environmental Management Programs  
Approved By: Jack E. Whitten, Chief  
Nuclear Materials Safety Branch B  
Attachments: Supplemental Information  
Partial List of Documents Reviewed

### Rancho Seco Nuclear Generating Station NRC Inspection Report 050-00312/08-001

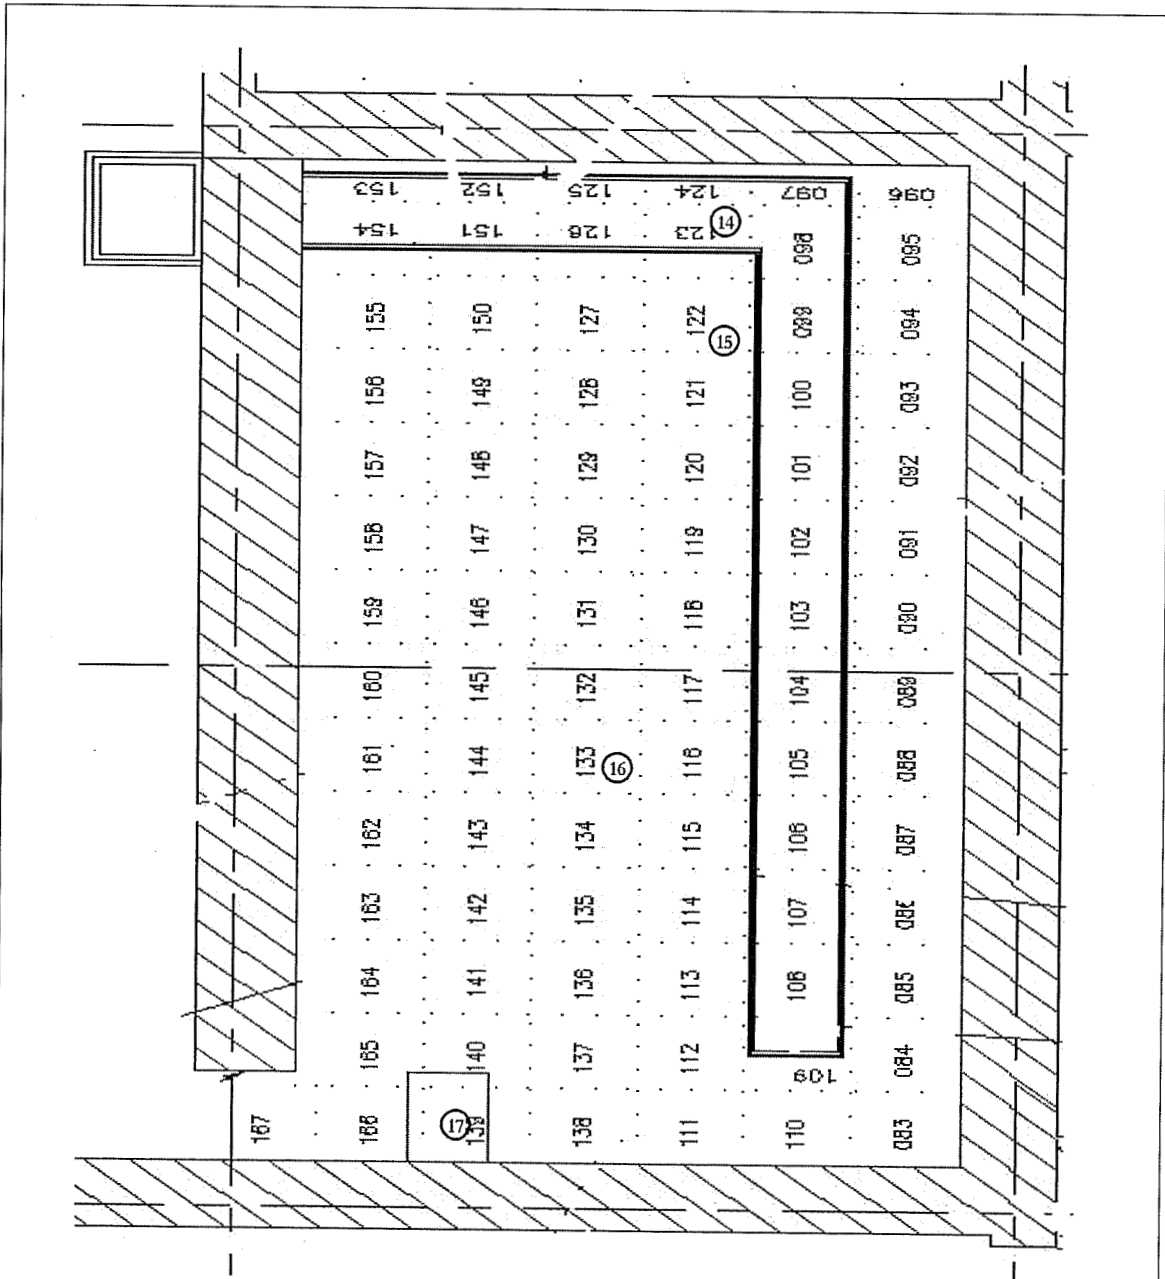
Figure 6: Survey Unit F8130201, Room 18 – Direct Measurement and Sample Locations

Beta and gamma surface scans identified several areas of elevated beta surface activity on the structural surfaces of the evaluated SUs with the Auxiliary Building. With one exception, additional investigation of these locations indicated that the majority of the elevated surface activity levels were attributable to localized areas of residual beta-gamma radiation within the matrix of the concrete media. In general, the elevated surface activity was limited to small areas that were interspersed throughout the rooms. The one exception was a discrete particle of Cs-137 and Co-60 that was found in Room 18. Direct measurements were performed at 26 locations. As mentioned above,

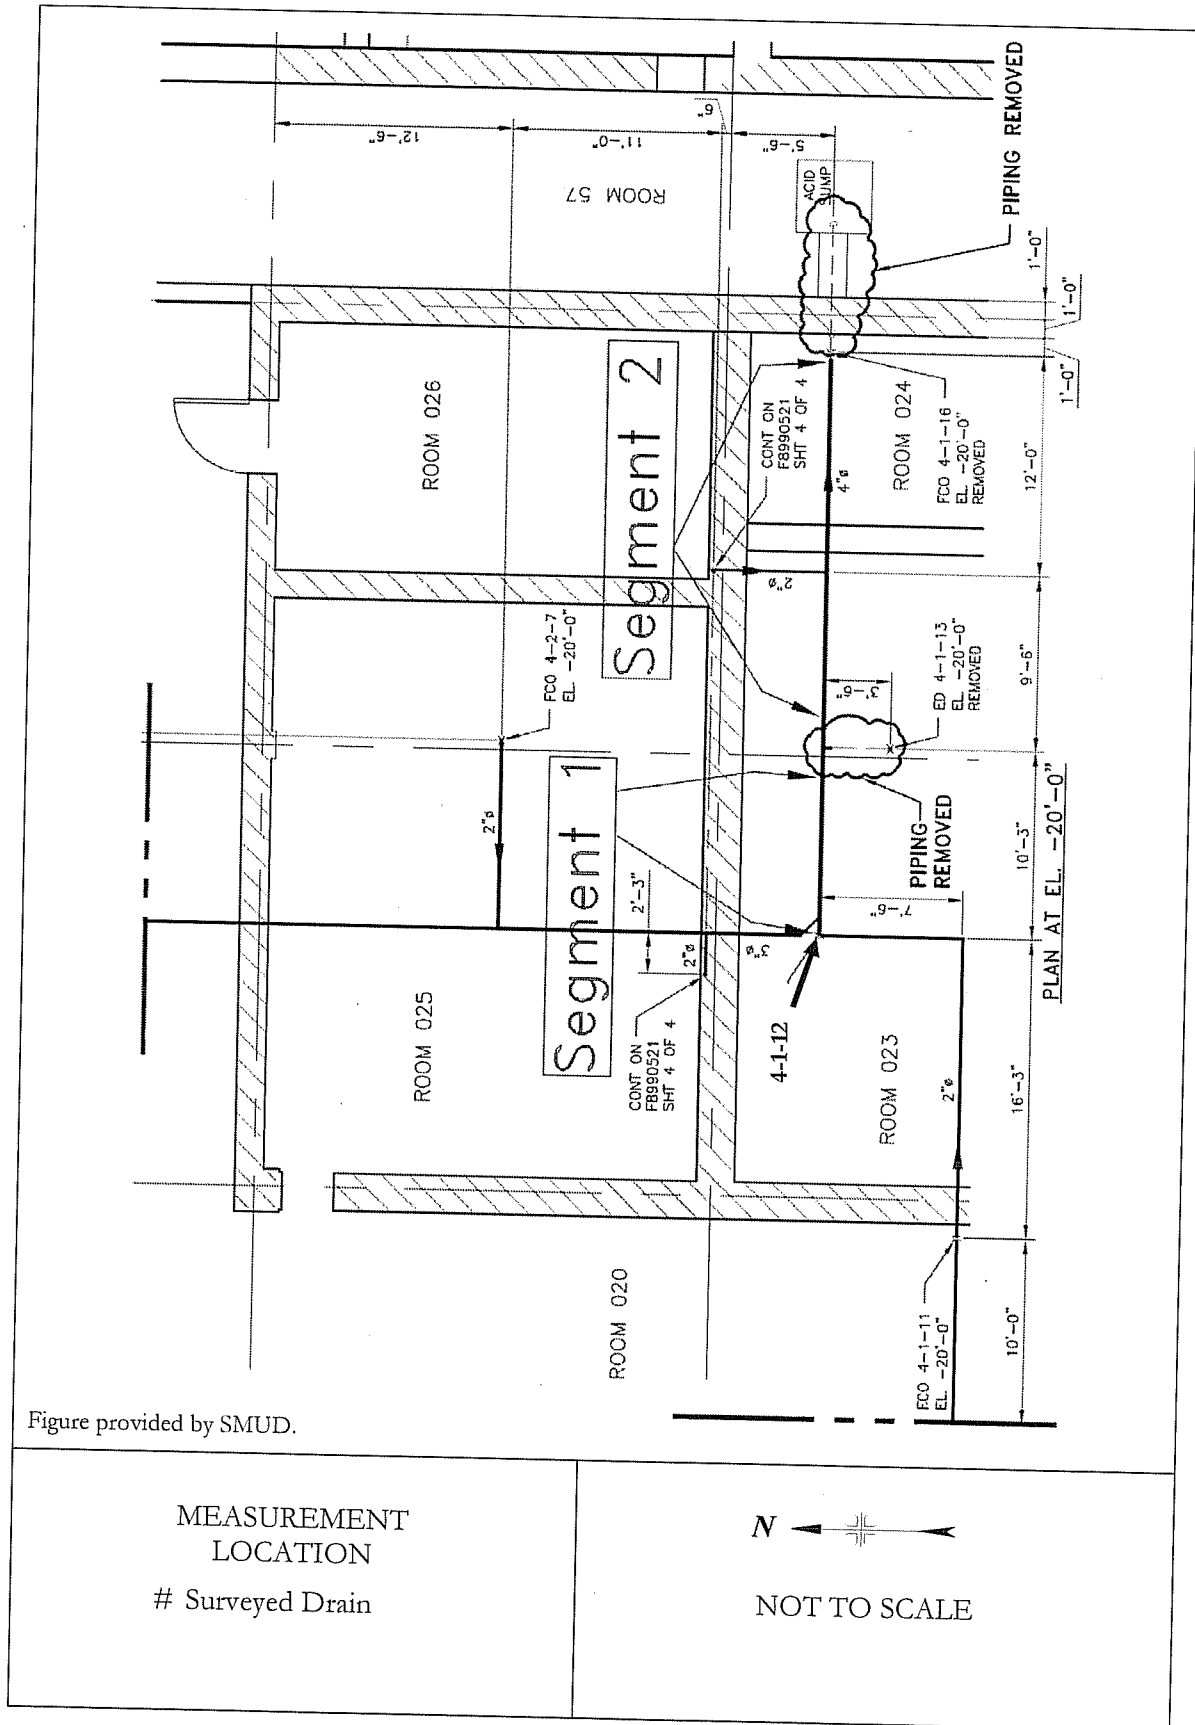
Figure 9: Survey Unit F8990521, Acid Waste Drains – Surveyed Drain 4-1-12, Segment 1

<sup>f</sup>SMUD originally numbered incorrectly Acid Waste Drain Line 4-1-12, Segment 1 as 4-1-13. Due to discrepancies in the survey data, ORISE recommends further evaluation of this drain line and the instrumentation used to collect the preliminary FSS data.
