# AMAG ROOT CAUSE - FINAL

1. Title: ~~XXXXXXXXXX~~ Feedwater Ultrasonic Flow Measurements Caused by Low Frequency Velocity Signals Result in Exceeding Licensed Maximum Power Level at Byron and Braidwood Stations

2. Unit(s): Byron Station Units 1 and 2  
Braidwood Station Unit 2

3. Action Tracking Item Number: 173510-14  
Report Date: 8/28/03

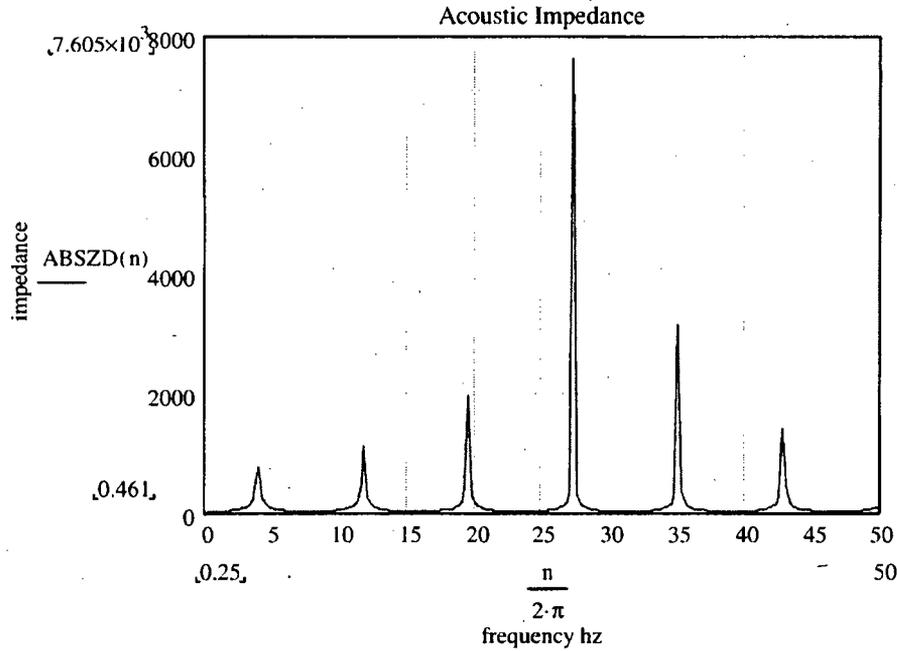
This plot shows agreement with the frequencies predicted using open-closed formulas for the common header, and suggests that the most significant mode for excitation of the common header would be approximately 27 hz at full flow conditions. A similar calculation for the combined pump discharge, bypass line, and common header, treated as a single diameter pipe carrying full flow yields the following results:

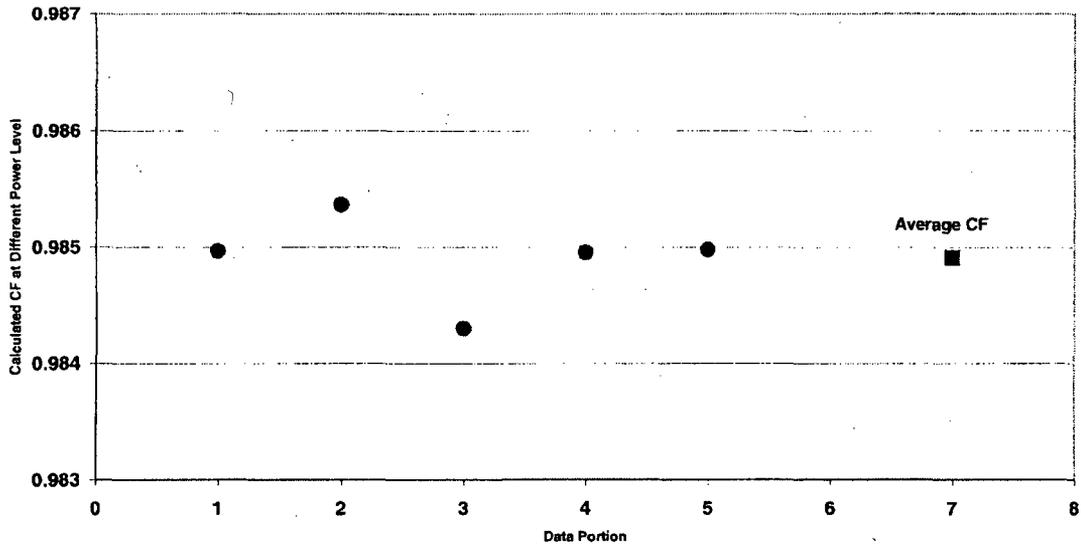
Figure 2. Calculated CF value for different data portion (Note: average CF is the average of all 5 calculated values).

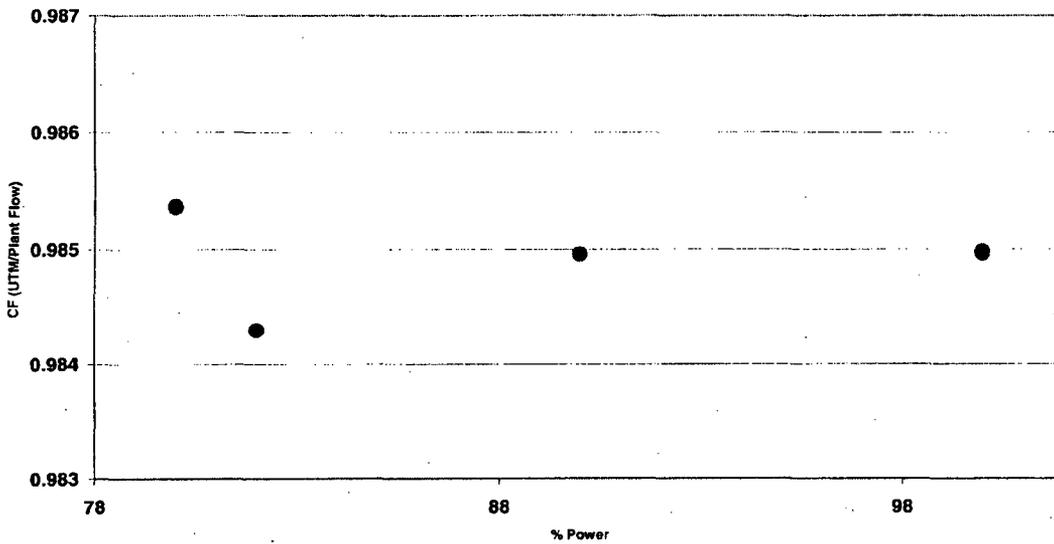
Figure 3. CF behavior as a function of power (Note: there are two points (CF for data portion 1 and 5) on top of each other at 100% power)
