ULNRC-05518

**DOCKET NUMBER 50-483
CALLAWAY PLANT UNIT 1
UNION ELECTRIC CO.
FACILITY OPERATING LICENSE NPF-30
RESPONSE TO REQUEST FOR ADDITIONAL INFORMATION
REGARDING REPORT OF FIRST REPLACEMENT STEAM GENERATOR
TUBE IN-SERVICE INSPECTION (TAC NO. MD7372)
Reference: AmerenUE ULNRC-05450, Results of First Replacement Steam
Generator Tube In-Service Inspection, dated October 25, 2007**

**RESPONSE TO NRC RAI QUESTIONS/REQUESTS REGARDING THE
REPORT OF RESULTS OF CALLAWAY PLANT'S FIRST REPLACEMENT
STEAM GENERATOR TUBE IN-SERVICE INSPECTION**

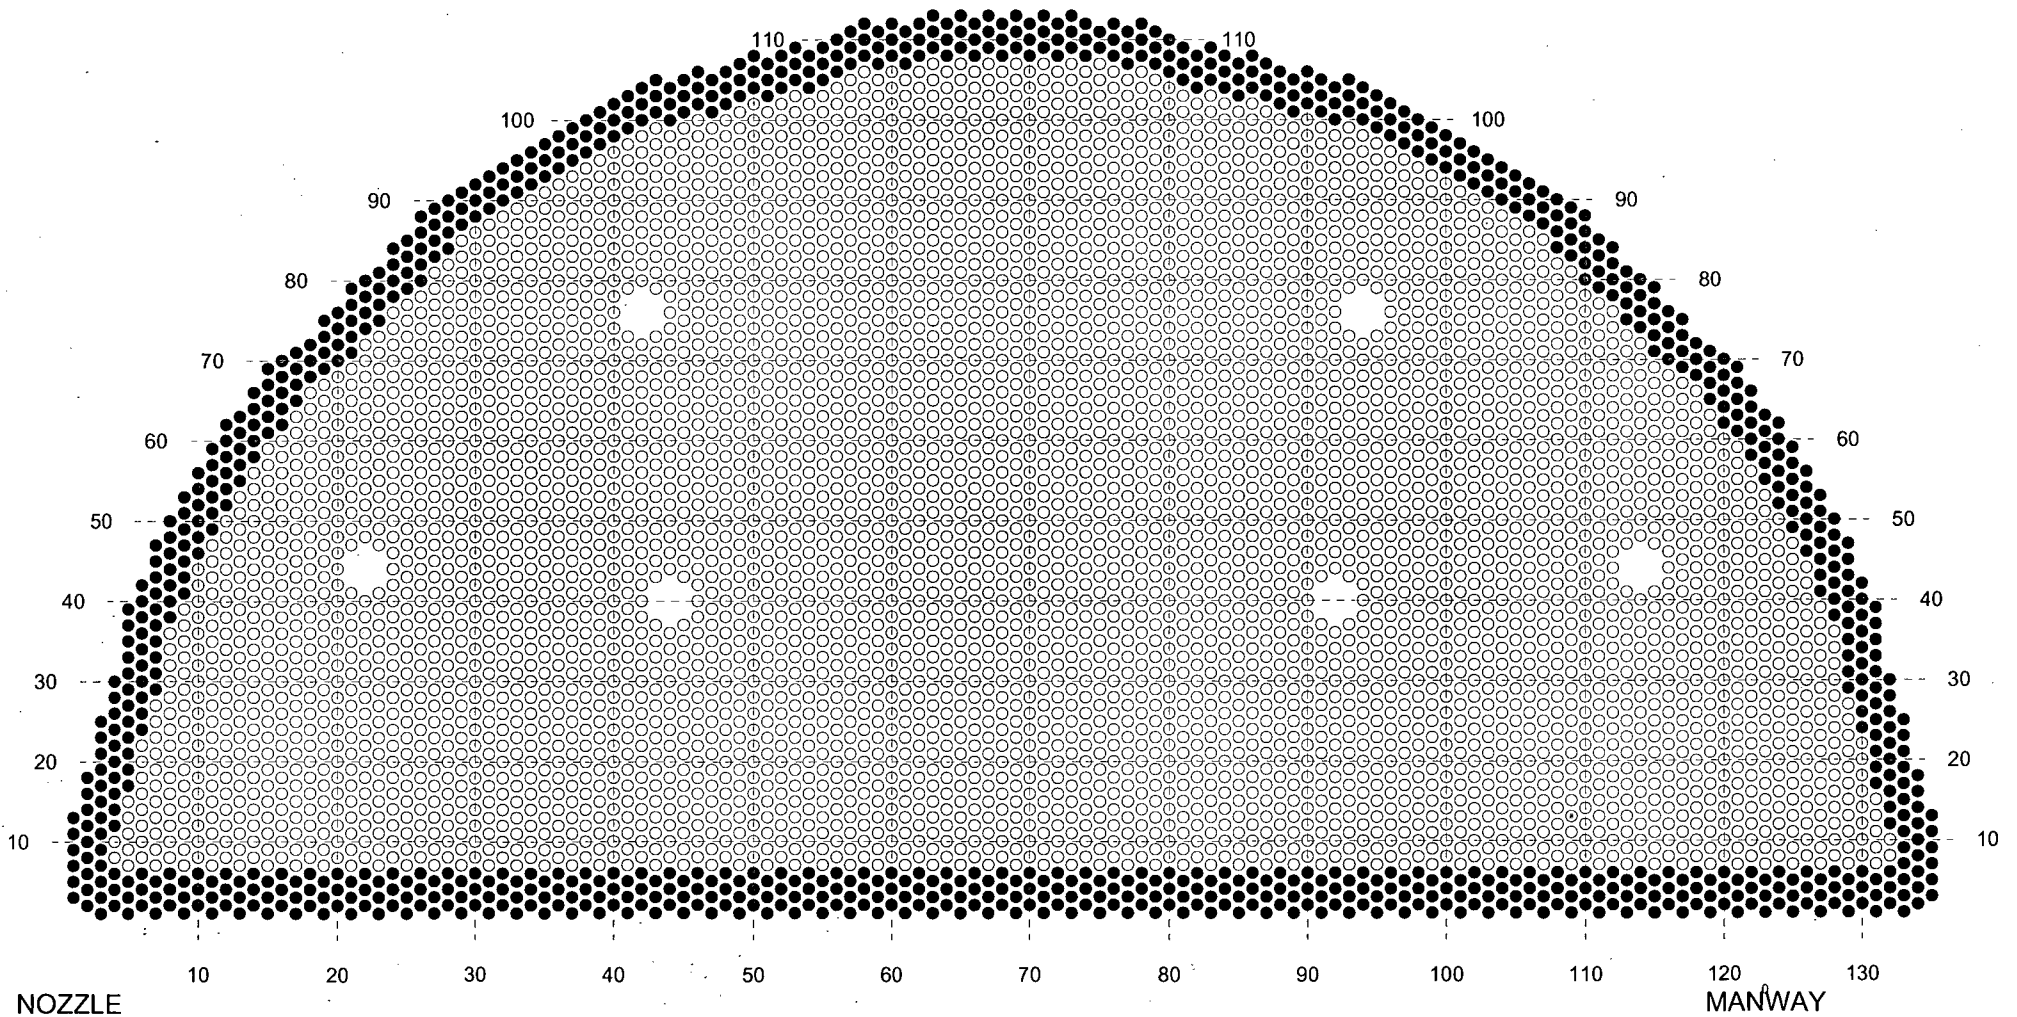
TUBE SHEET MAP (COLD LEG)

Periphery tubes in both the hot and cold leg tubes were inspected with the +Point. Refer to Letter Attachments 3 and 4 for more detail.

GROUP
A C/L TTS +3/-3

C/L Top of Tubesheet + Point Examination w/ Probe 610PP

S/G A
COLD
PRIMARY FACE

TOTAL TUBES: 5872
SELECTED TUBES: 965
OUT OF SERVICE (#): 1

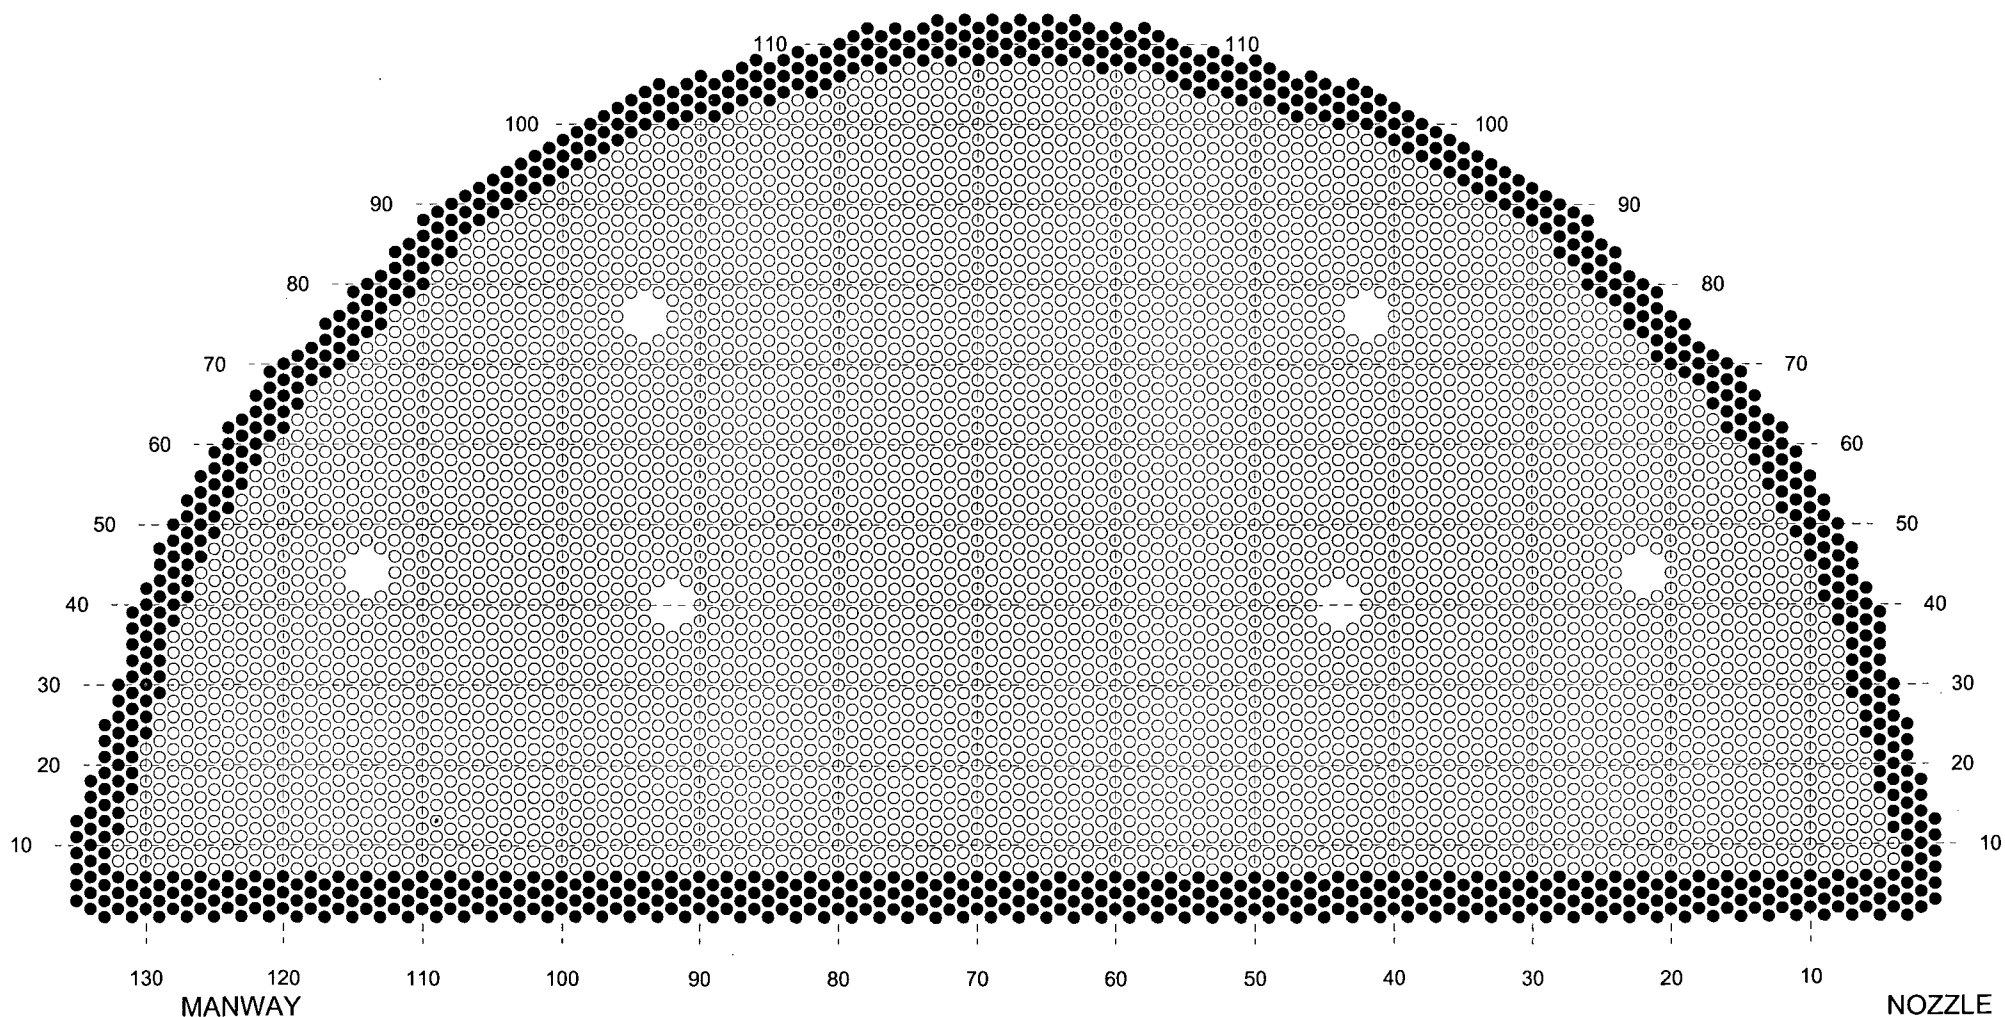
TUBE SHEET MAP (HOT LEG)

GROUP
A H/L TTS +3/-3

H/L Top of Tubesheet +Point Examination w/ Probe 610PP

S/G A
HOT
PRIMARY FACE

TOTAL TUBES: 5872
SELECTED TUBES: 965
OUT OF SERVICE (#): 1
