**UNITED STATES
NUCLEAR REGULATORY COMMISSION**
REGION I
475 ALLENDALE ROAD
KING OF PRUSSIA, PA 19406-1415

**SUBJECT: OYSTER CREEK GENERATING STATION - NRC INTEGRATED INSPECTION
REPORT 05000219/2009003**

Docket No. 50-219
License No. DPR-16

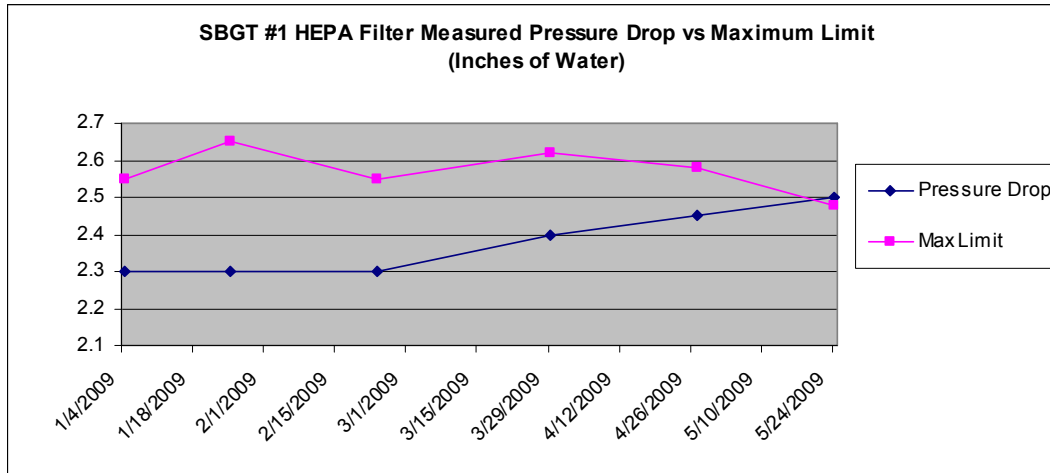
Exelon performed an evaluation (IR 923558) and determined that the filter started to experience a degraded trend in pressure drop across the HEPA filters beginning in March 2009. The evaluation identified that performance monitoring and trending on the SBGTS was not being performed as required by Exelon's procedure ER-AA-2003, "System Performance Monitoring and Analysis;" and that this trending information could have identified the degraded trend, allowing Exelon personnel to perform corrective actions prior to the #1 SBGTS being declared inoperable.

The inspectors reviewed #1 SBGTS performance data (flow, temperature, HEPA filter dP, Reactor Building dP) between January 2006 thru May 2009 and various Exelon procedures to determine if it was reasonable for Exelon personnel to have identified this degraded condition. The inspectors evaluated the performance data with the graph below and identified that in March 2009 the pressure drop began to increase.

Exelon's procedure ER-AA-2003 establishes the minimum standards for system performance monitoring by engineering personnel. The procedure states that system engineers will perform performance monitoring thru trending and analyzing system and component data against established action levels. The procedure further states that if adverse trends are identified then an evaluation should be performed to determine the required actions. The inspectors determined that there was sufficient data and procedural guidance available for Exelon to identify that an adverse trend existed on the #1 SBGTS upstream HEPA filter.

Exelon's corrective actions included replacing the HEPA filters, reviewing #2 SBGTS historical performance data, and reviewing the expectations for system monitoring with engineering personnel.
