Replacement Steam Generator

Divider Plate Weld Joint Separation

Root Cause Evaluation

San Onofre Nuclear Generating Station, Units 2 & 3 REPLACEMENT STEAM GENERATORS

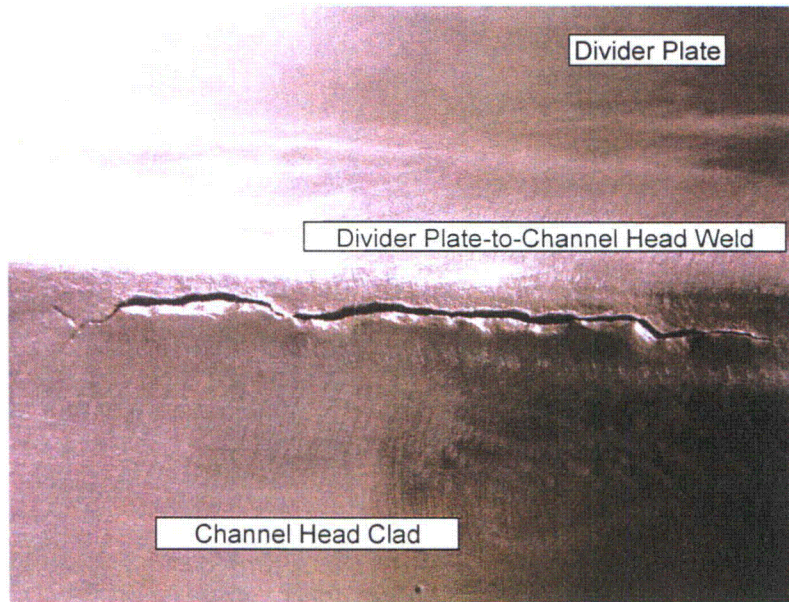
Figure 1-1 RSG 3B Crack in the Divider Plate-to-Channel Head Weld

On the 3B RSG, a 120 mm (5-inch) long crack on the cold leg side of the divider plate-to-channel head weld was reported on March 18, 2009 during inspection after completion of the primary and secondary side hydrostatic pressure tests (see Figure 1-1).

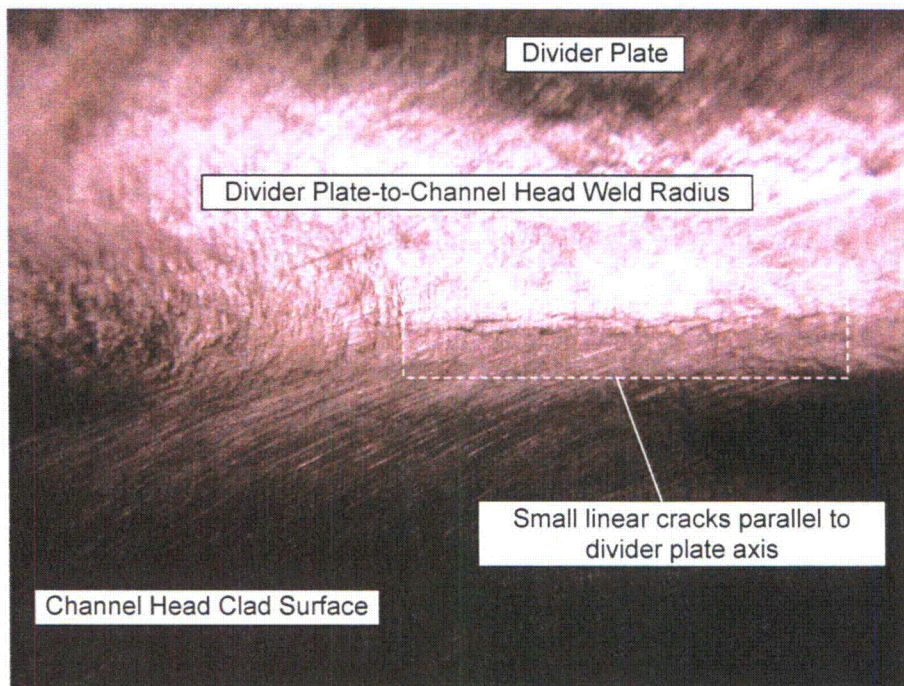
Figure 2.1-1 RSG 3A Hot-Side Divider Plate-to-Channel Head Weld PT Indications

On the 3A RSG, nine small cracks were found on the hot side of the divider plate-to-channel head weld (Figure 2.1-1). The PT indications were in the center of the channel head flat bottom area, extending over a total distance of approximately 1200 mm (~47"). No indications were found on the cold side of the weld..

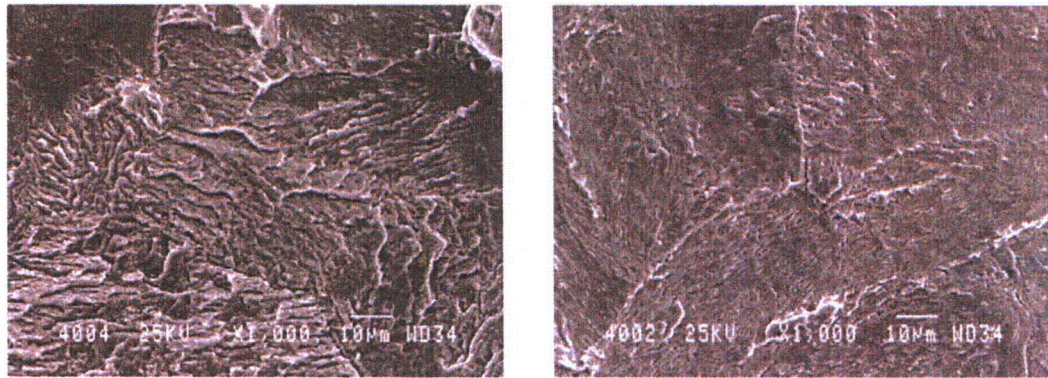
Figure 3.1-2 Fracture surfaces of the Unit-3 samples

- The crack observed on the surface of the divider plate-to-channel head weld fillet on the 3B RSG was a ductile fracture.
- Where the butter/clad separated from the base metal, the fracture surface characteristics were indicative of a brittle fracture. Figure 3.1-2 (left) shows quasi-cleavage and (right) shows Type II grain boundary-like pattern, both typical for brittle fractures.

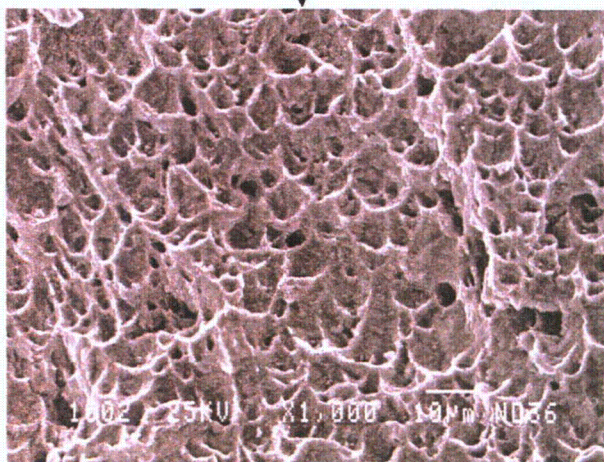
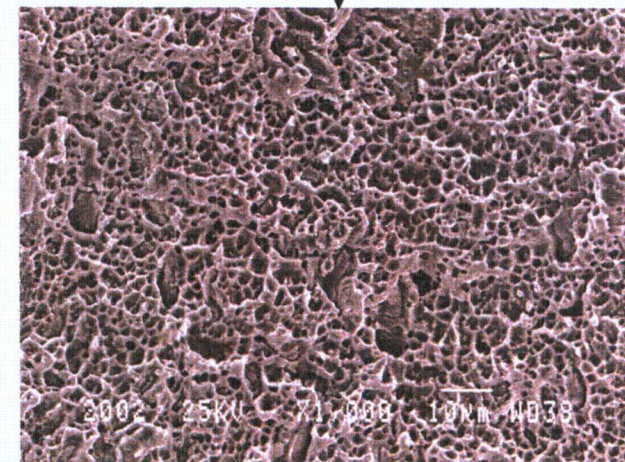
Fig. A. 8(1) SEM observation of fracture surface of TP A-1 (sample A)

Ductile fracture surface with dimple

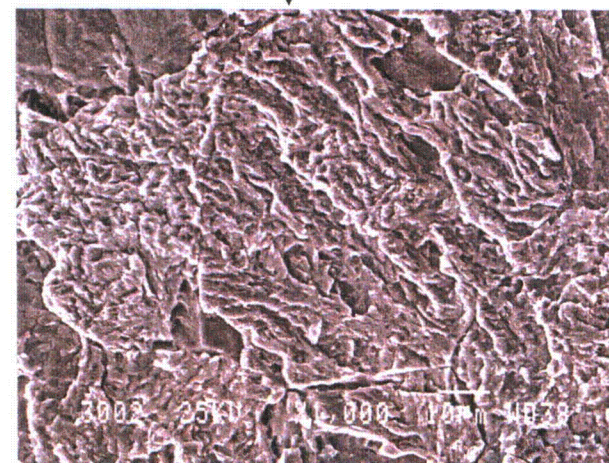
Fig. A.8(2) SEM observation of fracture surface of TP A-1 (sample A) (Continued)

Quasi-cleavage fracture surface

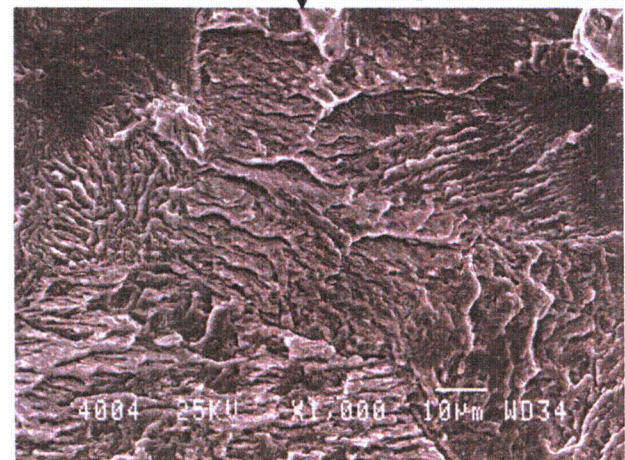
Fig. A.10(1) SEM observation of fracture surface of TP A-2(sample A)

Quasi-cleavage fracture surface

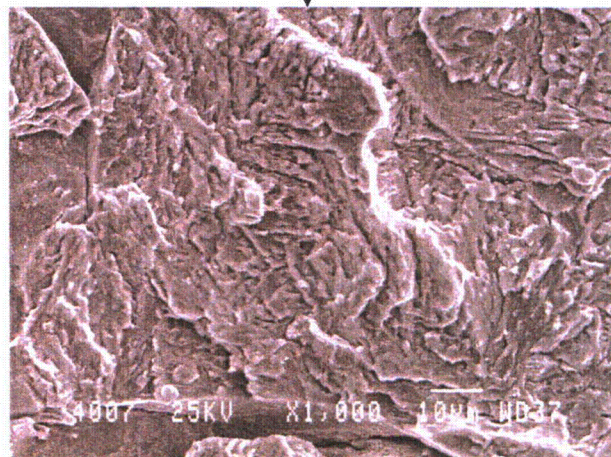
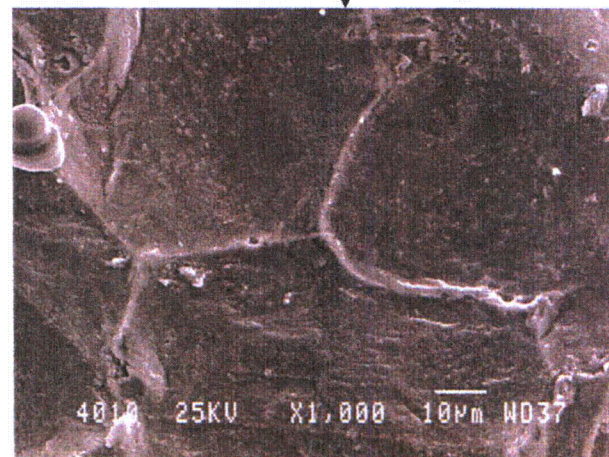
Fig. A.10(2) SEM observation of fracture surface of TP A-2(sample A) (Continued)

Quasi-cleavage fracture surface

Dendrite-boundary-like pattern

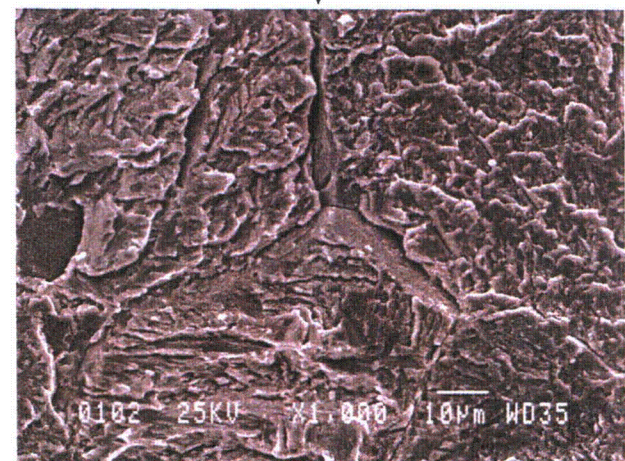
Fig. A. 20(1) SEM observation of fracture surface of sample B (152 buttering)

Quasi-cleavage fracture surface

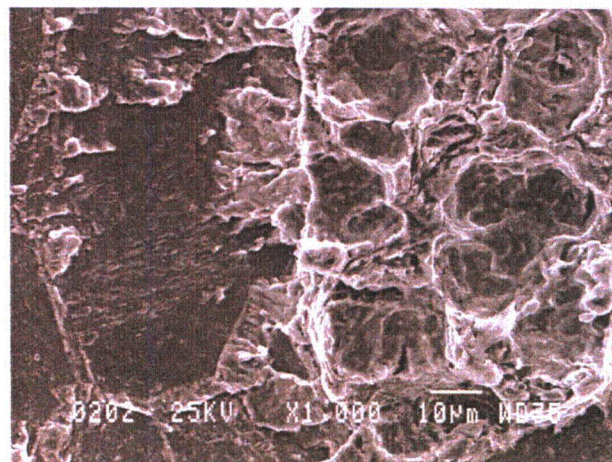
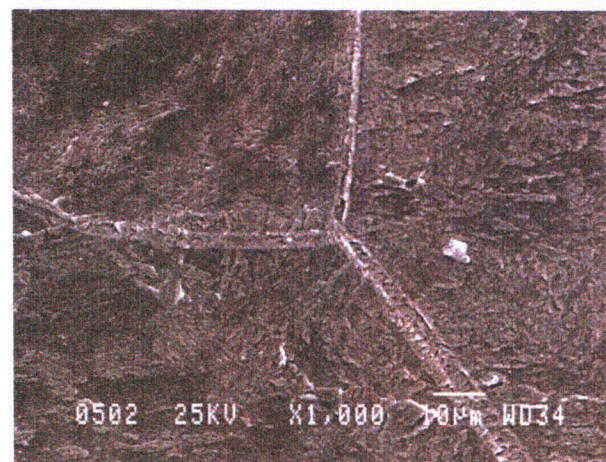
Fig. A. 20(2) SEM observation of fracture surface of sample B (152 buttering) (continued)

Ductile fractured surface

Dendrite-boundary-like pattern

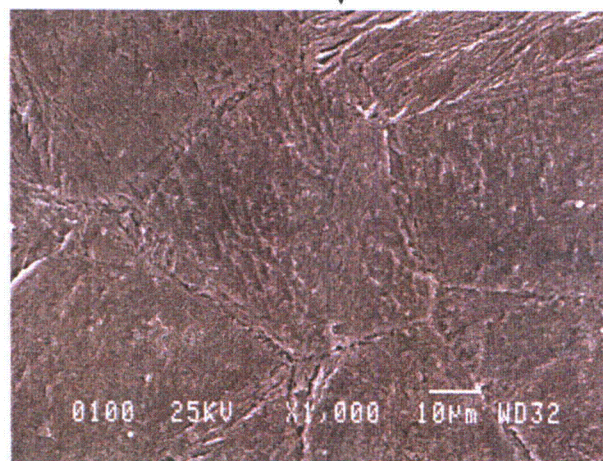
Fig. A. 21(1) SEM observation of fracture surface of sample B (Low alloy steel channel head)

Grain-boundary-like pattern

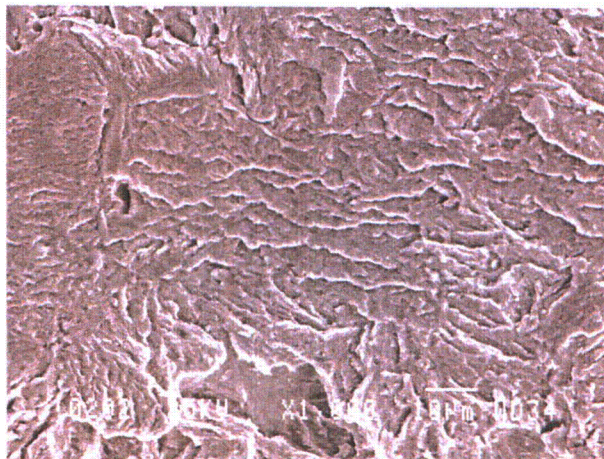
Fig. A. 21 (2) SEM observation of fracture surface of sample B (Low alloy steel channel head) (continued)

Quasi-cleavage fracture surface
