Fig. A.24(1) Vickers hardness of cross section of sample B (152 buttering)

Fig. A.25 Vickers hardness of cross section of sample B (Low alloy steel channel head)

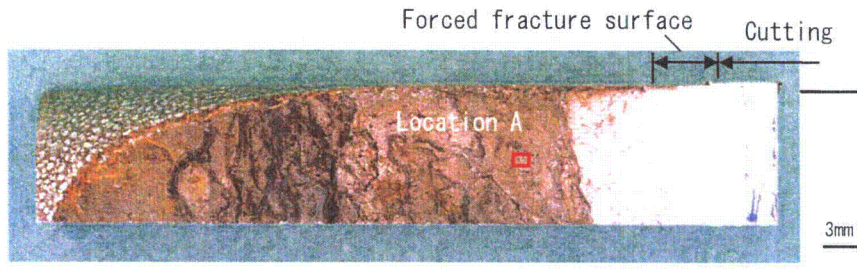
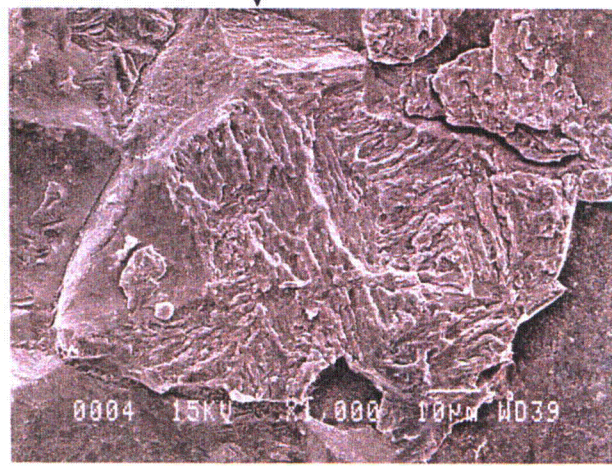
Fig. A. 31(1) SEM observation of fracture surface of TP C-1 (sample C)

Dendrite-boundary-like pattern

Quasi-cleavage fracture surface

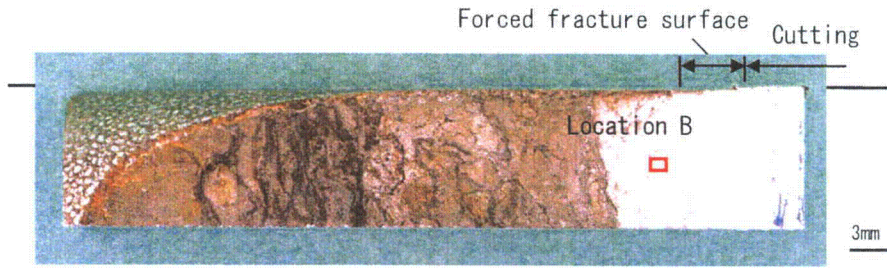
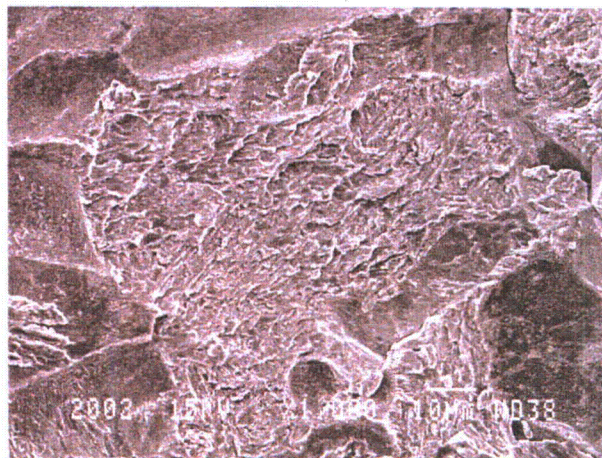
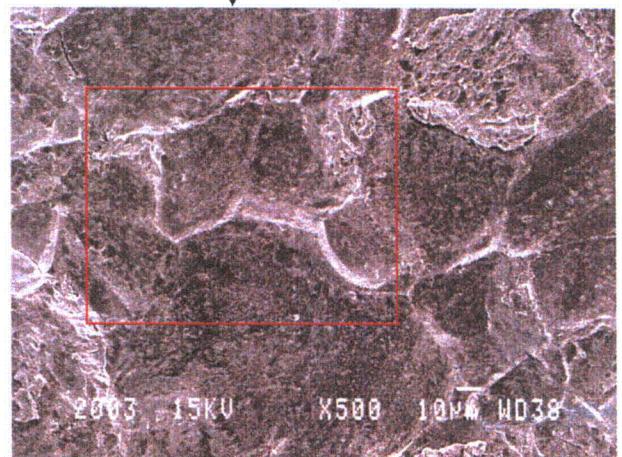
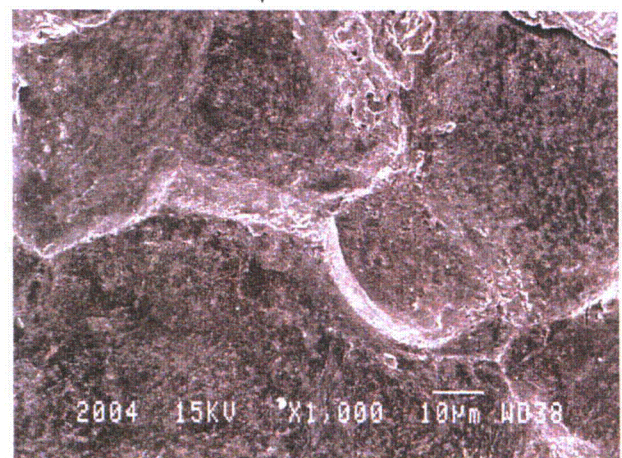
Fig. A.31(2) SEM observation of fracture surface of TP C-1(sample C) (Continued)

Quasi-cleavage fracture surface

Dendrite-boundary-like pattern

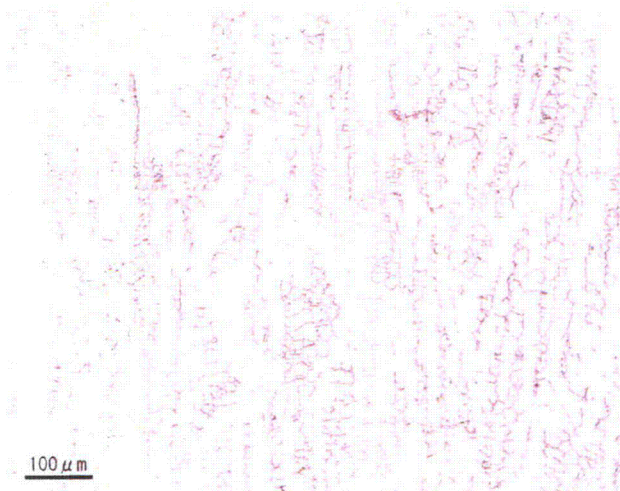
Detail observation of location E
(LAS)

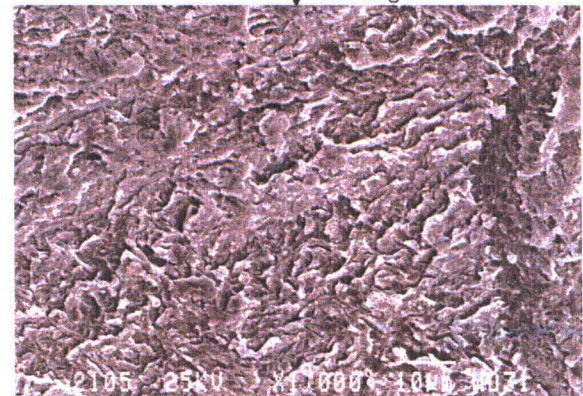
Fig.A.38(1) SEM observation of fracture surface of sample D (152 buttering)

Dendrite boundary like or grain boundary like pattern

Quasi-cleavage fracture surface

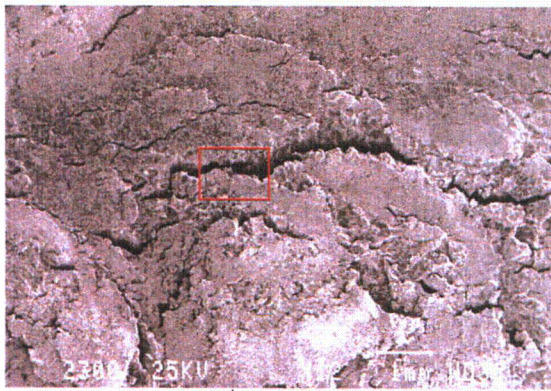
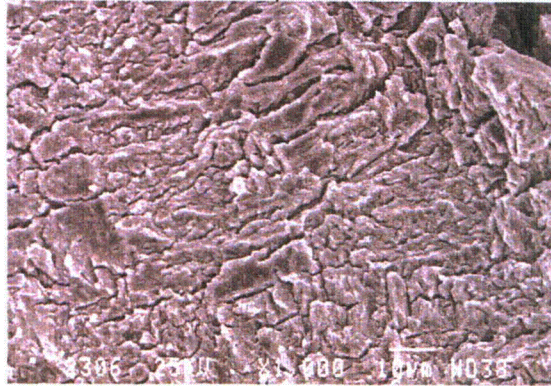
Detail observation of location B

Quasi-cleavage fracture surface

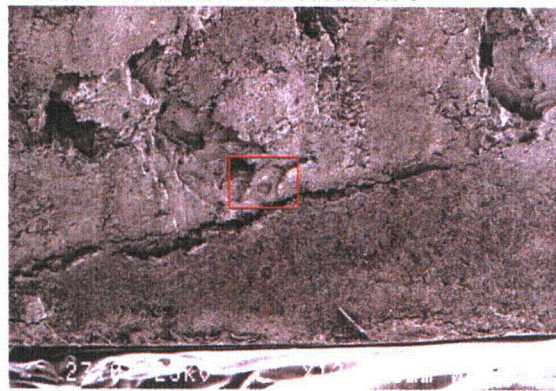
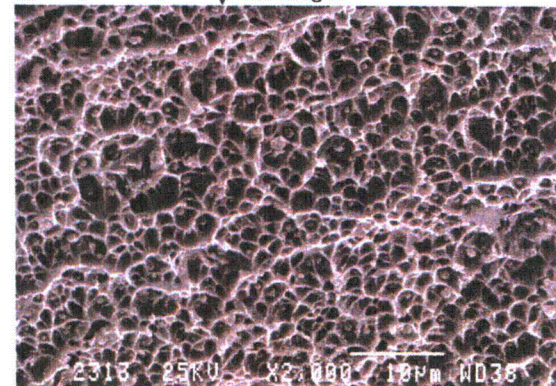
Detail observation of location C

Ductile fracture surface

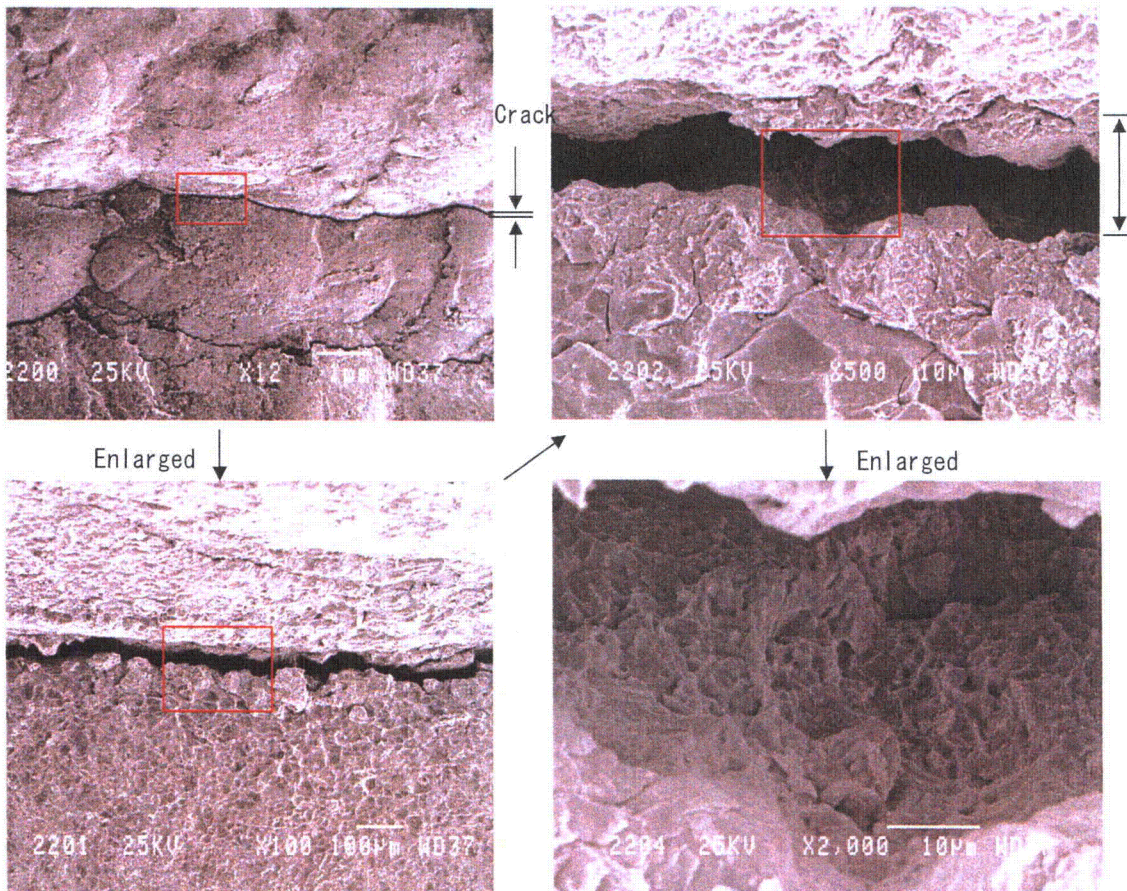
Fig.A.38(3) SEM observation of fracture surface of sample D (boundary between 152 buttering and stainless steel clad by SMAW)

Ductile fracture surface

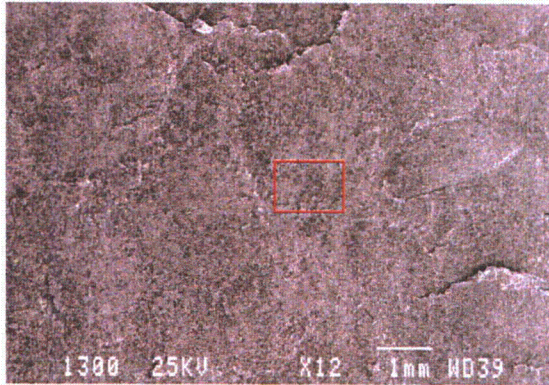
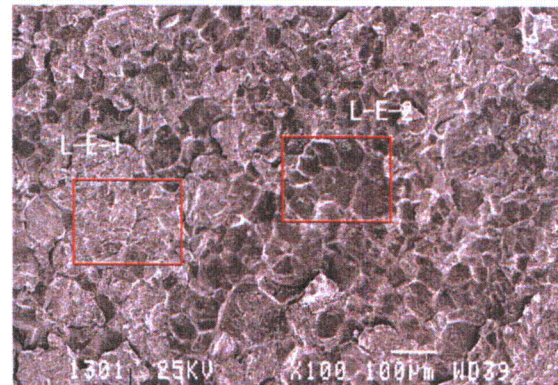
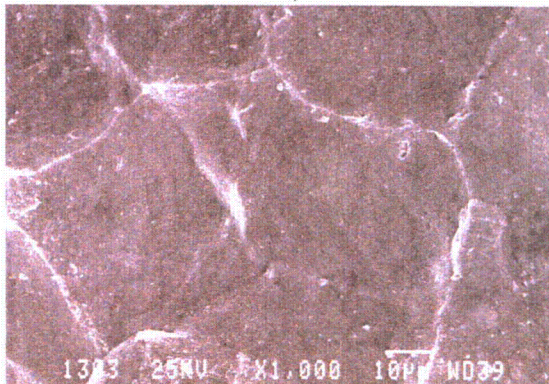
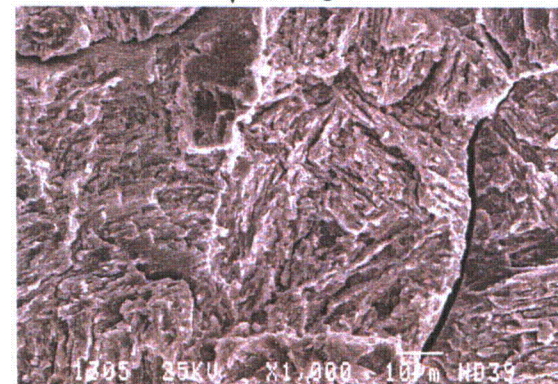
Fig.A.38(4) SEM observation of fracture surface of sample D (Stainless steel clad by ESW)

Dendrite boundary like or grain boundary like

Quasi-cleavage fracture surface

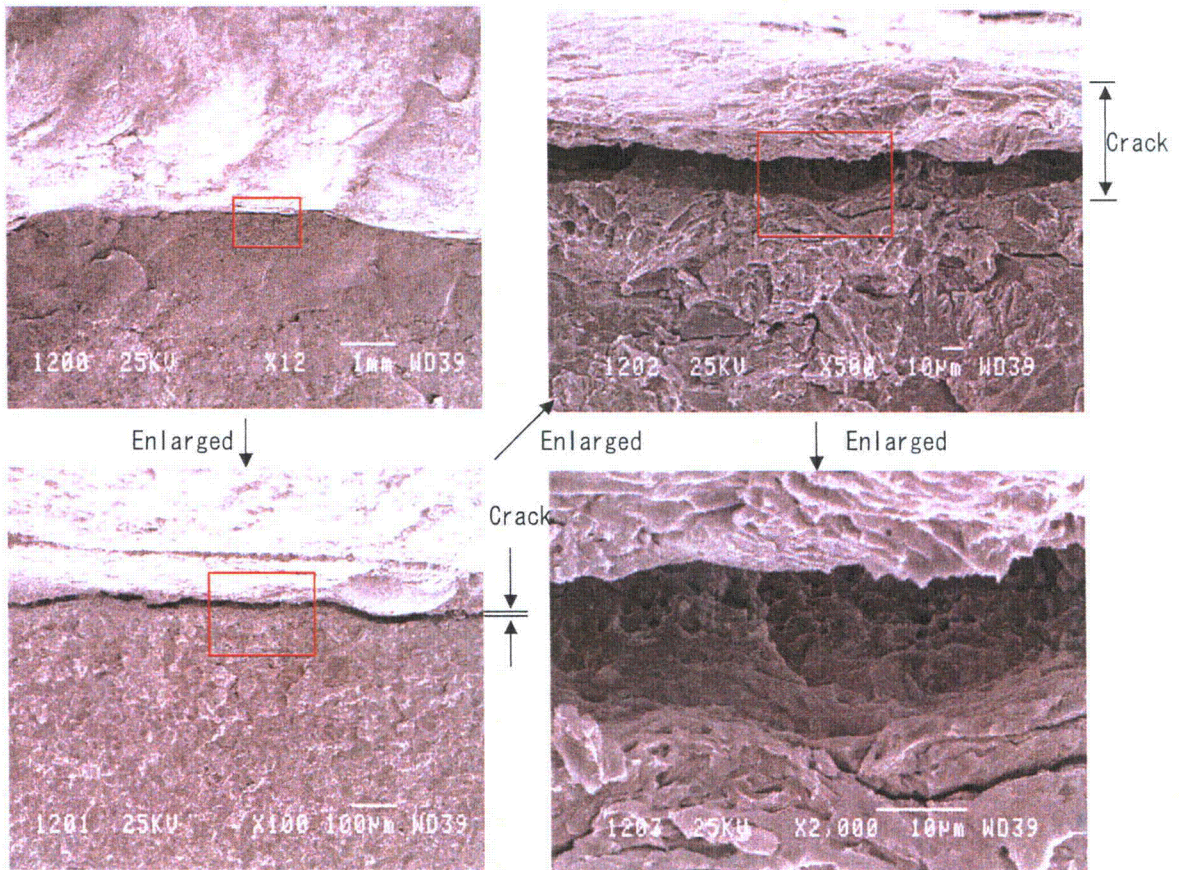
Fig.A.38(5) SEM observation of fracture surface of sample D (boundary between 152 buttering and stainless steel clad by ESW)

Ductile fracture surface

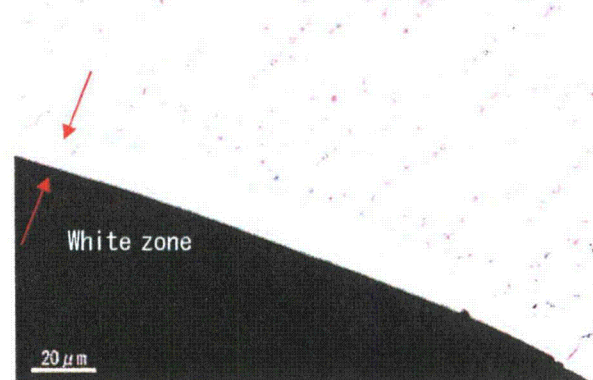
Fig.A.39(2) Microstructure observation of cross section of sample D
 (152 buttering and boundary between 152 buttering and stainless steel clad)

- Crack propagated near boundary between 152 buttering and stainless steel clad.
- Crack opened widely.
