II. Second Investigation

The purpose of this report is to provide results of additional investigation of I type mockups and boat samples collected from the U3B and U3A RSGs.

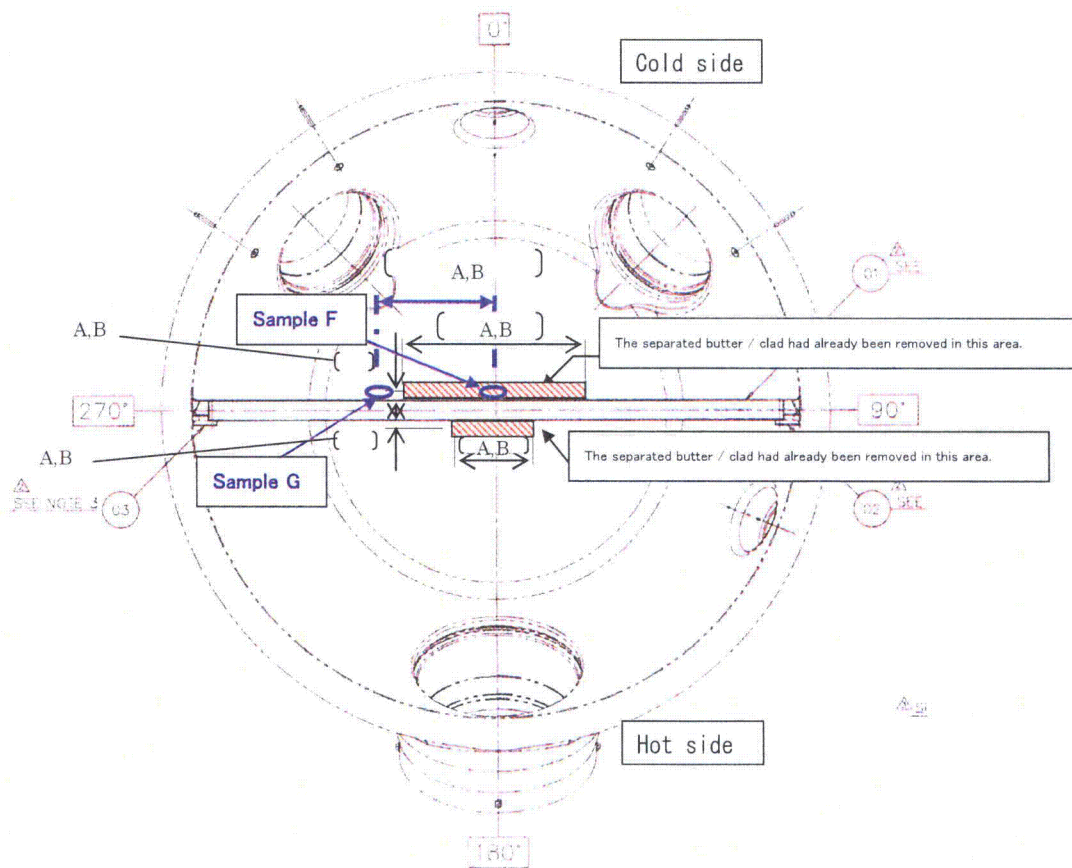
Figure A.44(1) The collecting location and schematic illustration of boat samples.
(collecting location of boat samples)

2 boat samples were additionally collected from Unit 3A RSG at the location as shown in Figure A.44. The detail of the each sample was shown in Table A.5.

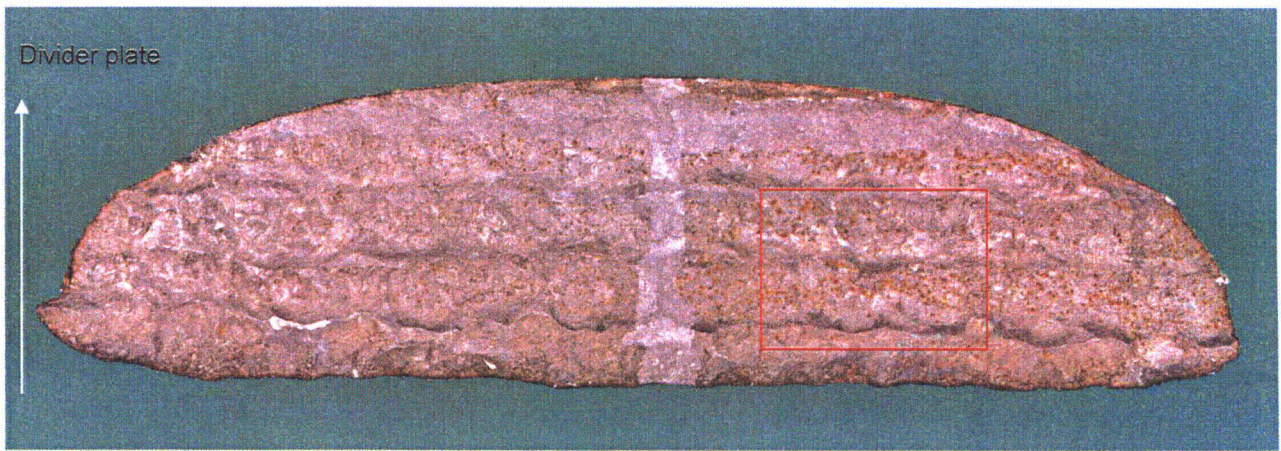
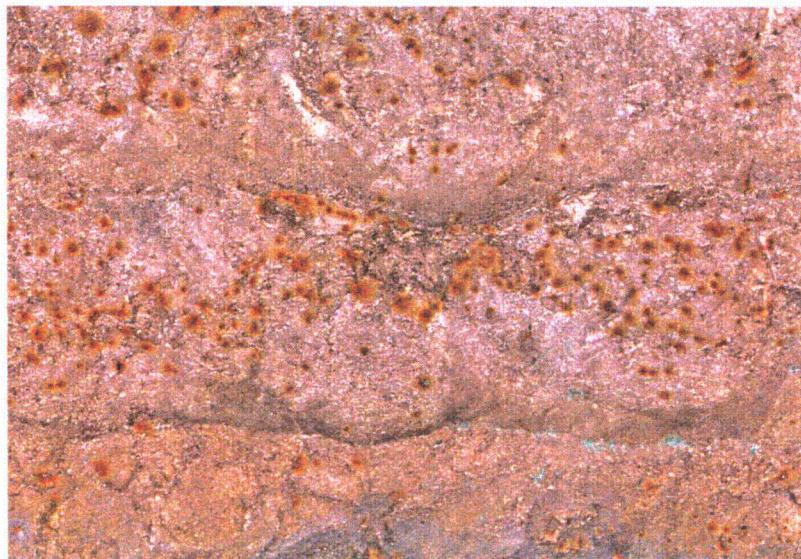
Figure A.47 Appearance of fracture surface of sample F

Figure A.47 shows appearance of fracture surface of the sample. A rough surface was observed on the fracture surface as observed in sample F. It is supposed that the rough surface corresponds to welding bead shape of 152 buttering.

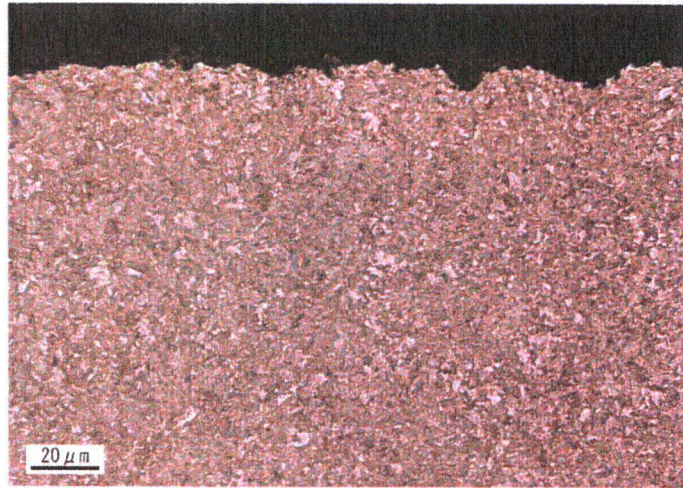
Figure A. 53(2) Microstructure of the cross section of LAS in I type model (before 152 buttering)

Any difference in grain size was not observed between machining and grinding after 152 buttering in I type mockups as shown in Figure A. 53(1). The effect of gouging on grain size was observed before 152 buttering as shown in Figure A. 53(2).

TP.2-1, ESW + Gouging + grinding
Grain size number: 13, Grain size: 0.004mm

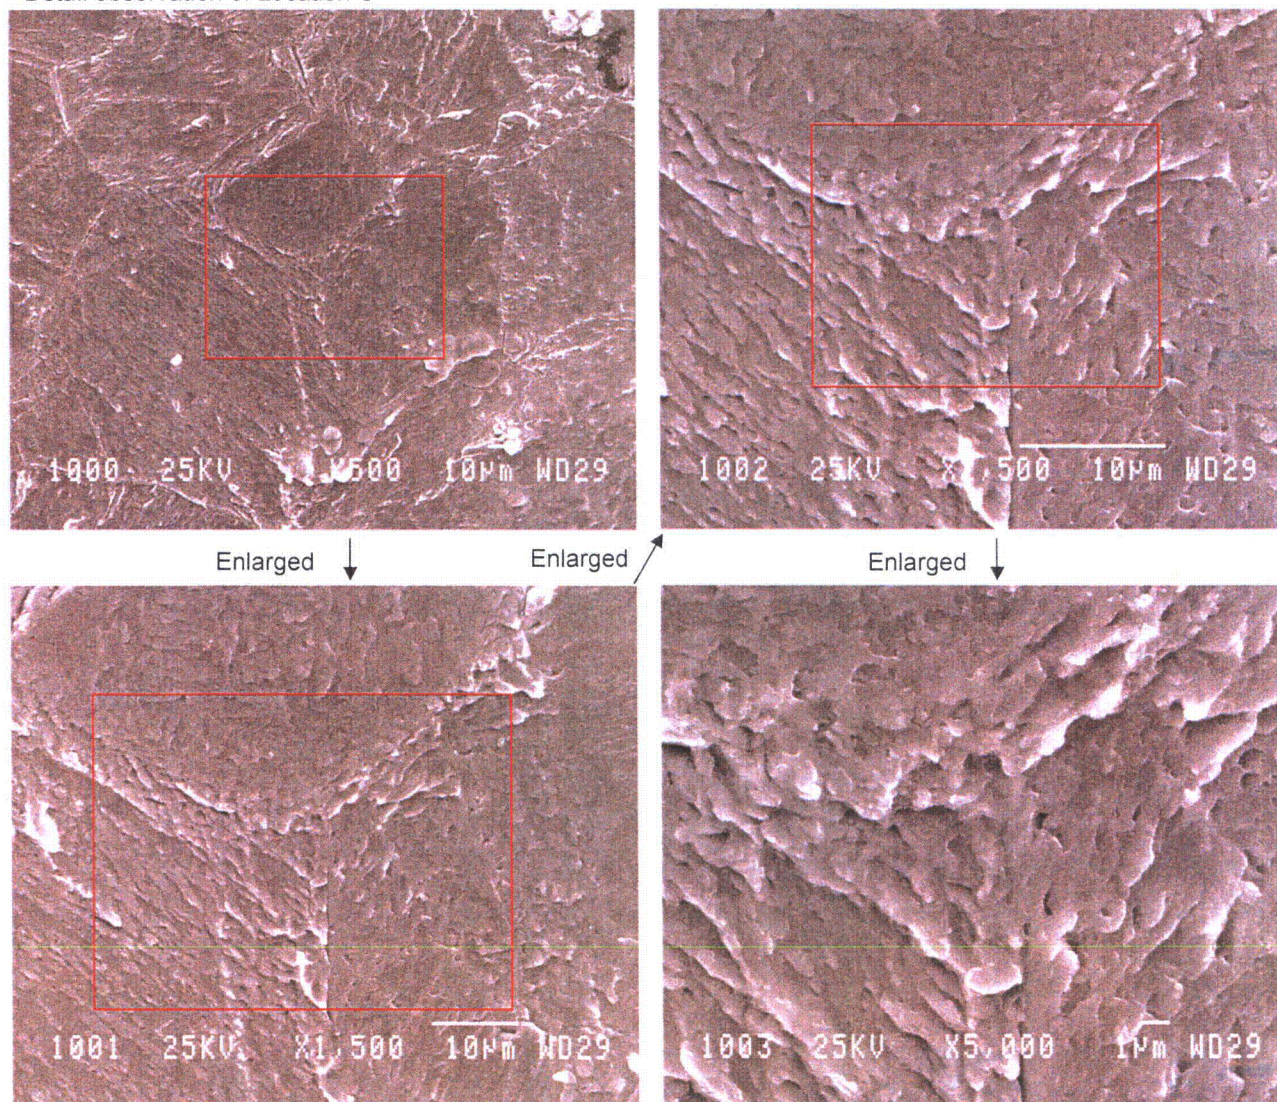
Figure S.2(2) SEM pictures of the fracture surface of the boat sample
(Sample A, TP A-2, location A)

- 1) At high magnification, the fracture surface of separation between low alloy steel and 152 buttering appeared to be like martensitic lath structure.
- 2) At high magnification, the fracture surface of separation between low alloy steel and stainless steel clad reveals relatively smooth surface.
- 3) Component variations were observed in 152 buttering adjacent to the separation.
- 4) It was observed that there was a certain level of compositional distribution of Fe, Cr and C at the fracture surface.
