Unit 1 Cook Nuclear Plant Turbine Event Status Report

***Nuclear Regulatory Commission
Presentation
November 2, 2009***

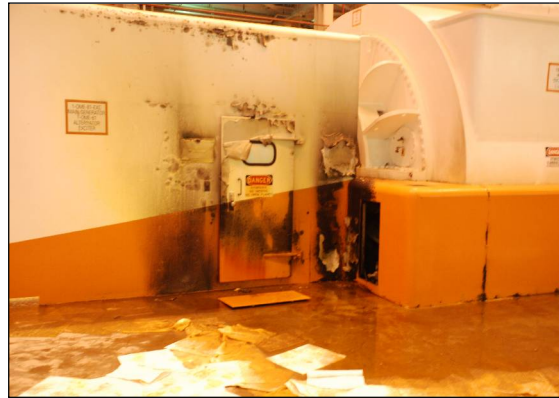
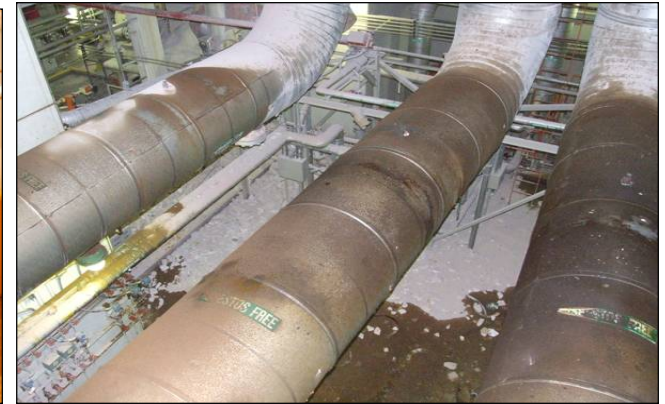
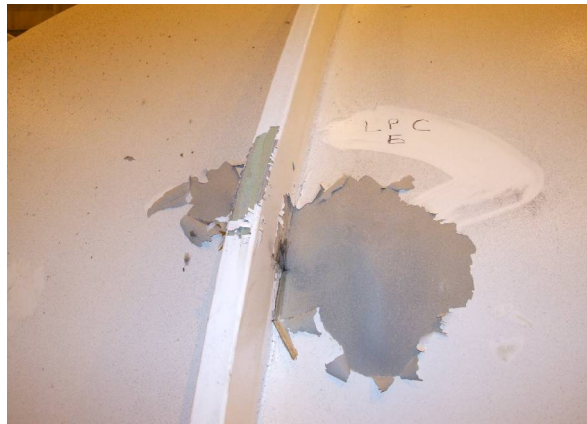
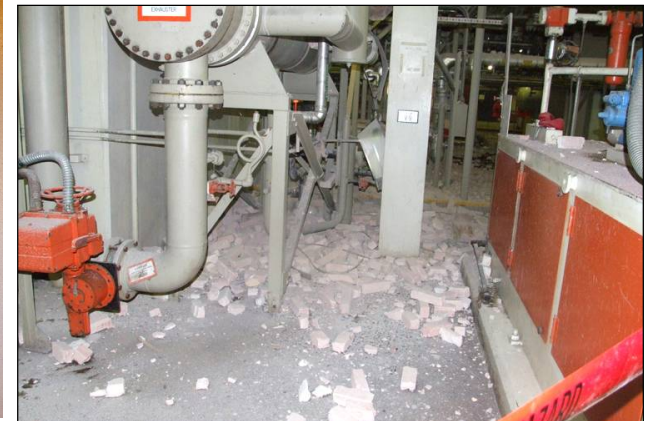
- Fire damage to main generator/exciter housing
- Turbine damage
- Piping insulation damage
- Visible concrete damage around turbine
- Oil spills
- Damaged hangers and supports on various pipe systems

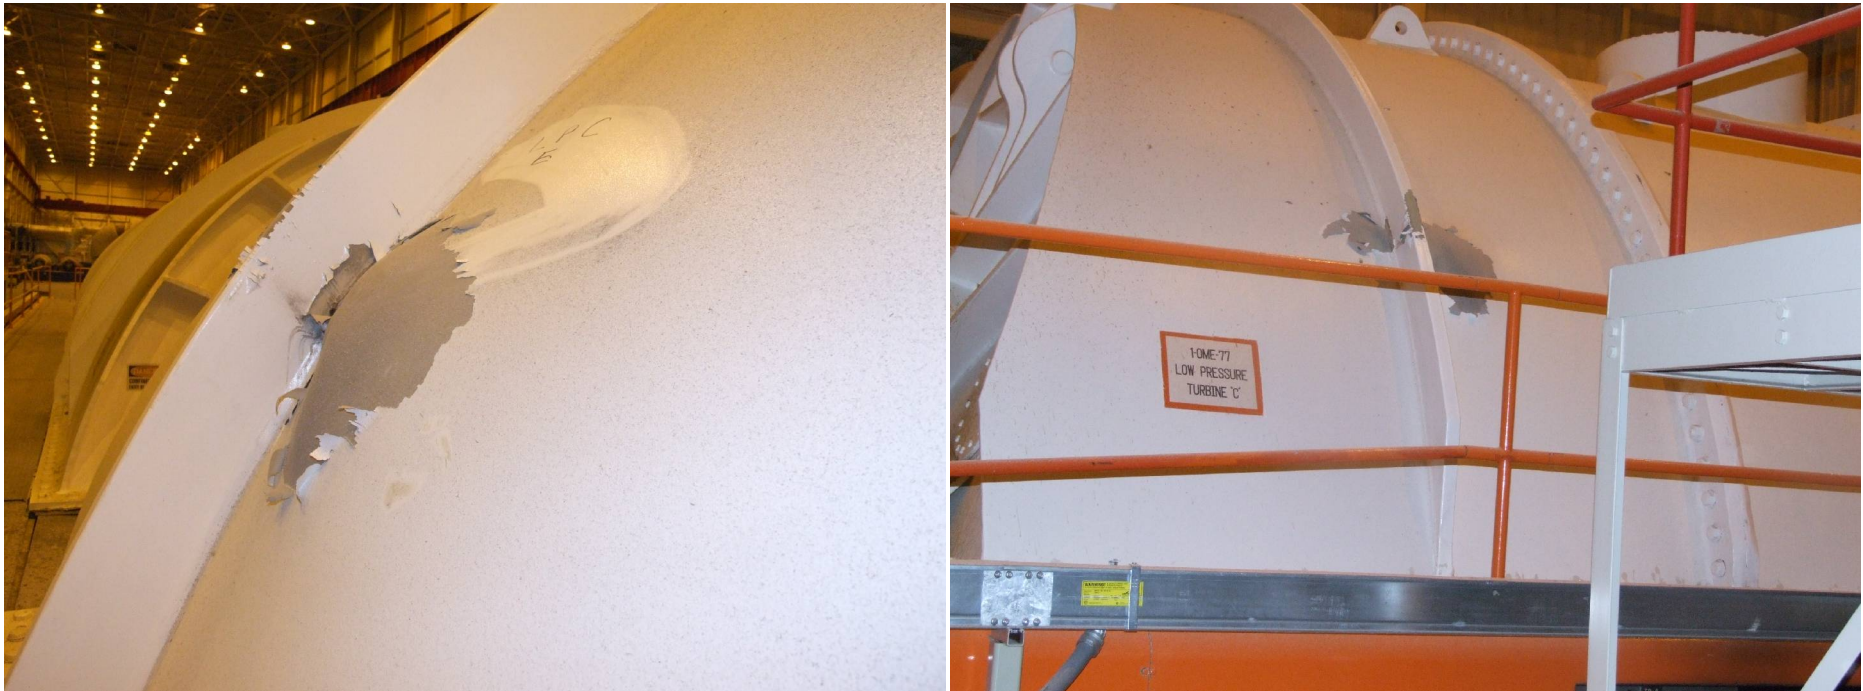
- LP turbine exhaust hoods
 - LP turbine exhaust hoods display evidence of blade impact
 - All blades were contained within turbine hoods
 - Bearing housings were displaced

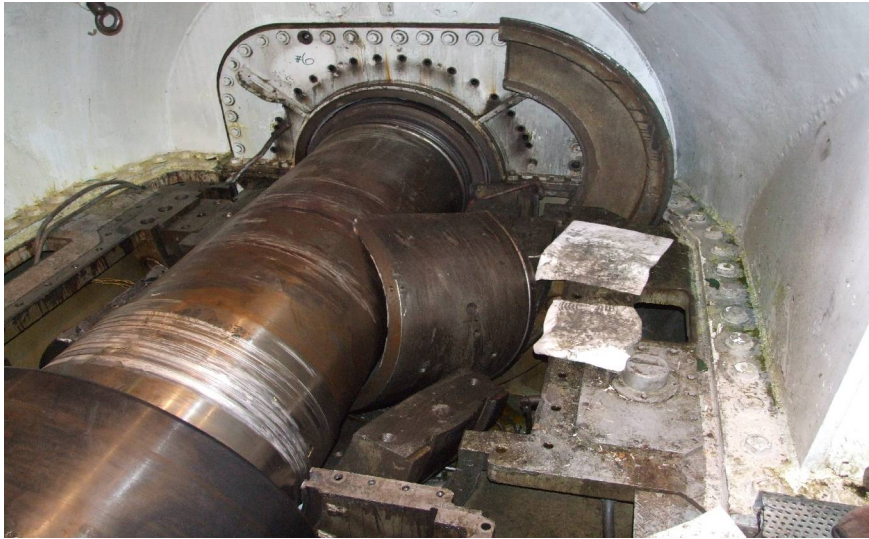
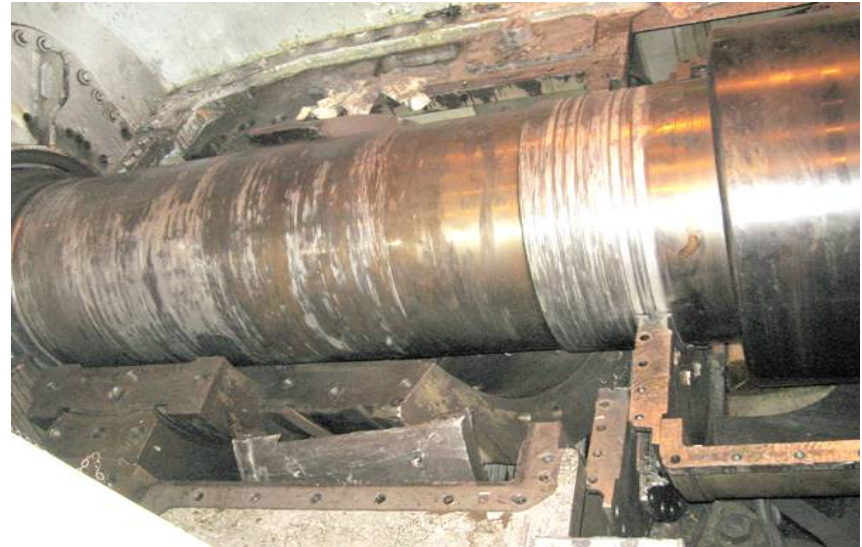
- Turbine shafts
 - No coast down or turning gear operation
 - Significant shaft scoring
 - Bearing damage evident at all 12 main bearing locations

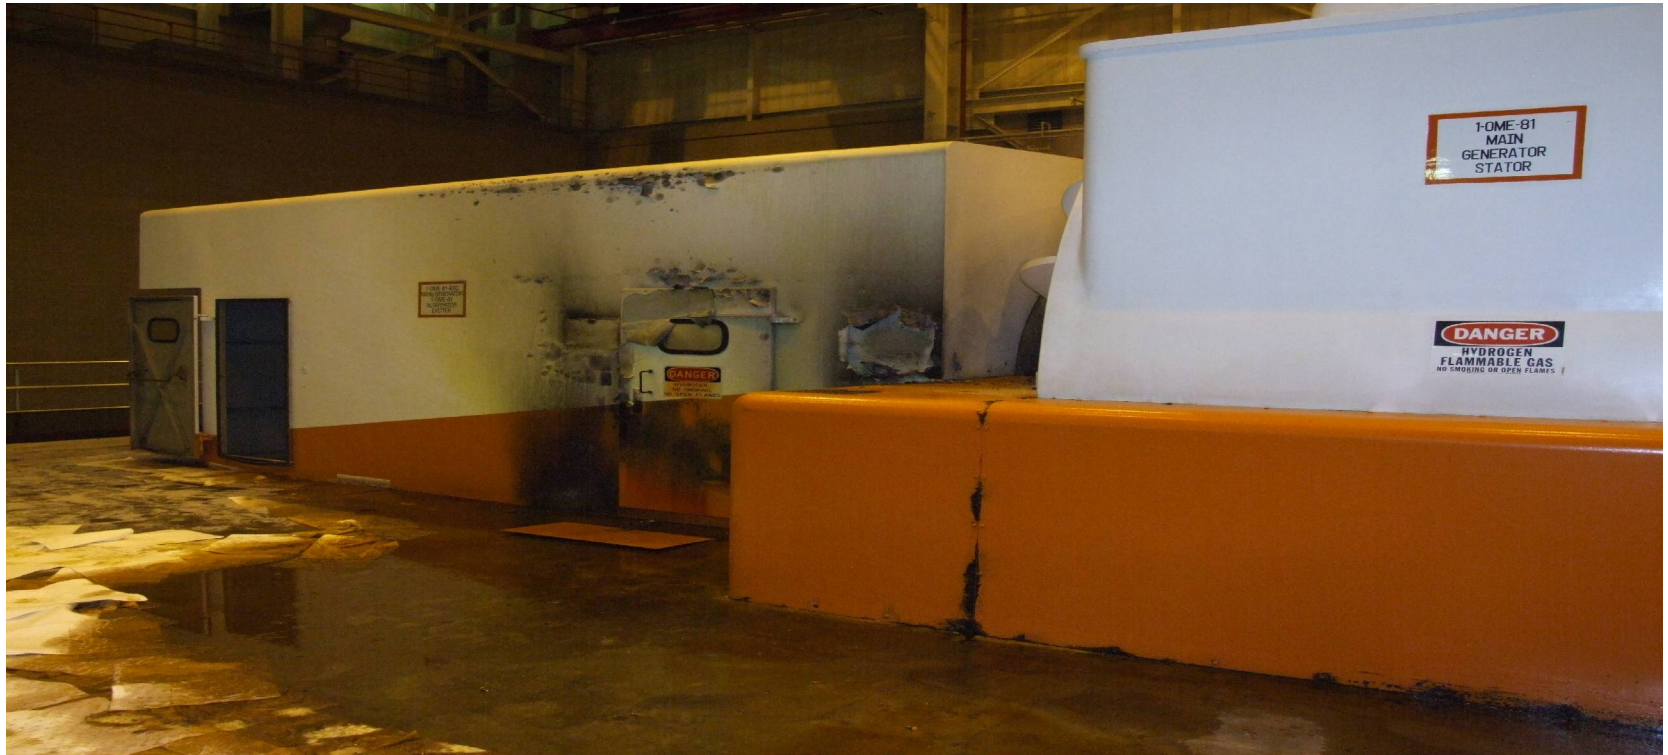
- Fire due to failure of generator hydrogen seal
- Fire brigade responded and extinguished fire within 23 minutes
- Excellent local fire department assistance

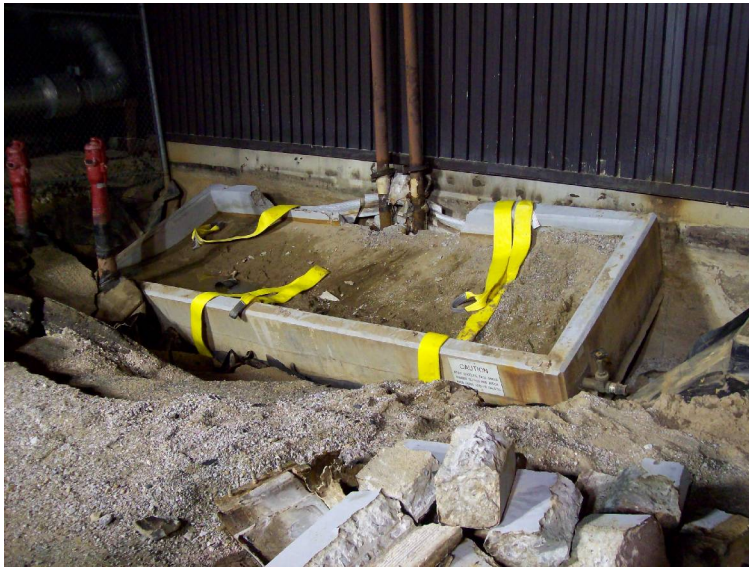
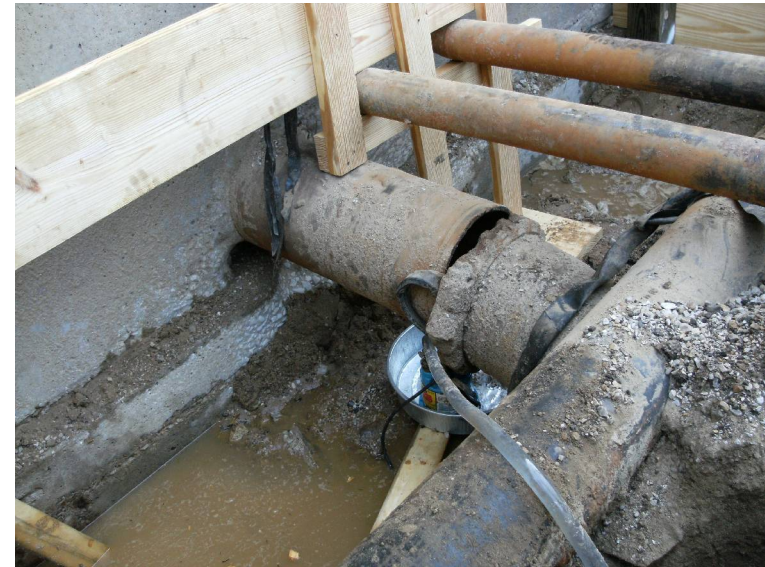
- The Fire Water System experienced complications including a breach of the piping on the West side of the plant, draining of the South Fire Water Tank and failure of the East Diesel Fire Pump.
- The NRC sent a fire protection inspector to the site on September 21, 2008, to launch a Special Inspection Team (SIT).
- The on-site NRC resident inspectors and SIT inspectors monitored activities associated with full restoration of the site-wide fire protection system and conducted an investigation into the causes of both the turbine failure and the fire suppression system failure.
- A number of enhancements were identified and entered into the Corrective Action Program.

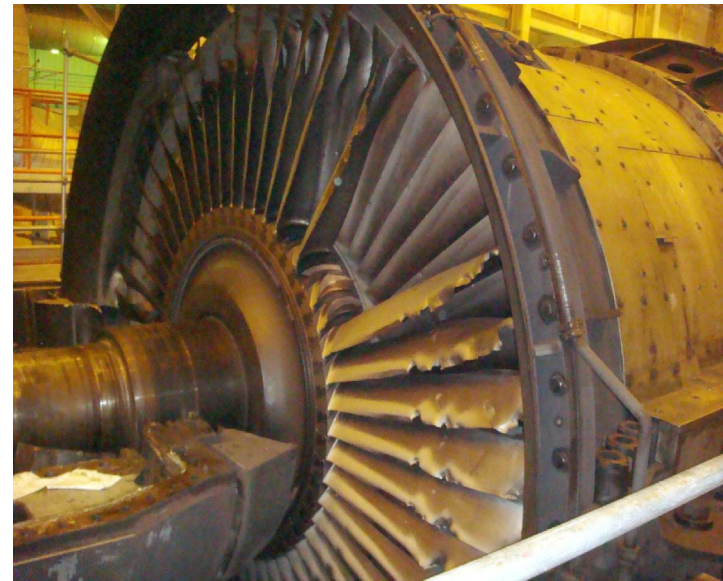
- Blade #40 on LP turbine B, turbine side (LP B TS) is liberated due to high cycle fatigue
- Blade #56 on LP B TS also exhibited high cycle fatigue and is liberated during the event
- Blade #189 on LP turbine C TS also exhibited high cycle fatigue and is liberated during the event
- Blades #29 and #64 on LP B TS fracture in overload during the event
- The loss of 5 L-0 blades creates a severe unbalance condition on the rotor

- The high vibration of the unbalanced turbine causes extensive damage to connected systems.

- Interim repaired LP turbines without L-0 blades
- Replace LP turbines with proven design in 2011
- Design to be validated by a third party review
- Additional turbine monitoring instrumentation

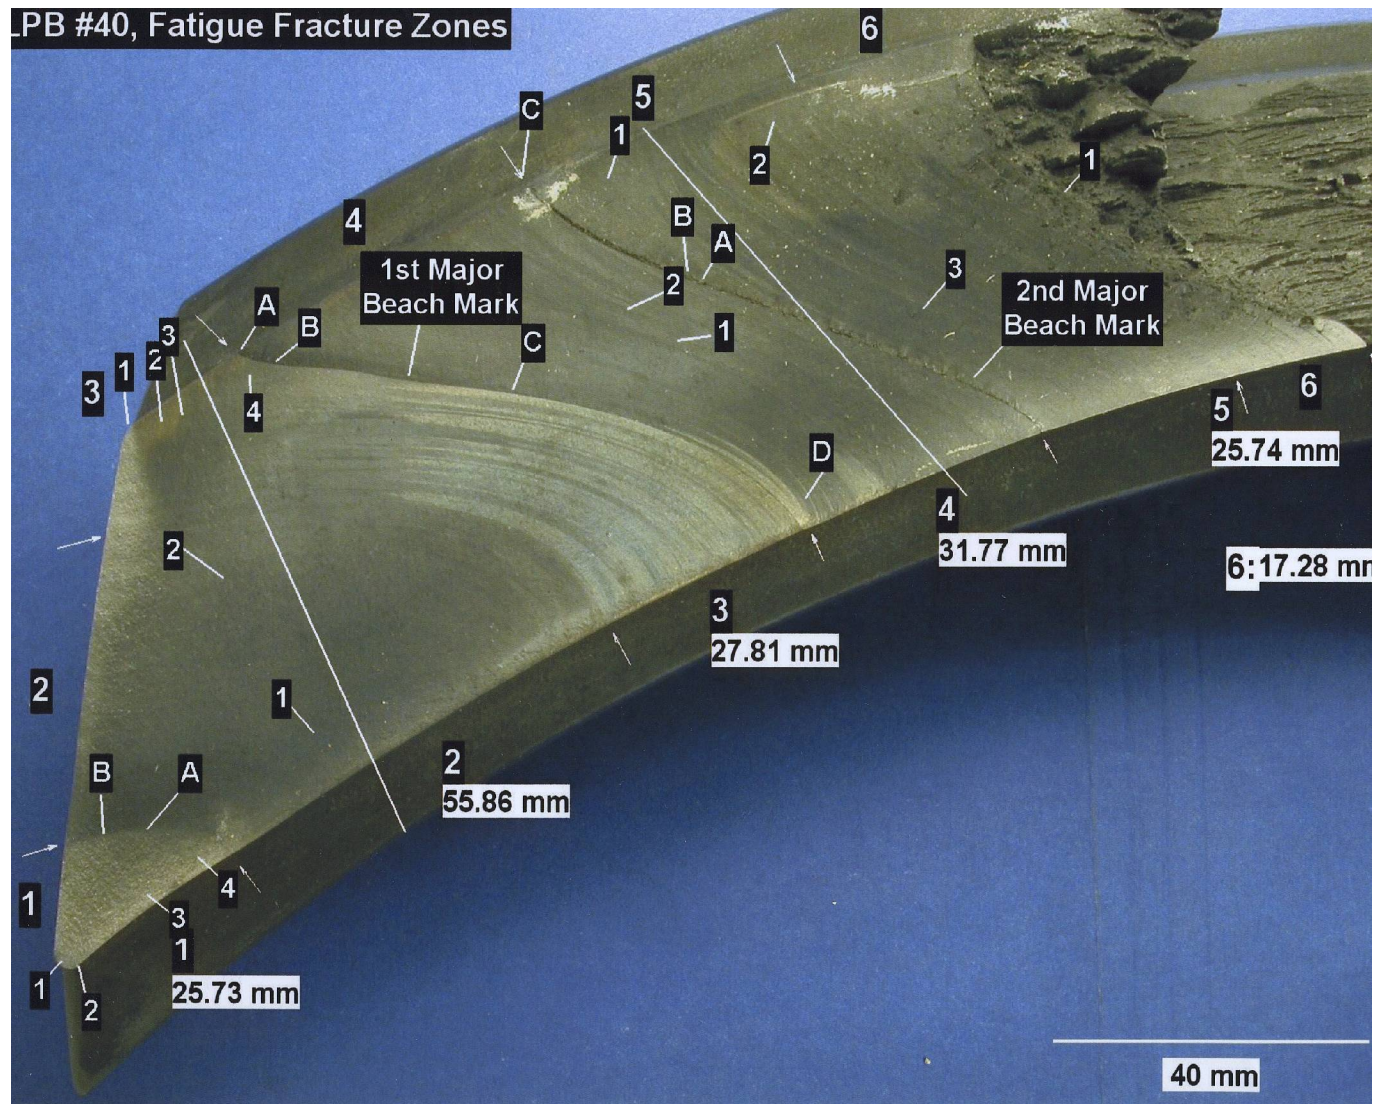
LPB Blade #40 Fracture Surface Distinctive Zones and Beach Marks

A Blade-Rotor System Design Which Failed to Provide Adequate Stress Margin in at Least Three L-0 Blades

- Blade vibrations
- Indications of non-uniform loading in root engagement
- Normal electrical grid variations correlate to fracture beach marks

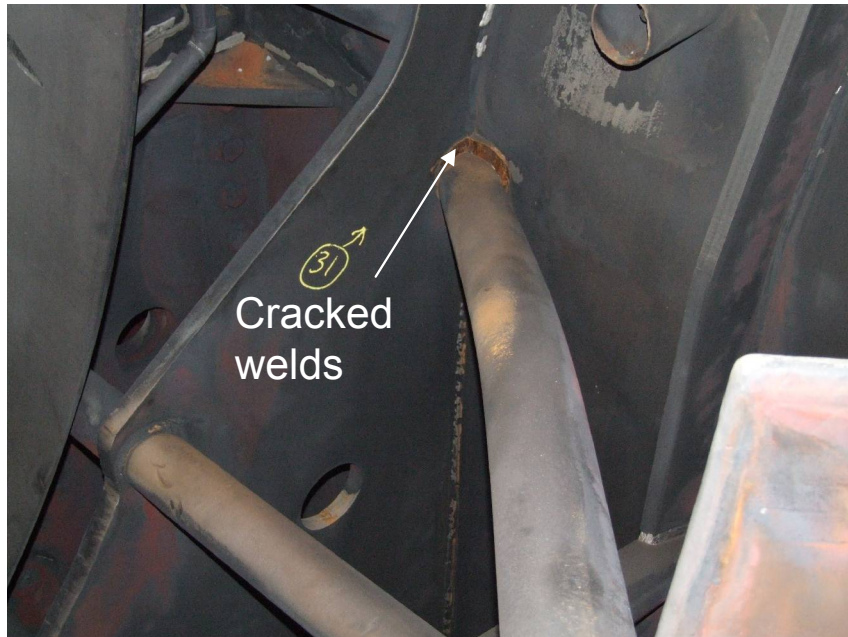
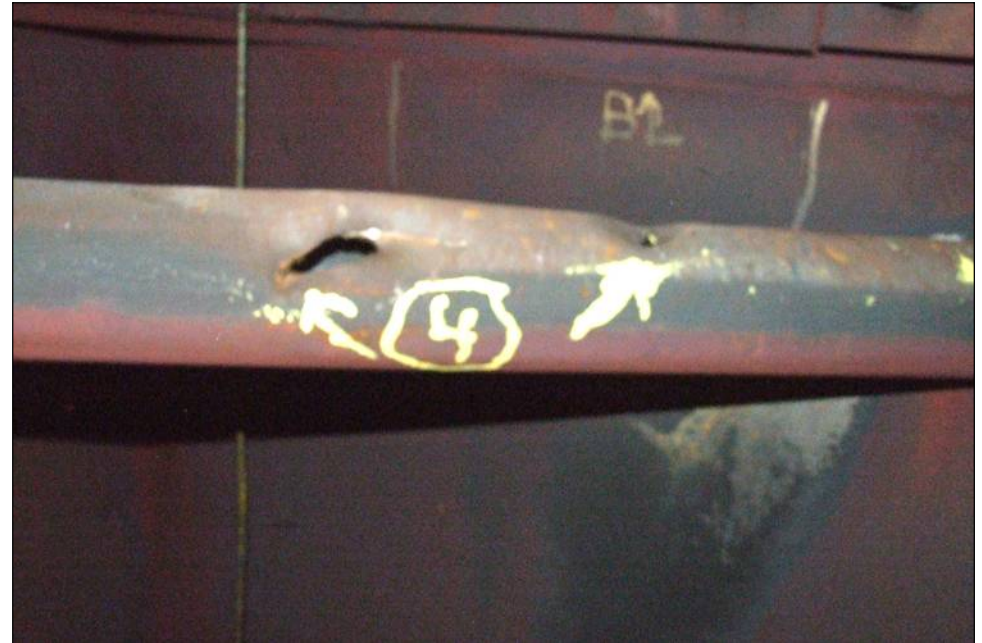
Initial Inspection of LEHs

- Structural supports and struts damaged
 - Grout cracking and foundation bolts damaged
 - Cone extension have moved
-
- LEHs required extensive repairs and are now complete

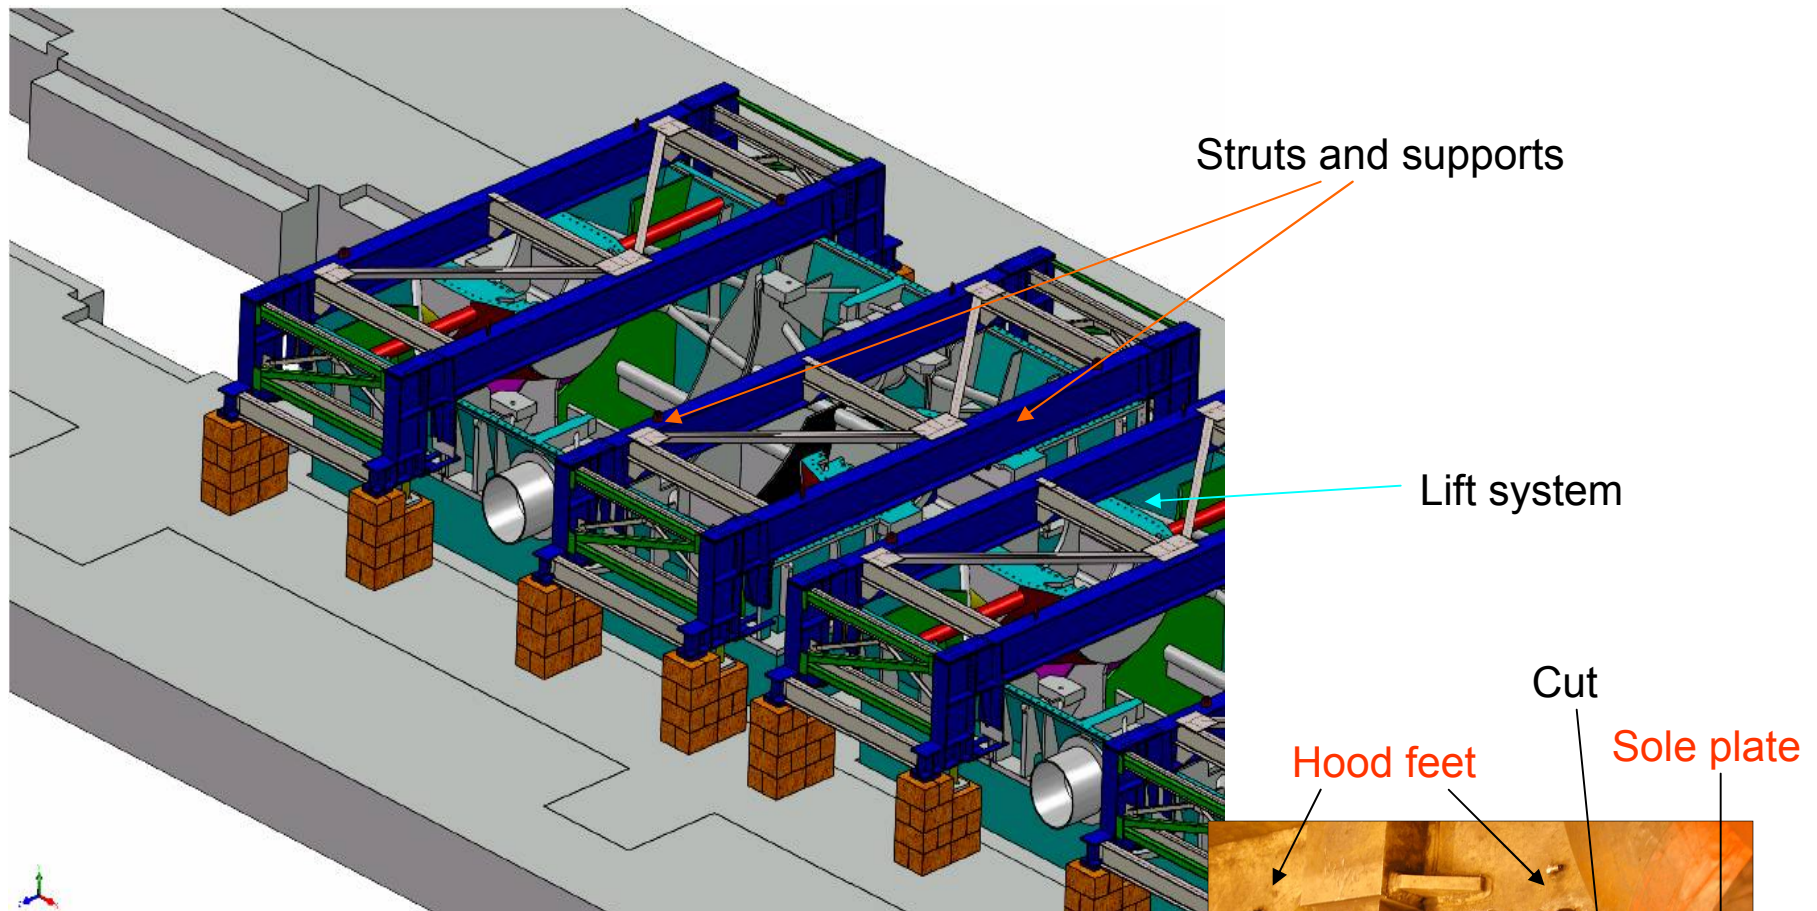
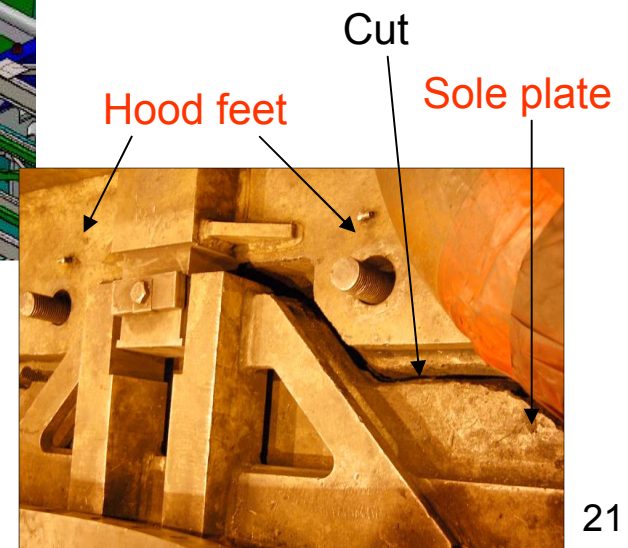
Lifting LEH's

- Sole plates between hoods were welded, due to event, to bottom of LEH feet. Had to be cut without effecting hood supports.

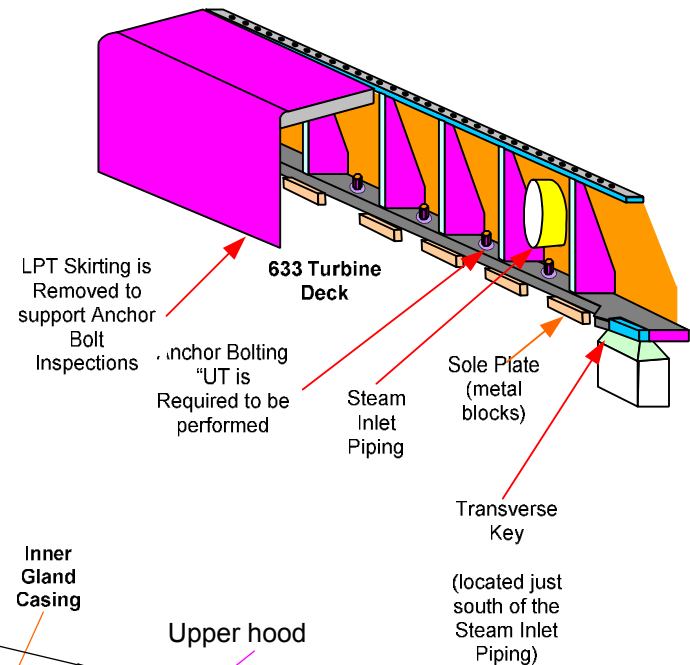
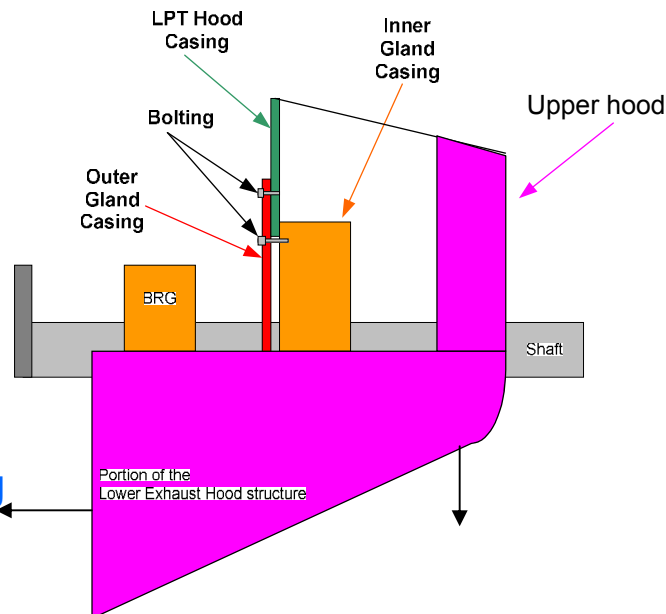
Inspection after Lift

- Sole plates welded to bottom of LEH feet causing damage to feet, requires machining
- Cone extensions have pushed vertical wall on north and south ends
- Large number of welds inside the cones had to be repair and stressed relieved.

- 1) Number of welds
- 2) Lift hoods additional 2' for machining
- 3) Machining feet and verticals

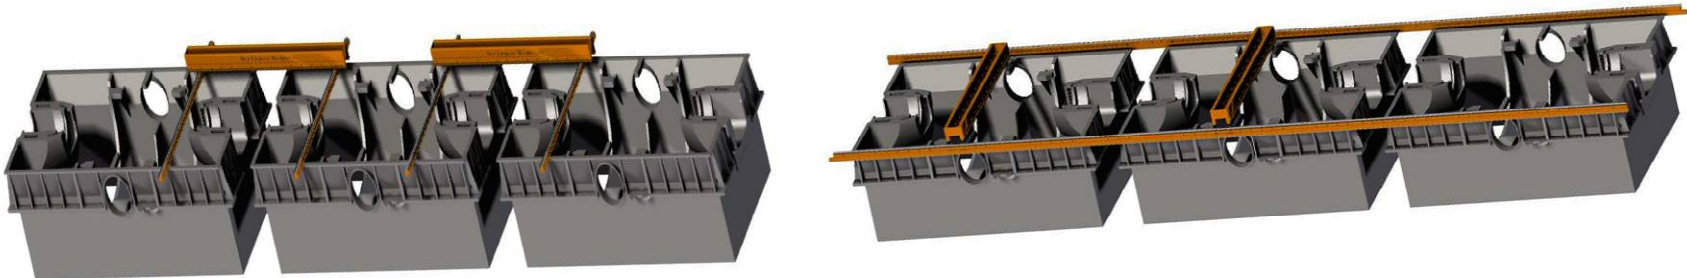
Repairs after LEH's Set

Stress relieve of cones during welding and hood movement due to welding

- 100% NDE on welds revealed more repair than expected.
- Weld build-up on horizontal cone section and bolt holes.
- Machining on horizontal cones
- Installation of strut modification
- Weld buildup and machining on horizontal surfaces for UEH and LEH fit.
- Lower exhaust hood alignment to centerline
- Weld buildup for boring operations
